137th TRIANNUAL AIRDROP REVIEW and MALFUNCTION SAFETY ANALYSIS BOARD

Oct 25 - 27, 2011

MALFUNCTIONS / INCIDENTS REPORTED

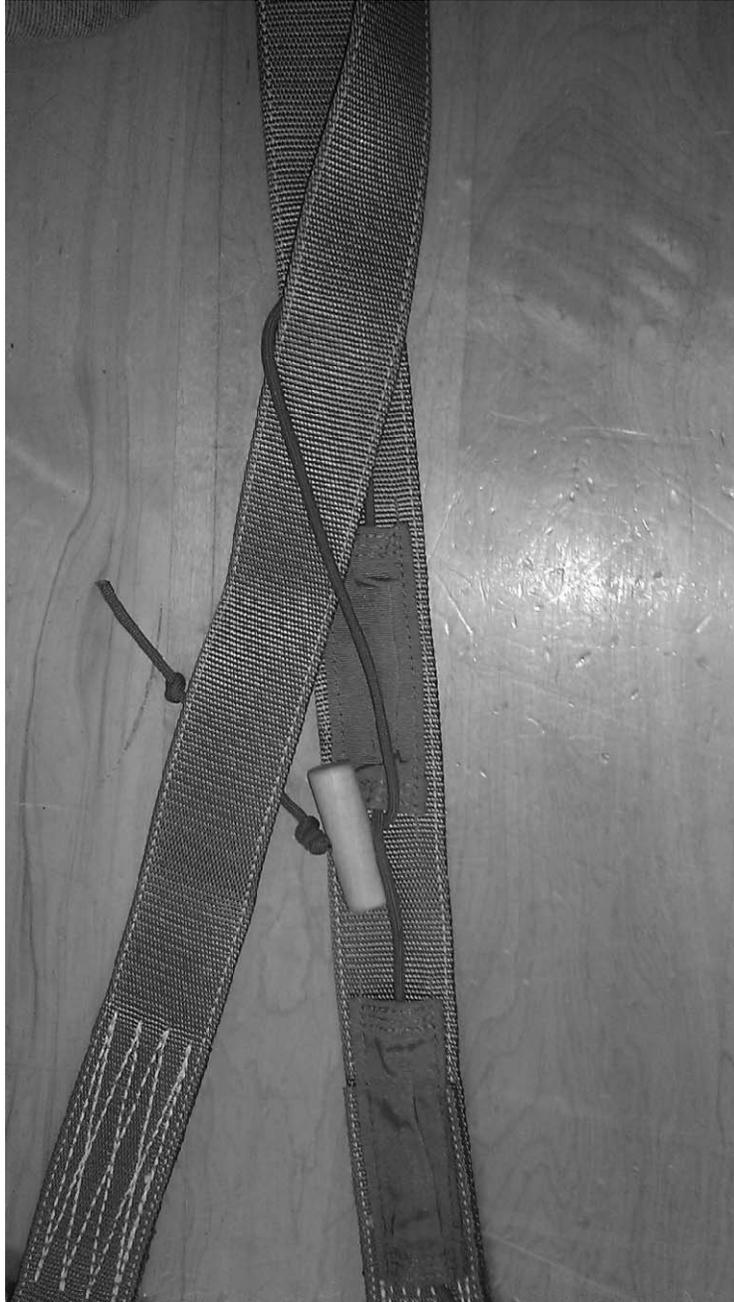
SL1_20110511_EODTEU1_MC6_TangledSteeringLine_C2

Description of Suspected - Malfunction - Incident - damaged incurred: unit was conducting combat equipment jumps as part of MC-6 transition training. Jumper executed a normal ramp exit from a C-2 aircraft travelling at 120 KIAS. While checking canopy jumper noticed his right steering line was wrapped around both right risers and the toggle had become trapped between the riser and exposed portion of steering line between the upper and lower steering line guide channels. Jumper steered canopy with left steering line and landed without further incident.

Suspected Cause of Malfunction - Incident: undetermined due to insufficient facts.

MC-6 Steering Line tangled around risers. (Re-created in the loft)

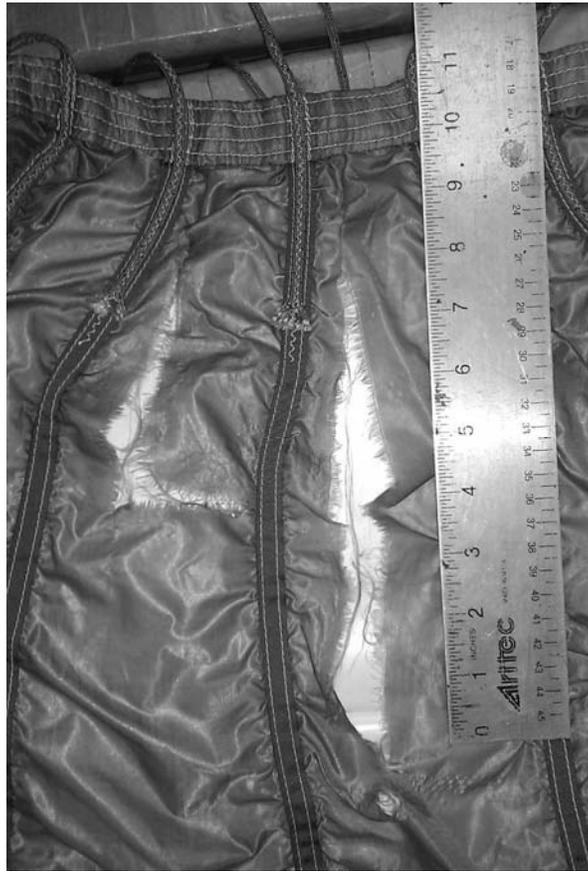
Gores 19 & 20

- Canopy material near the apex on two adjoining gores (19 & 20) blew out during opening
- Both holes start near the upper lateral band and run more or less down the center of each gore
- One hole is approximately 11 inches long and the other hole is approximately 5 inches long
- There is additional minor damage (small tears less than an inch long) to two other gores (17 & 18) in the same area.

Suspected Cause of Malfunction - Incident: Unknown at this time.

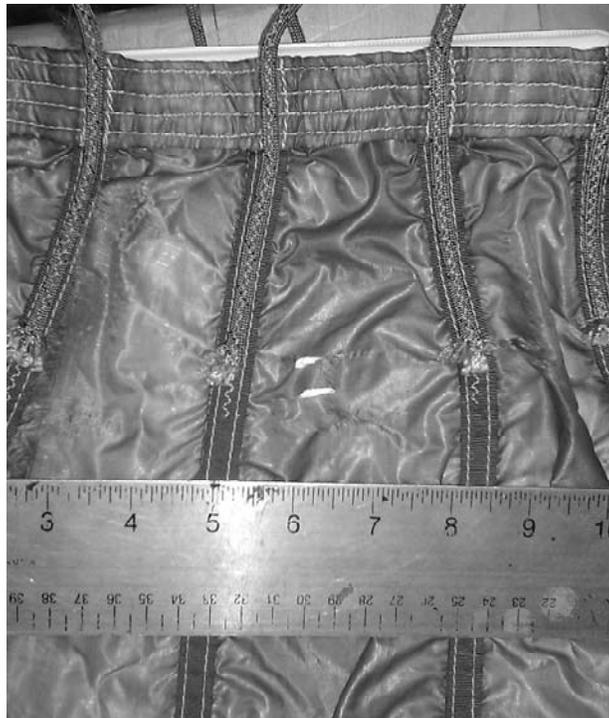
Gores 17 & 18

- In addition to the small holes there are what appear to be friction burns running horizontally across both gores.

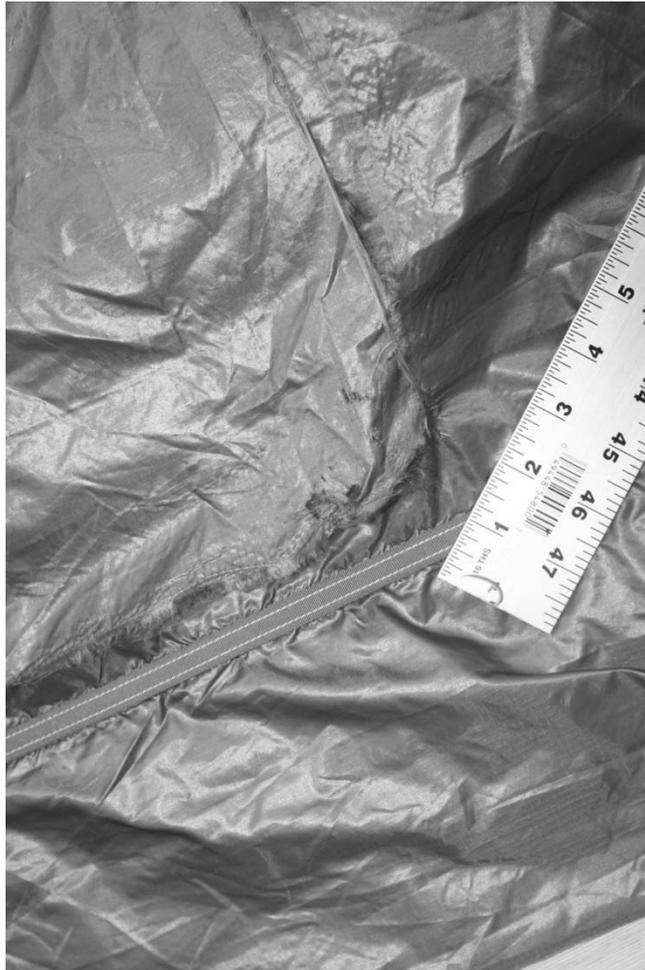
Gore 10 Panel B Corner Burn

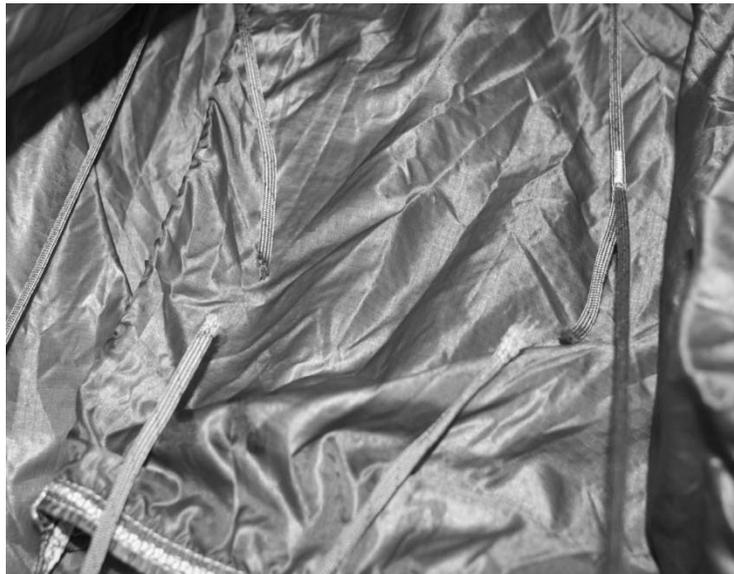
Left Control Line Broken

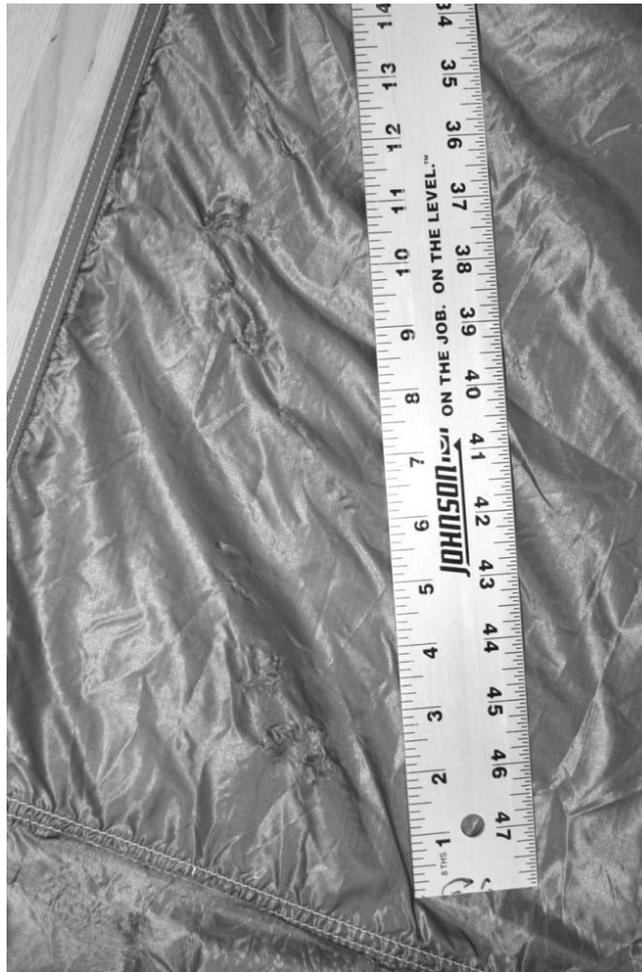
Gore 13 Panel C Various Holes

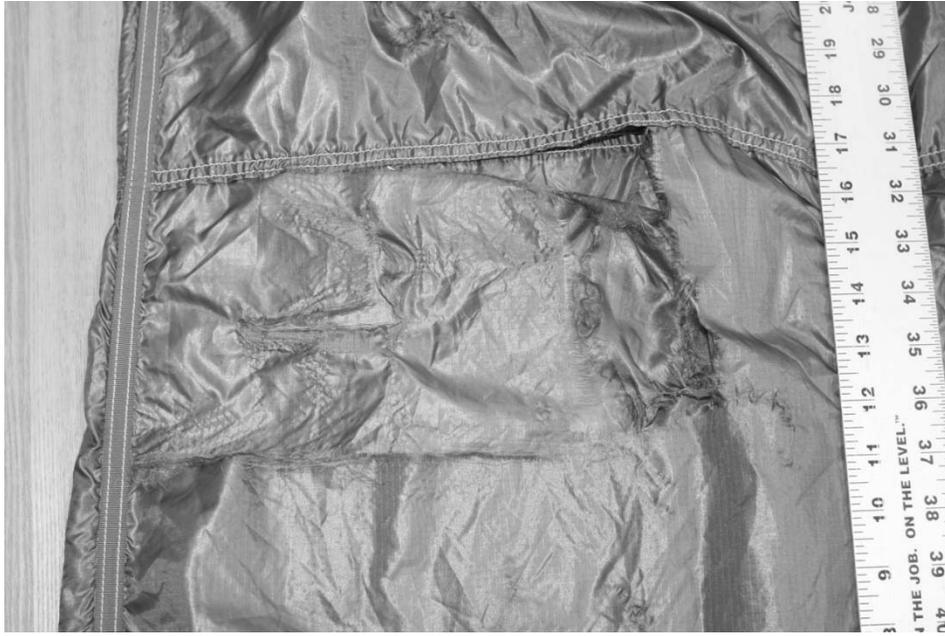
Gore 13 Panel B Burns and Tears

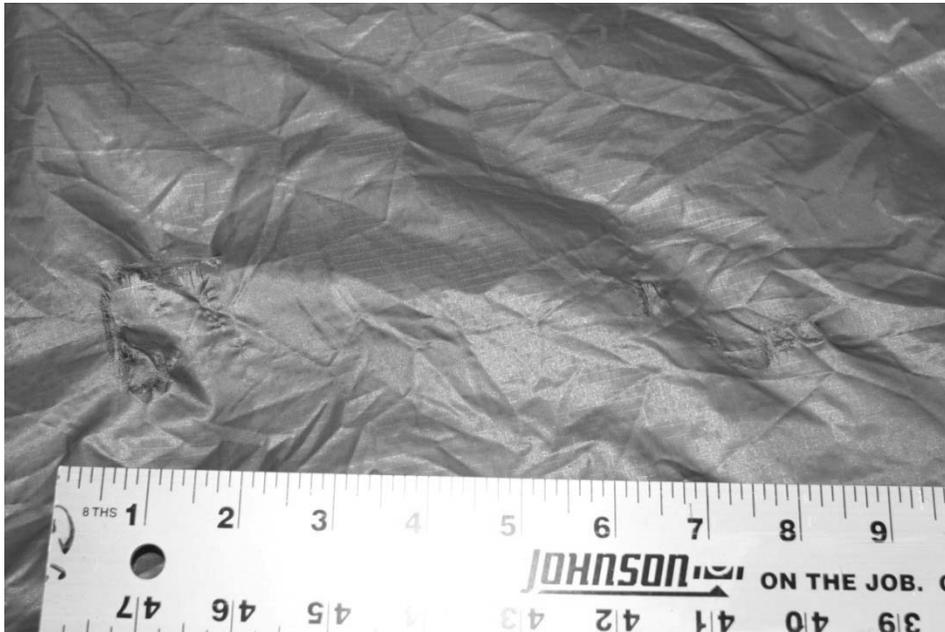
Gore 11 Panel B three holes

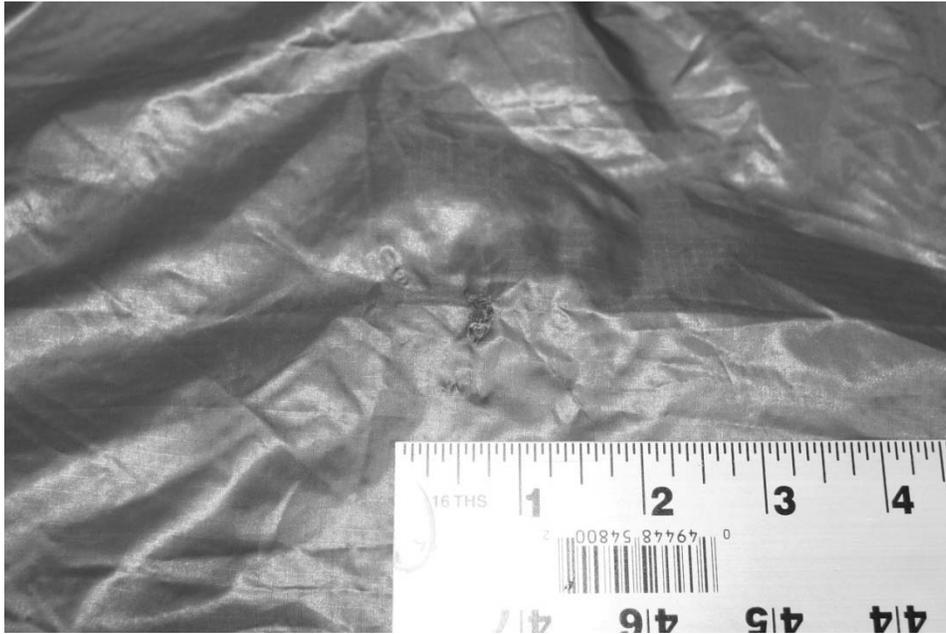
Gore 10 Panel C burn

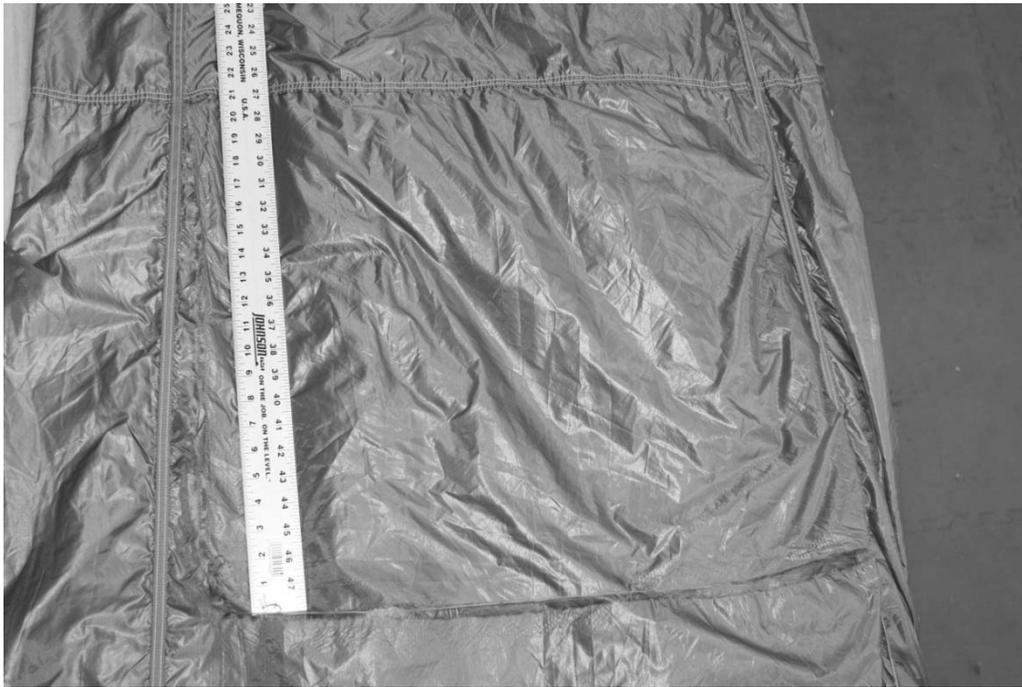
Gore 10 panel B tear in vertical seam

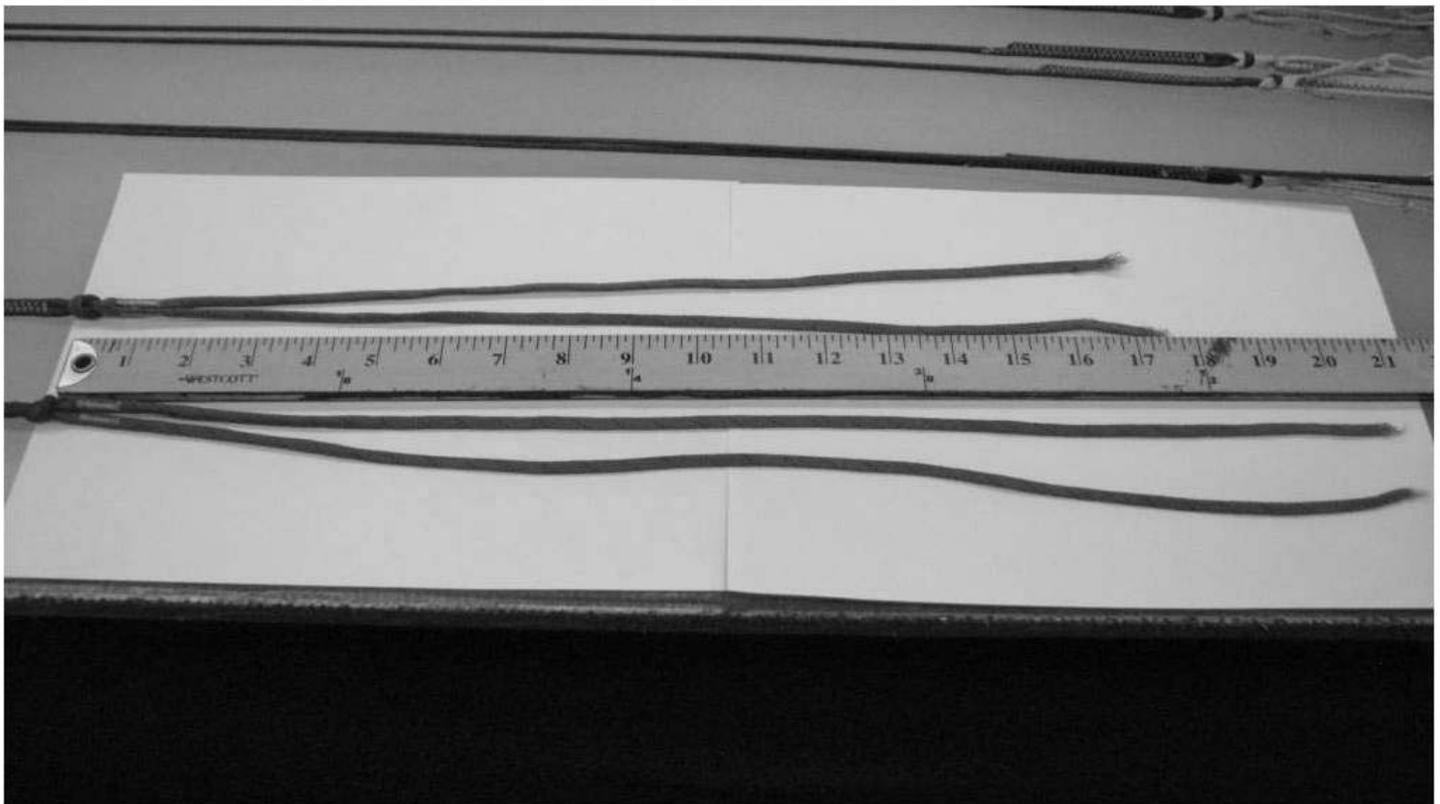
After looking at damage to canopy it seems as if the middle control lines are becoming wrapped around canopy during deployment and causing burn/holes to canopy and creating enough tension to break the gutted type II used in the middle control line assembly.

MC6 Serial # 19893 Control Lines

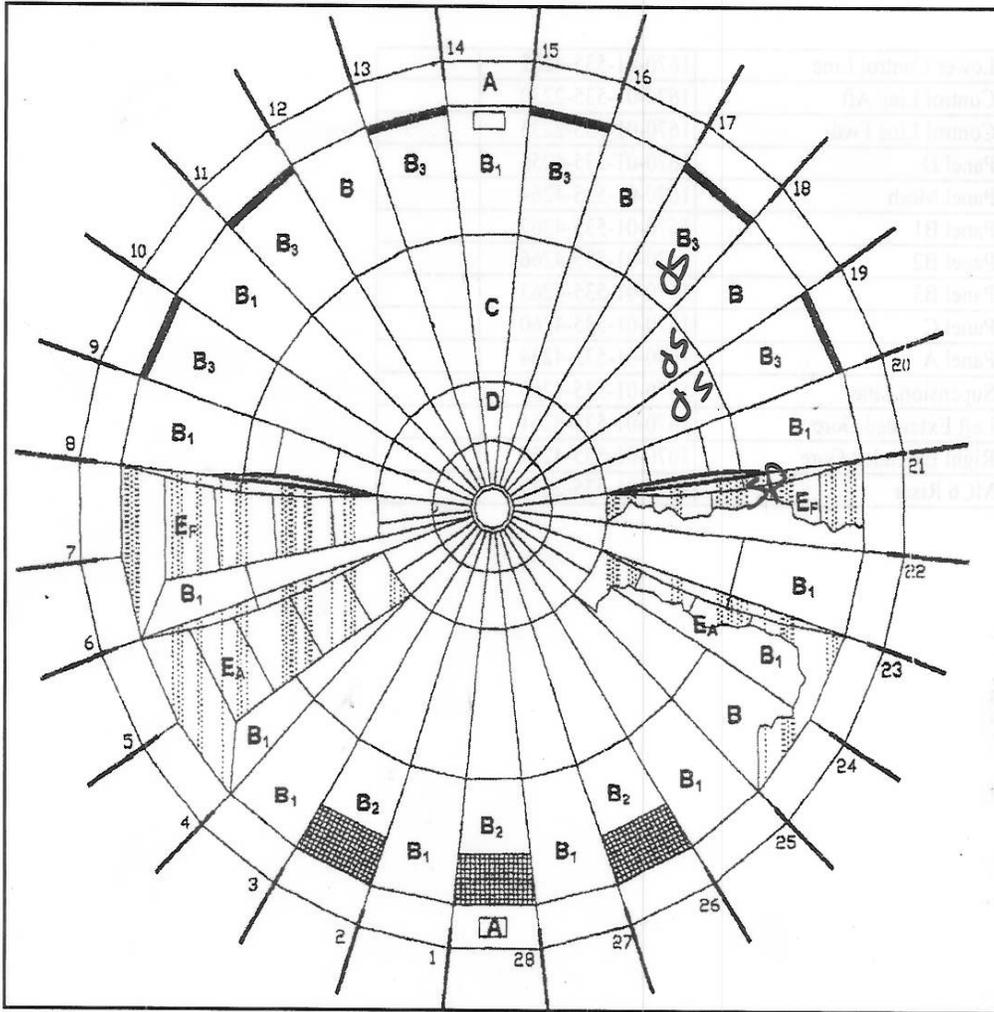
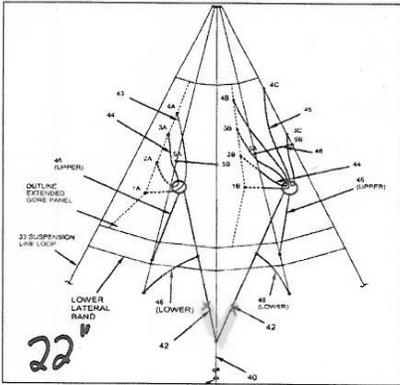
MC6 PARACHUTE SCHEMATIC

Burn 17 SEC 2
 Burn 18 SEC 3
 Burn 19 SEC 3
 RCL 292 1/2 / 14
 LCL 292 / 14
 Burn 21 SEC 2

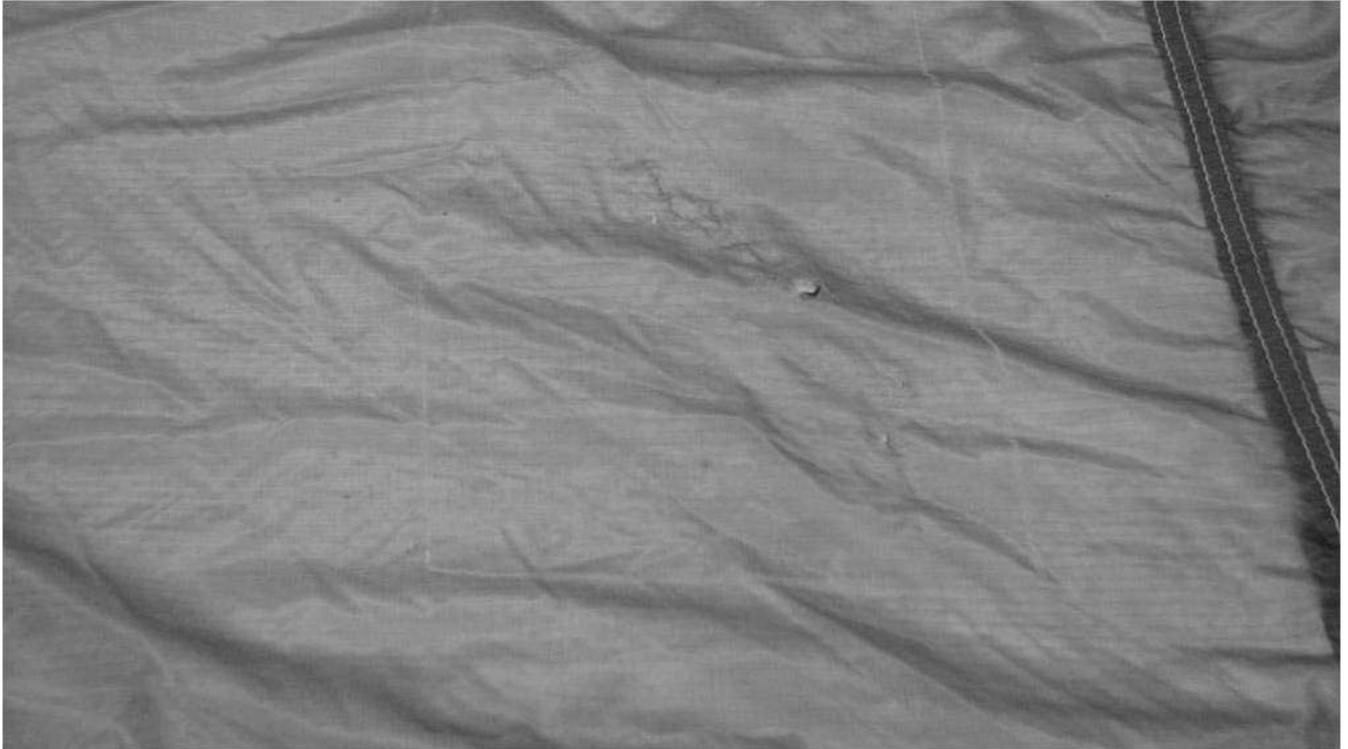
MC-6 Serial# 19893 Gore 17, Section 2 Burns

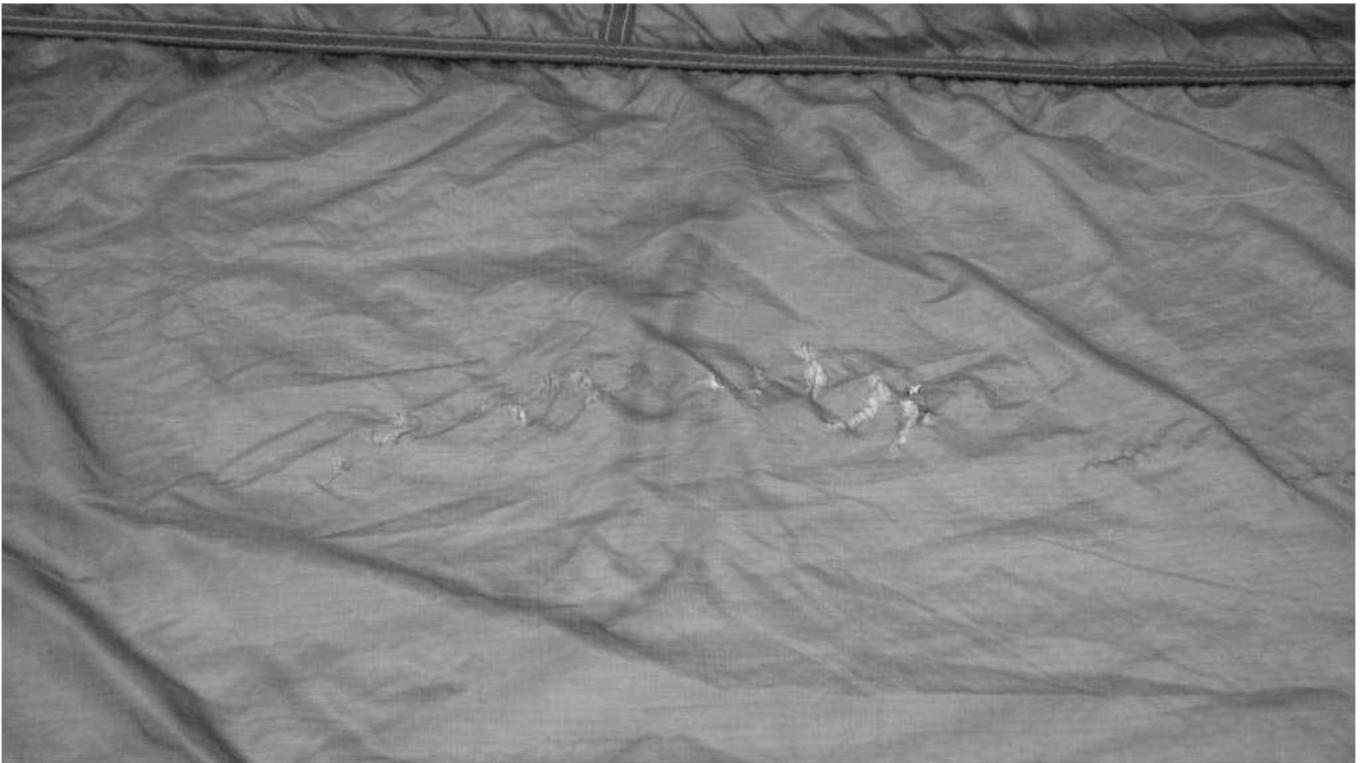
MC-6 Serial# 19893 Gore 19, Section 3 Burns

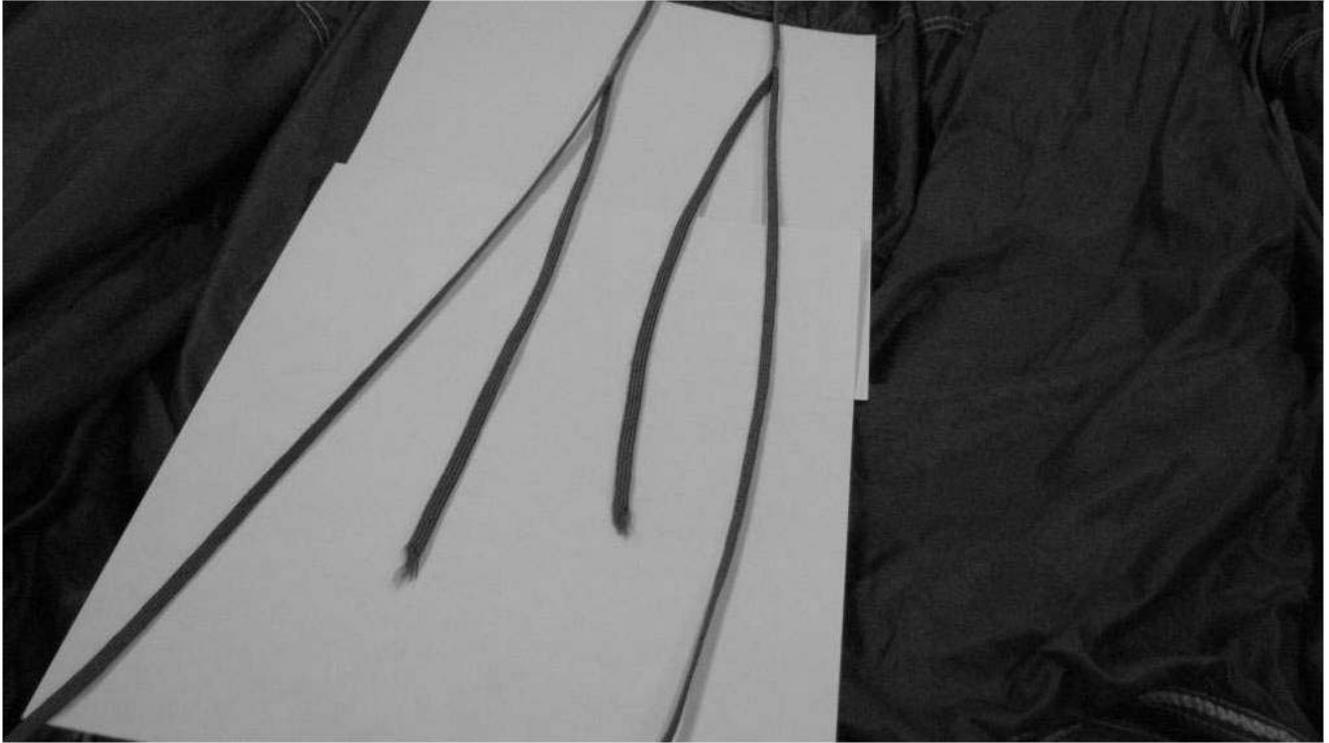
MC6 Serial # 19893 Left Mid Control Line

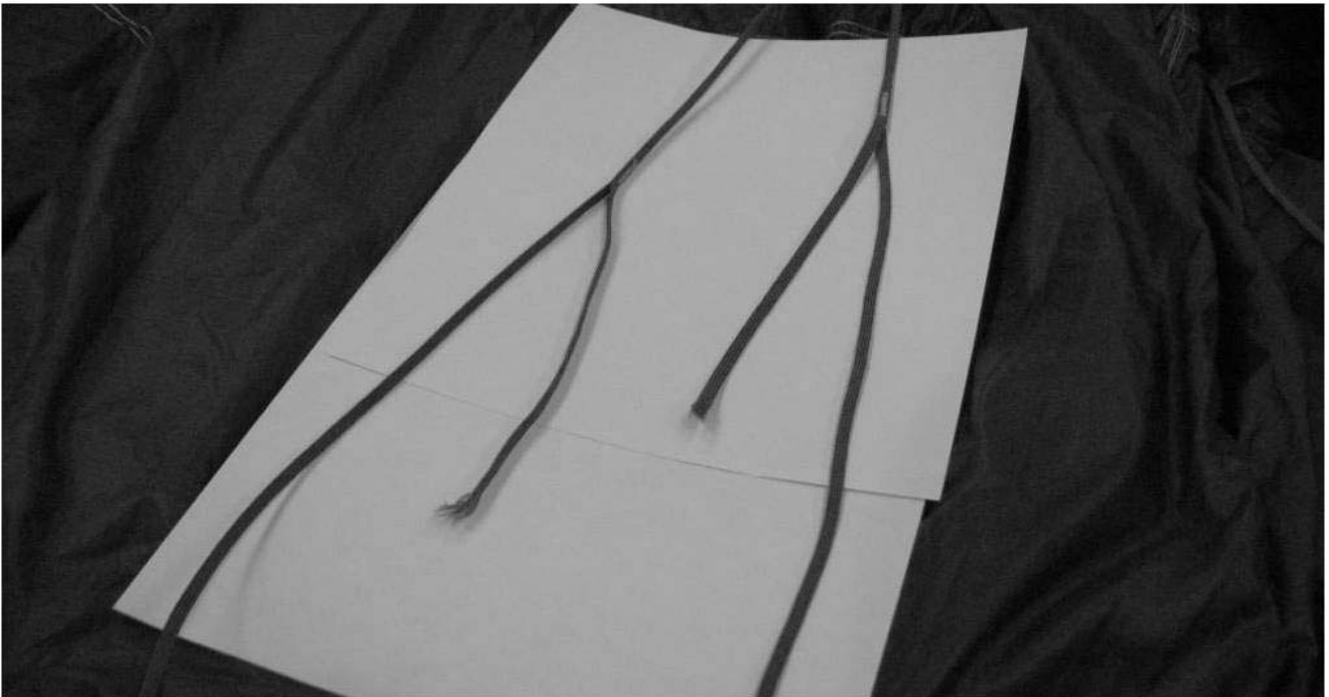
MC6 Serial # 19893 Right Mid Control Line

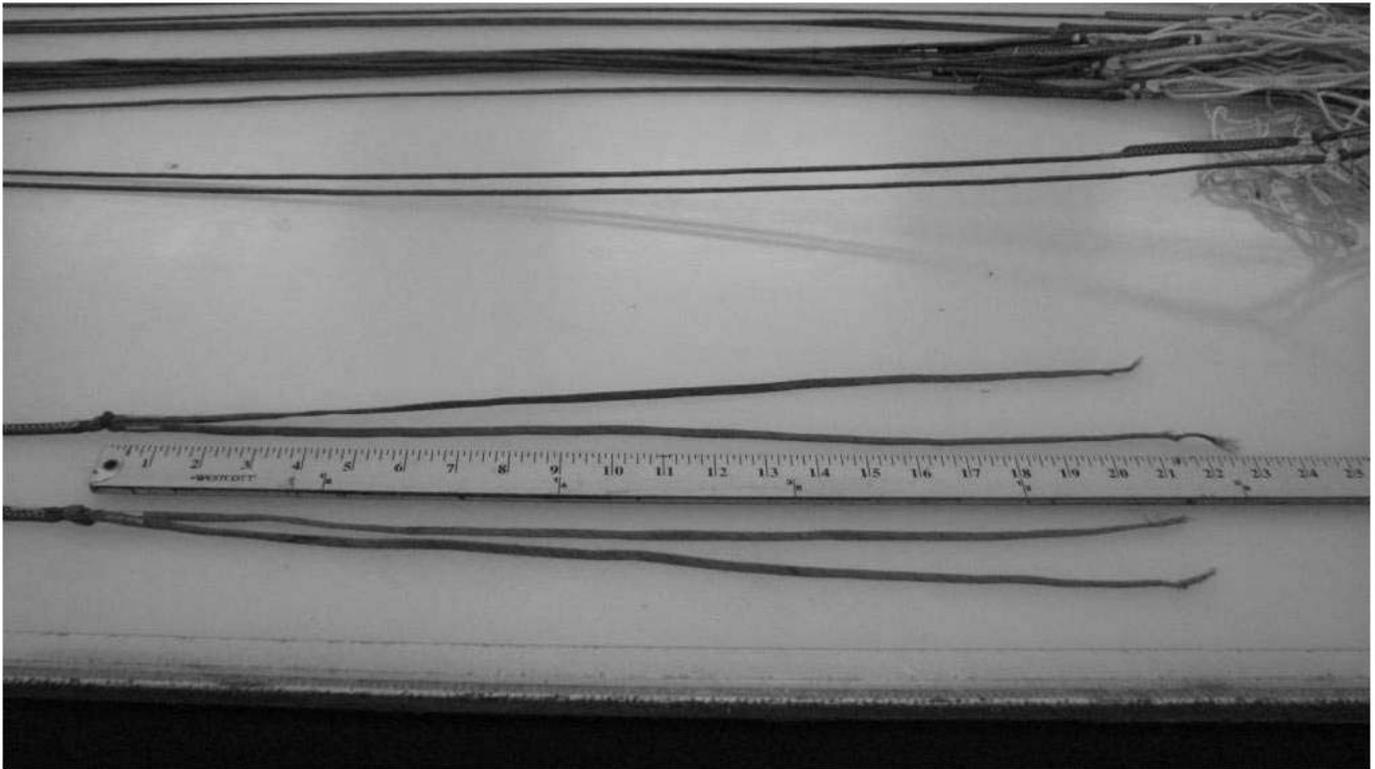
Suspected Cause of Malfunction - Incident: This was one of two parachutes on the same day with both control lines broken. Jumpers, height / weight / equipment / aircraft / and exit all seem to be the same. It was two different packers, packed on different days, with different IP's. There was a QA/QC pull down done of 4 random parachutes packed by these packers with no deficiency found during pull down. All packers were retrained and special attention was made to clearing middle control line assembly during pack up. After looking at damage to canopy it seems as if the middle control lines are becoming wrapped around canopy during deployment and causing burn/holes to canopy and creating enough tension to break the gutted type II used in the middle control line assembly. This parachute's lower control lines were rebased line to 290" at 14lbs tension. This is the 3rd jump sense rebase line.

MC6 Serial # 11450 Control Line

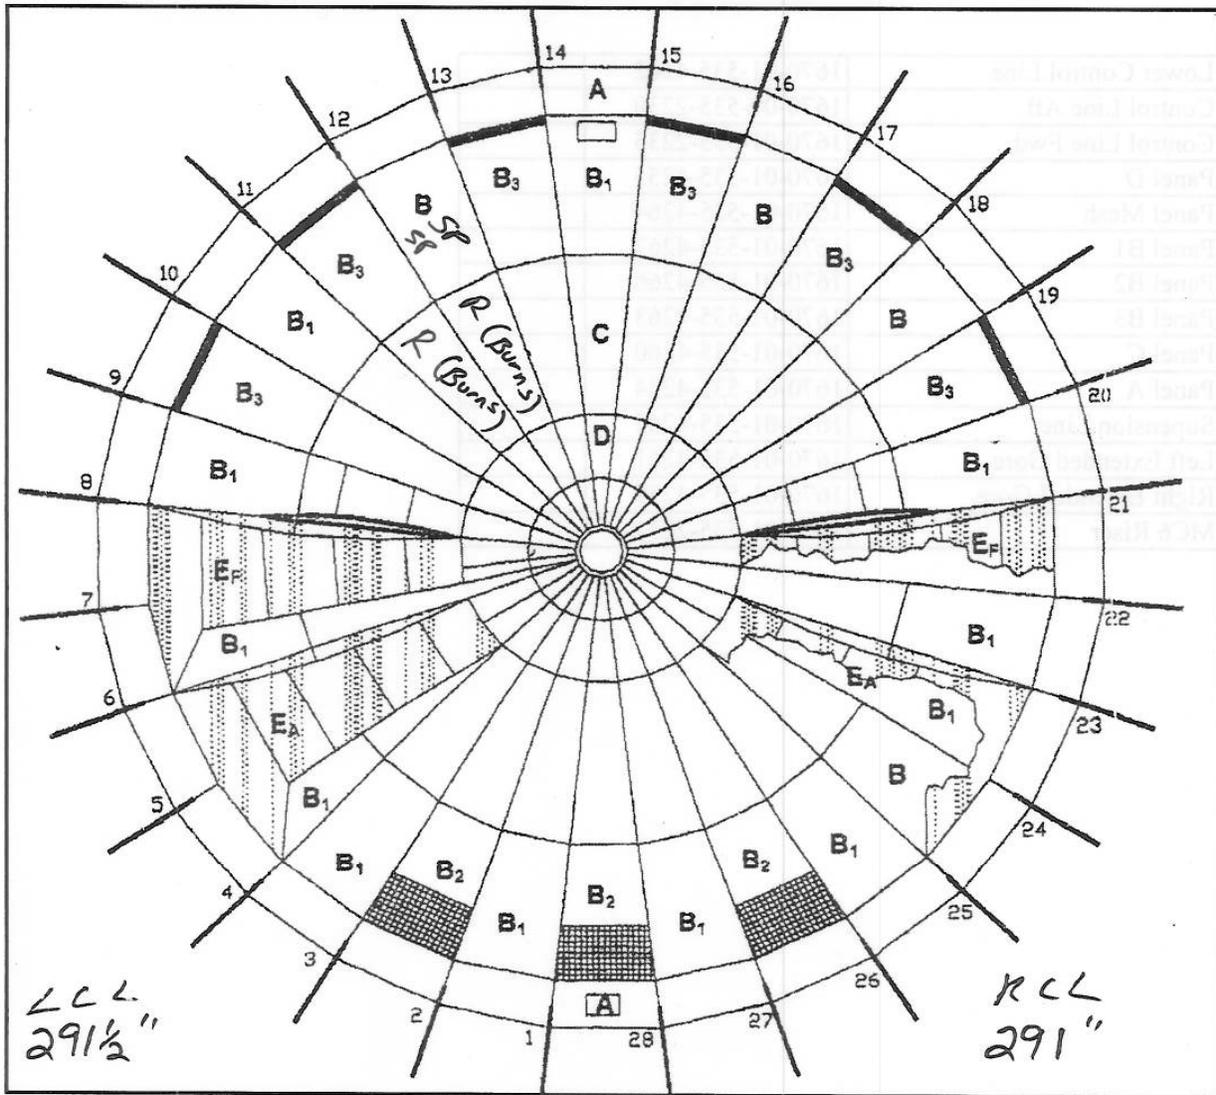
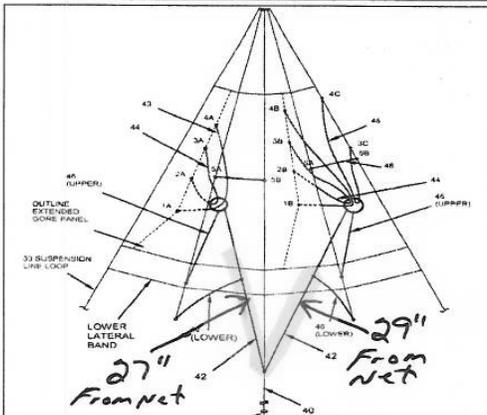
MC6 PARACHUTE SCHEMATIC

Burn 11 sec 3
 Burn 12 sec 2/3
 cage code
 02693

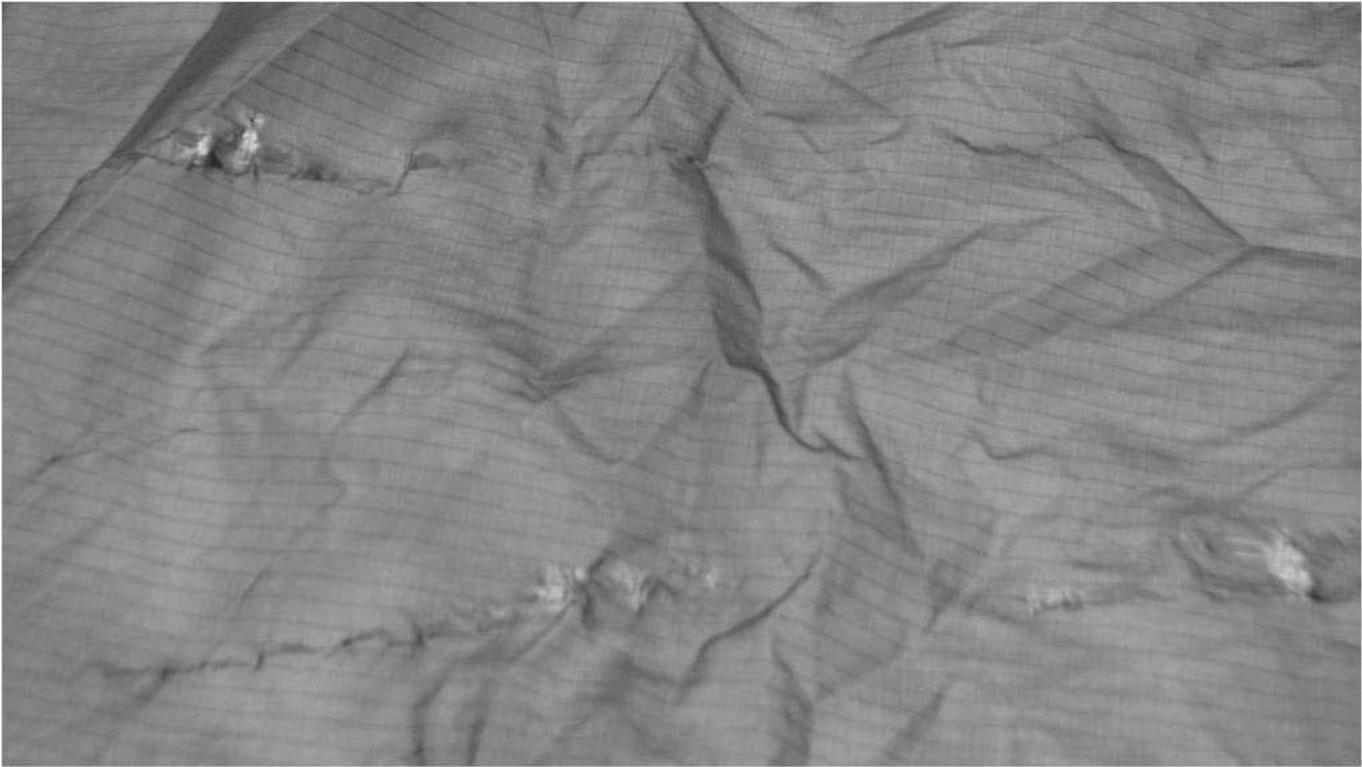
MC6 Serial # 11450 Gore 11, Section 3 Burns and Holes

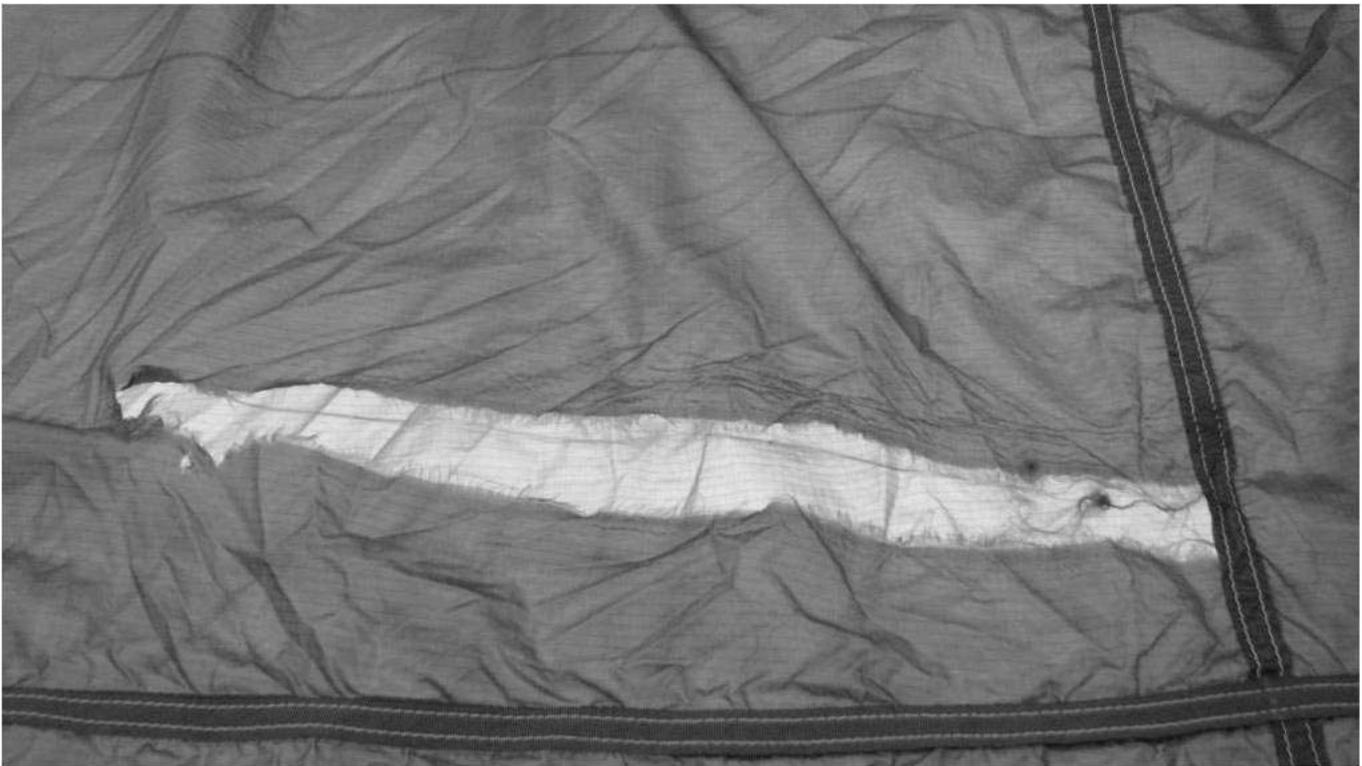
MC6 Serial # 11450 Gore 12, Section Burns and Holes

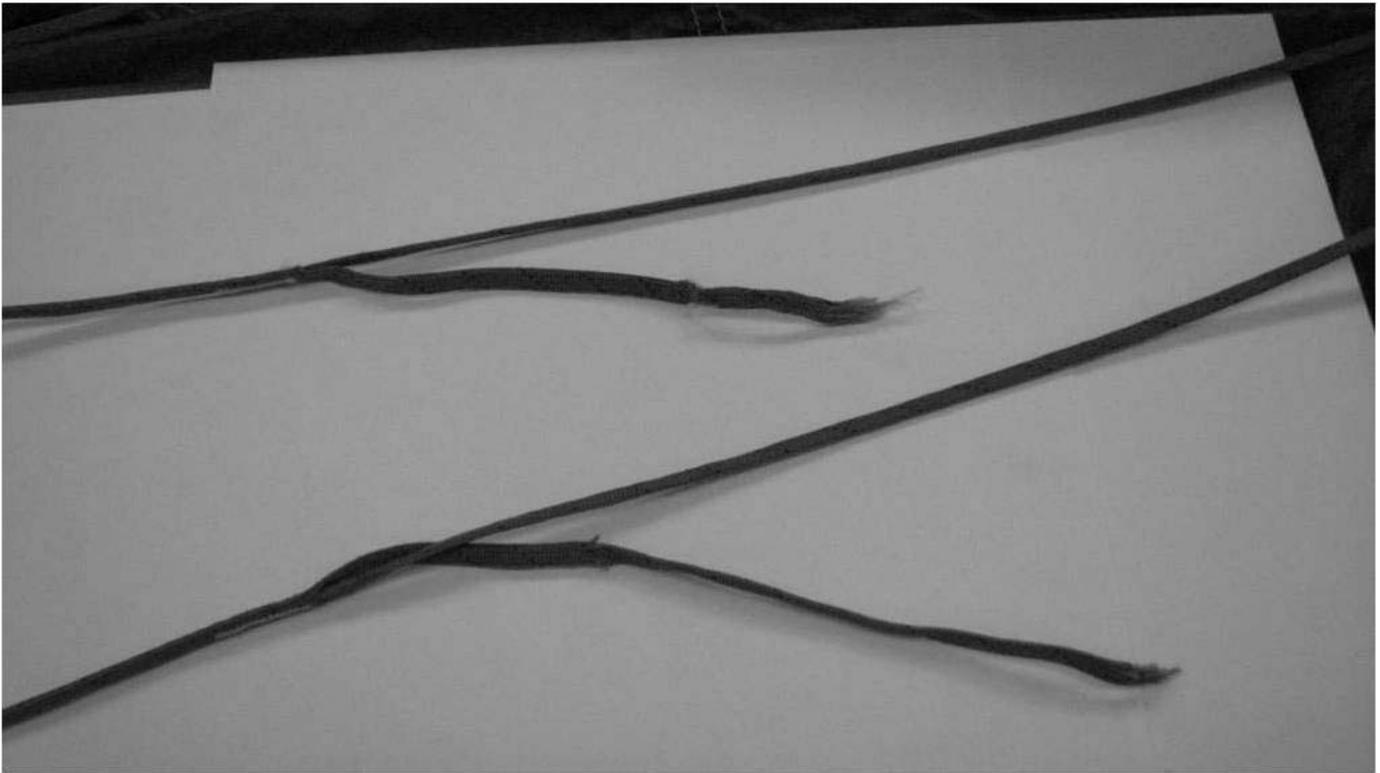
MC6 Serial # 11450 Left Mid Control Lines

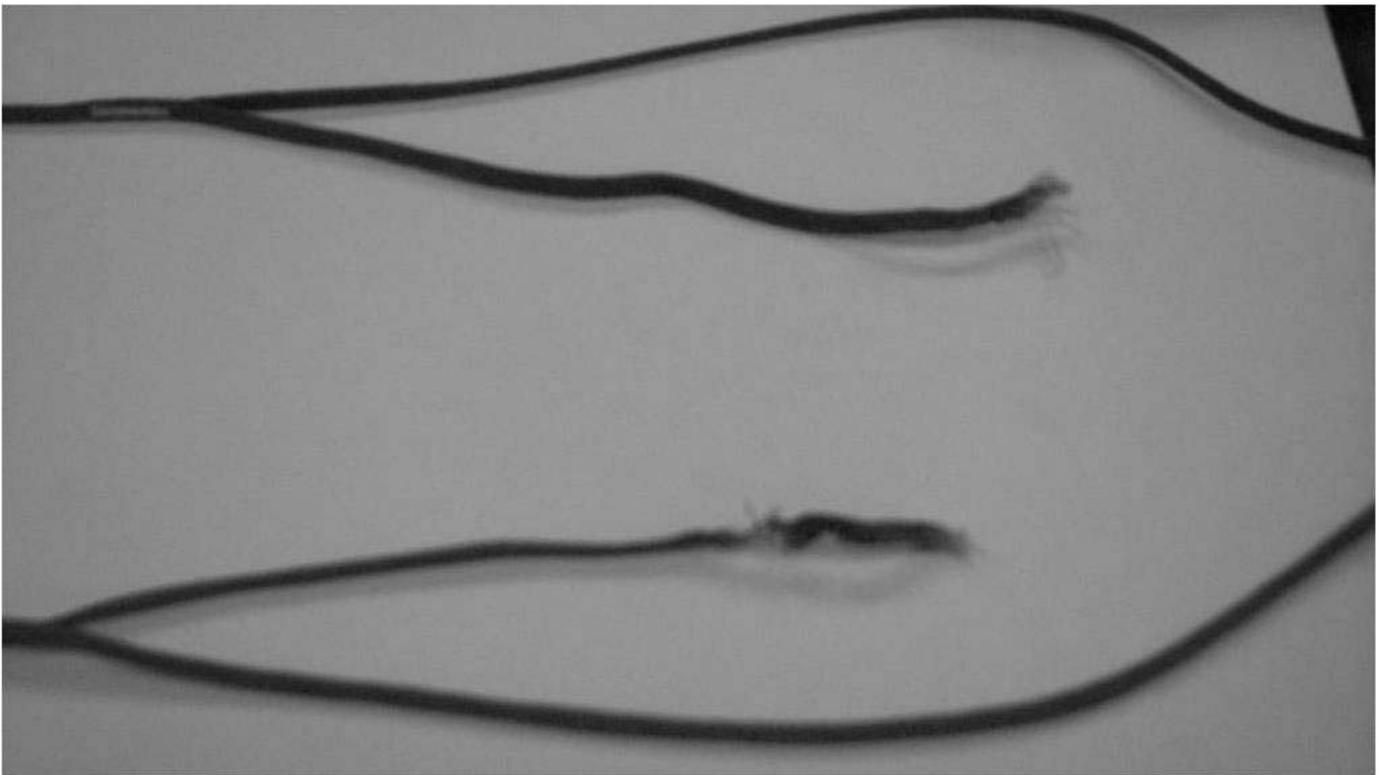
MC6 Serial # 11450 Right Mid Control Lines

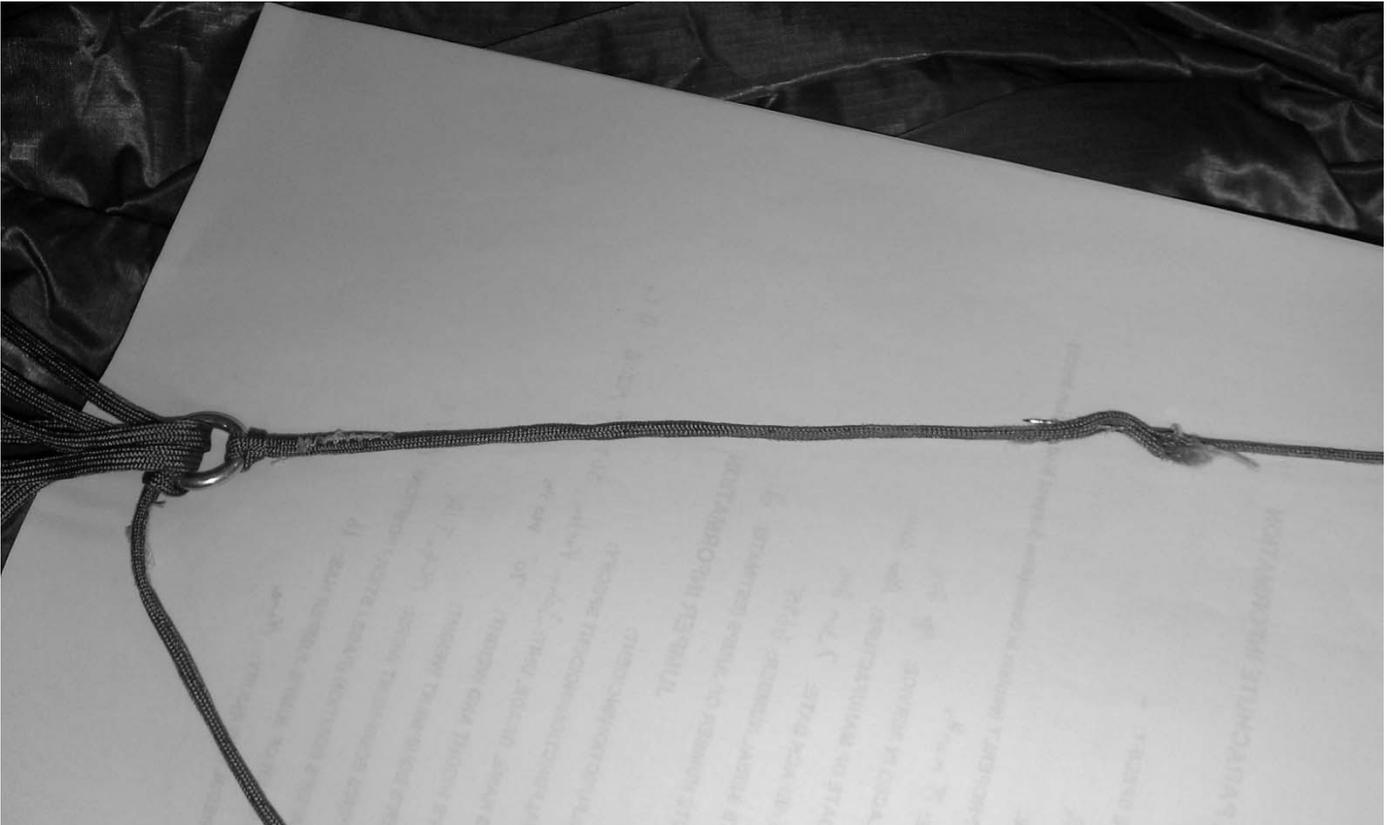
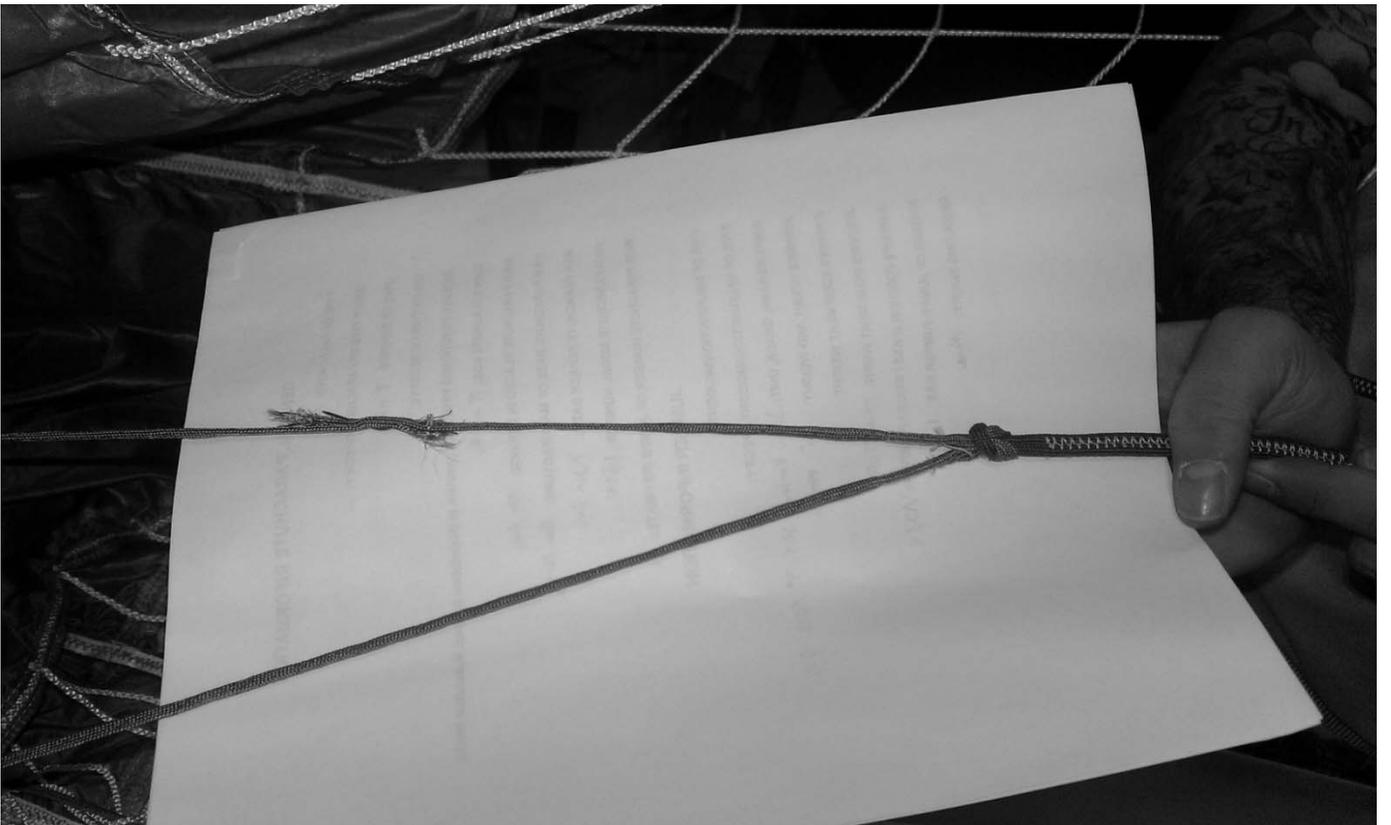
SL17_20110614_9MISB_MC6_BrokenControlLine_C212

The damage was on the left side of the middle control lines. The damage was the middle control line that is attached to suspension Line 7 and it was broken in two places on control line 42.

Suspected Cause of Malfunction - Incident: Jumper had twists that possibly caused tension on the middle control lines and cause it to break in two places.
