137th TRIANNUAL AIRDROP REVIEW and MALFUNCTION SAFETY ANALYSIS BOARD

Oct 25 - 27, 2011

MALFUNCTIONS / INCIDENTS REPORTED

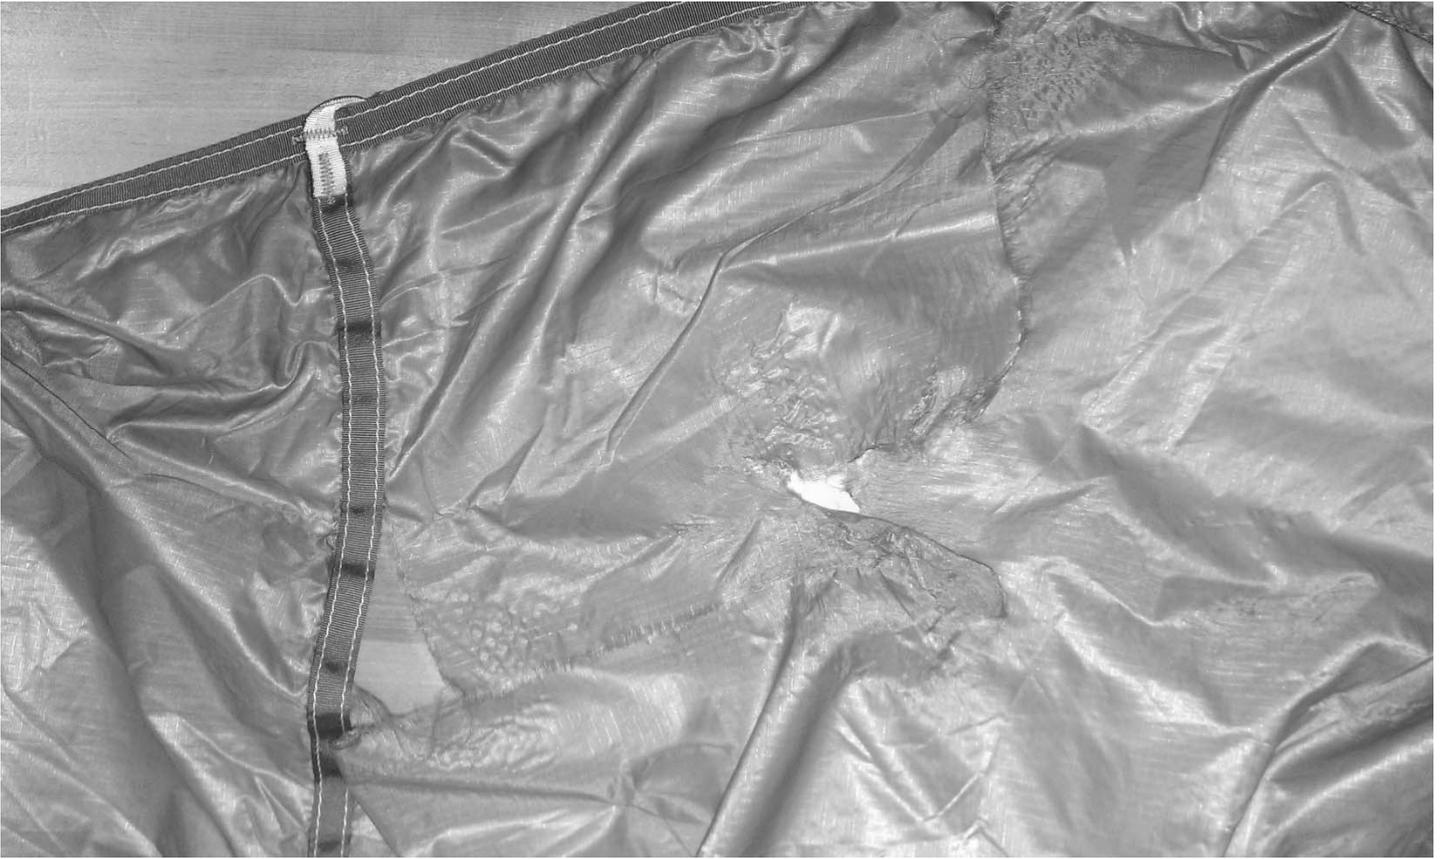
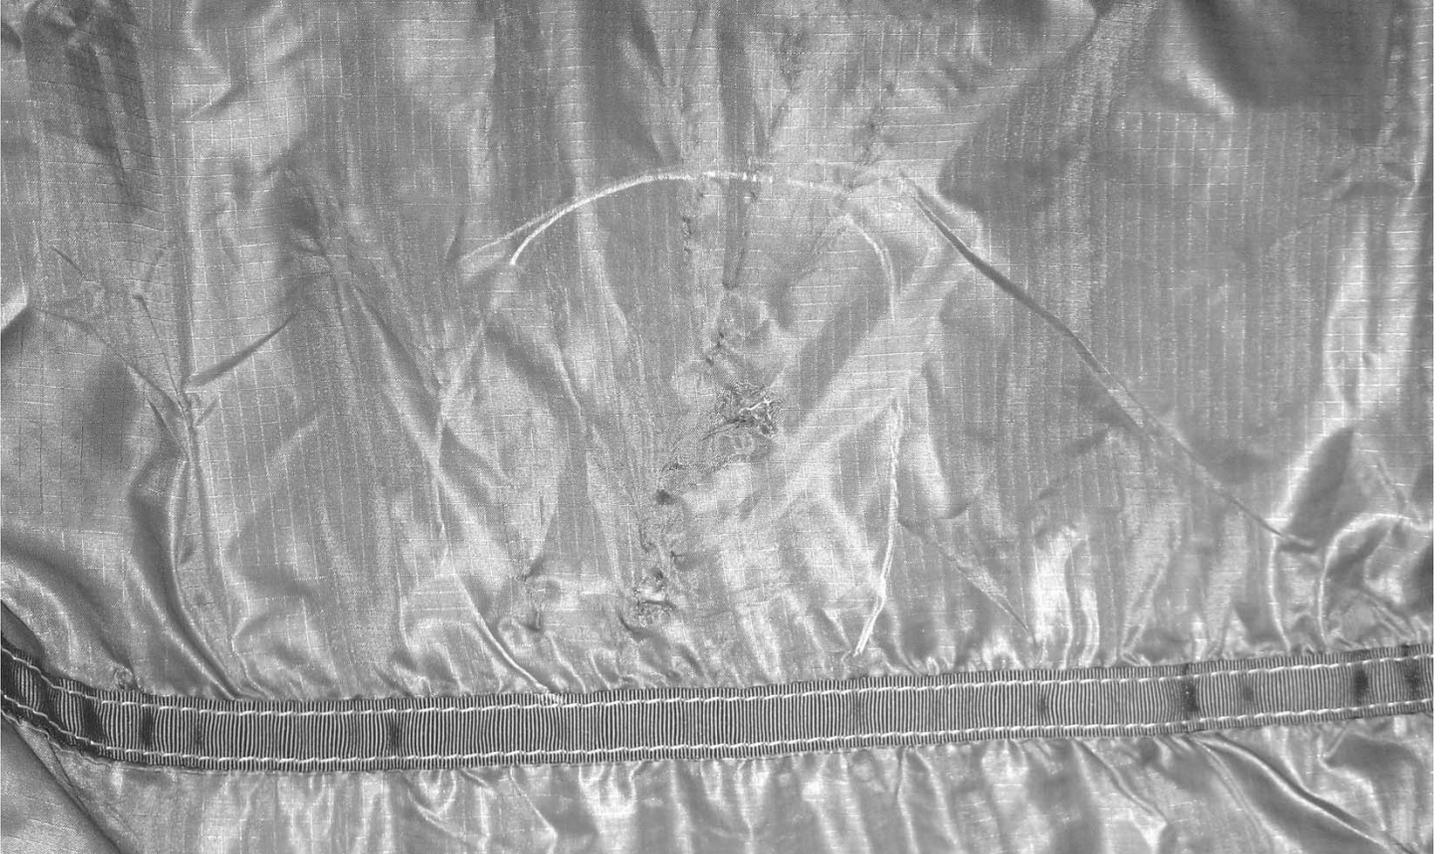
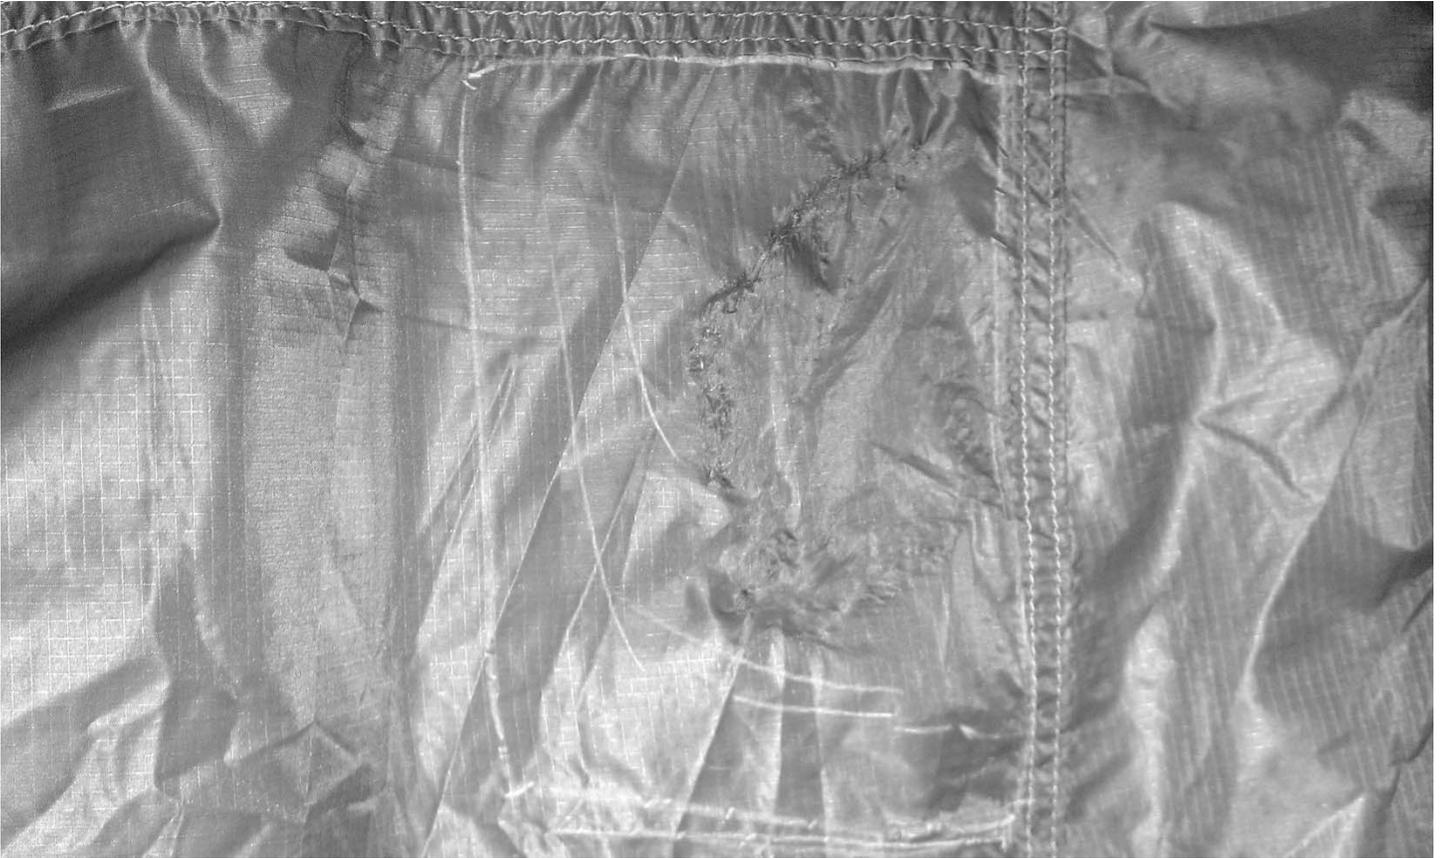
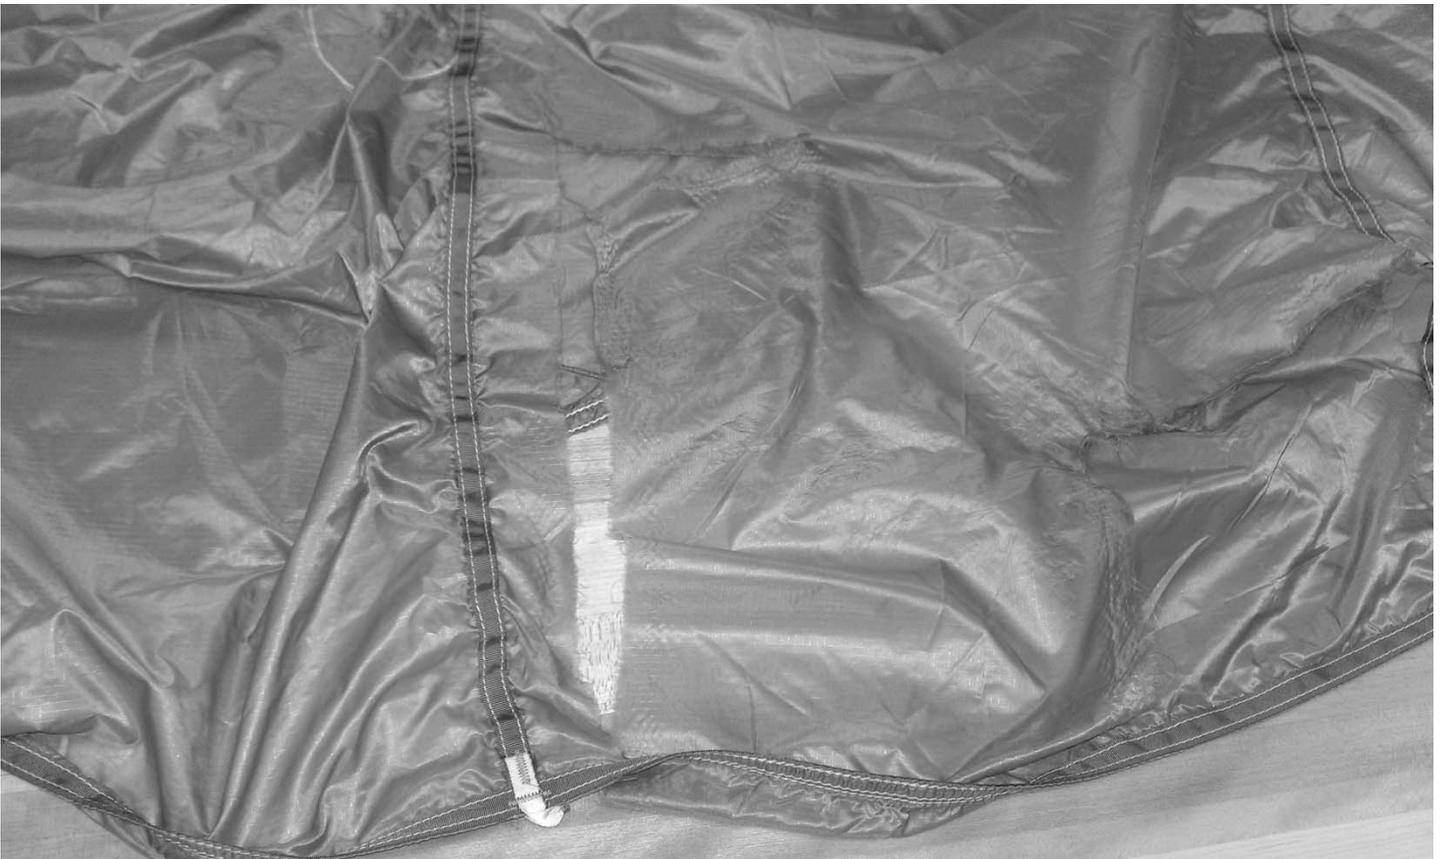
SL18_20110616_9MISB_MC6_PartialOpening_C212

Description of Suspected - Malfunction - Incident - Damaged Incurred: SM was jumper 11 on lift 10. SM had a weak exit which created twists in her canopy. The friction on the canopy and the upper control lines caused the lines to tear two holes on one panel and burn the canopy in another. SM had twists almost all the way to the ground which prevented the canopy from properly inflating. SM did not activate their reserve parachute because by the time the SM figured they needed to pull their reserve the ground was approaching so the SM just braced for impact.

Suspected Cause of Malfunction - Incident: Since the SM had a great amount of twists it prevented the canopy from fully inflating and also causing stress tears on the canopy in two places as well as a burn.

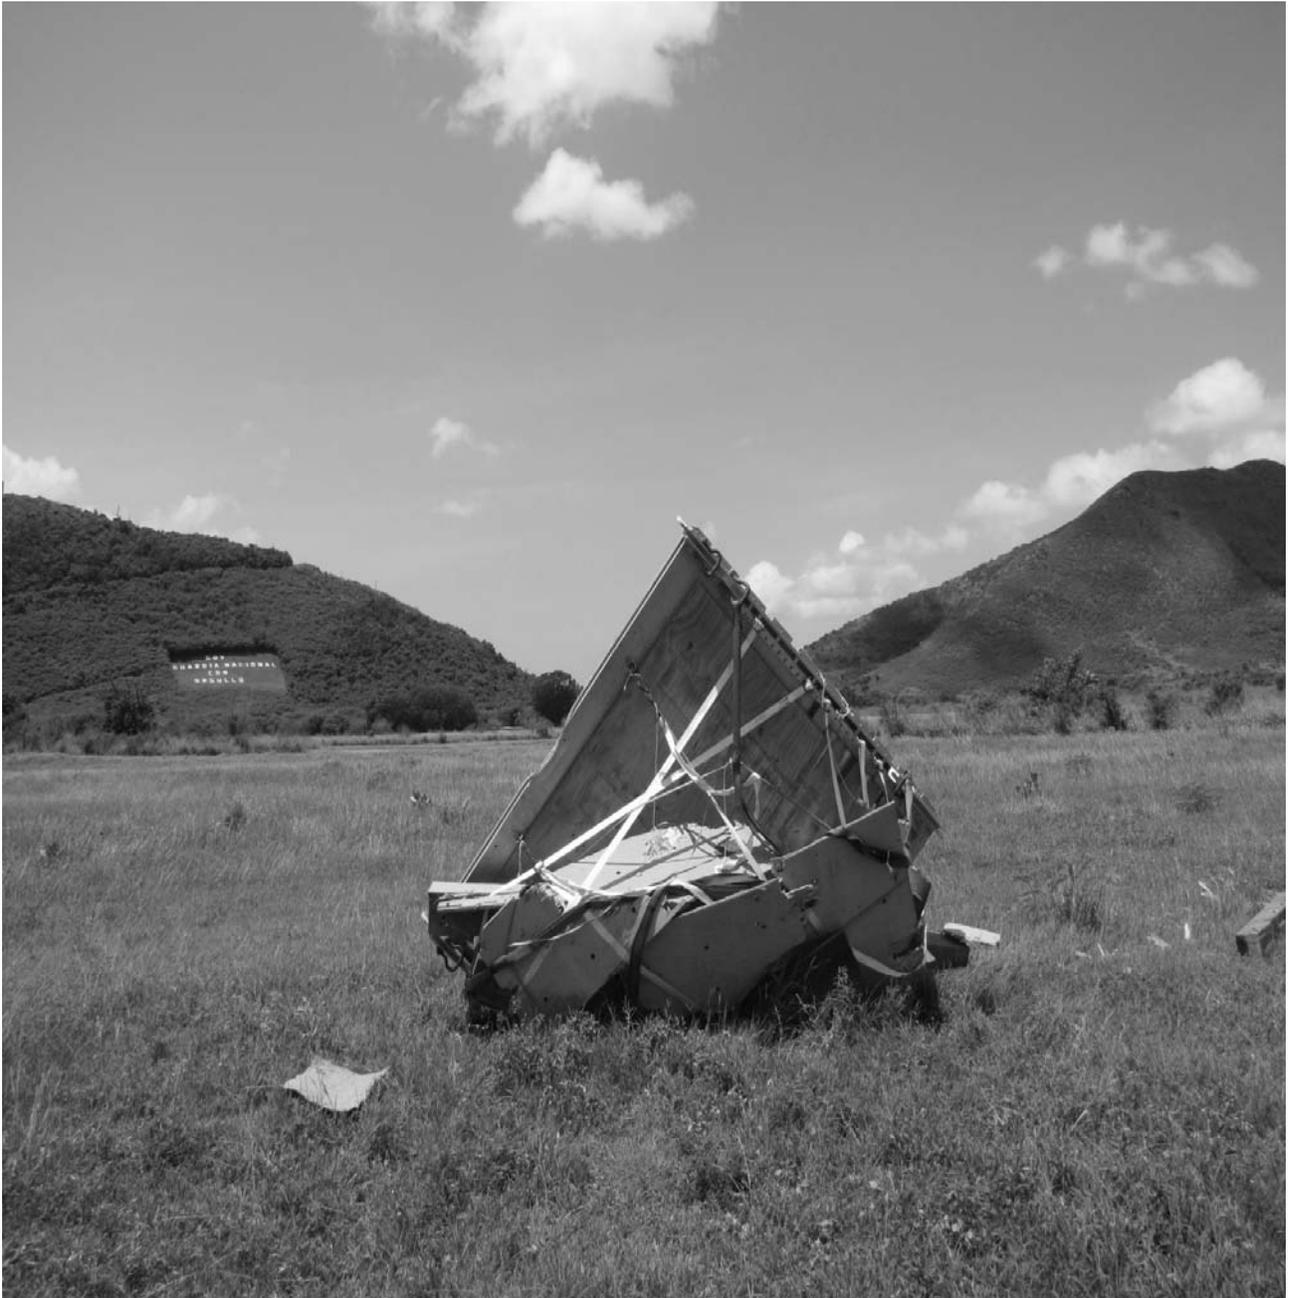
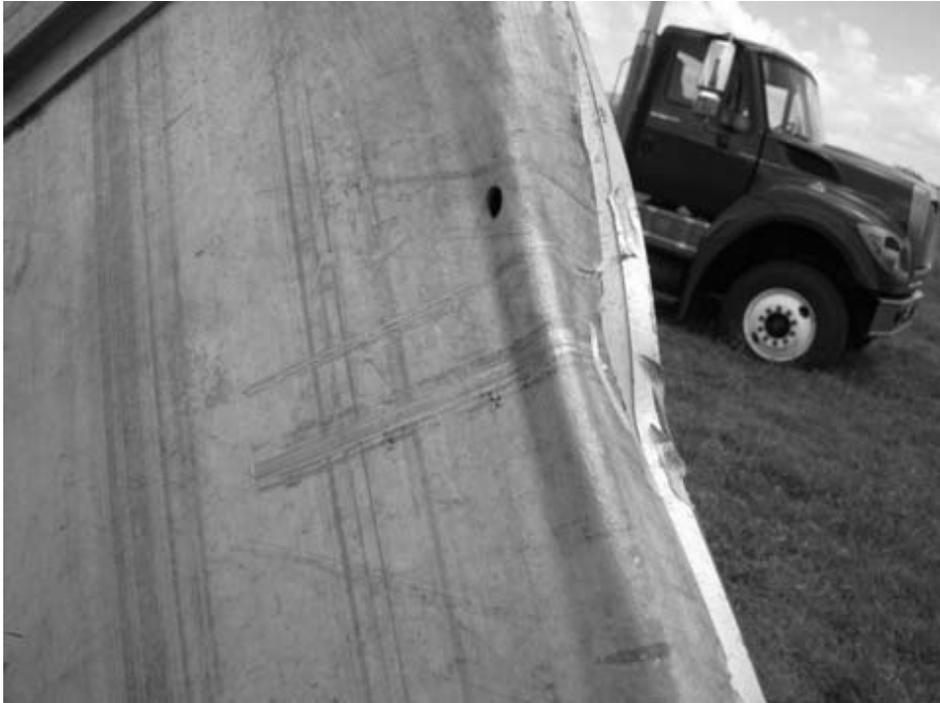
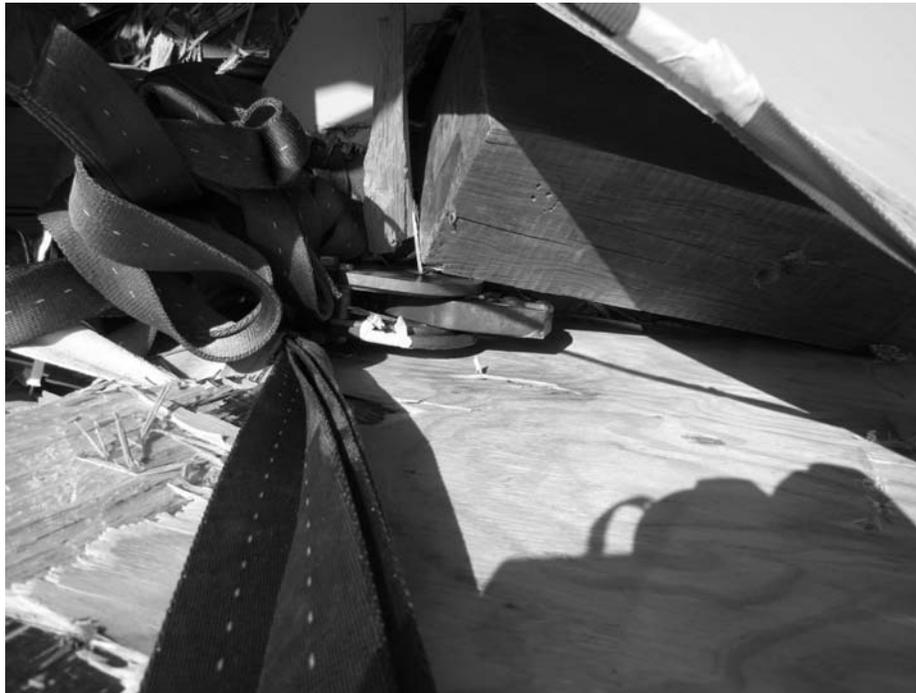
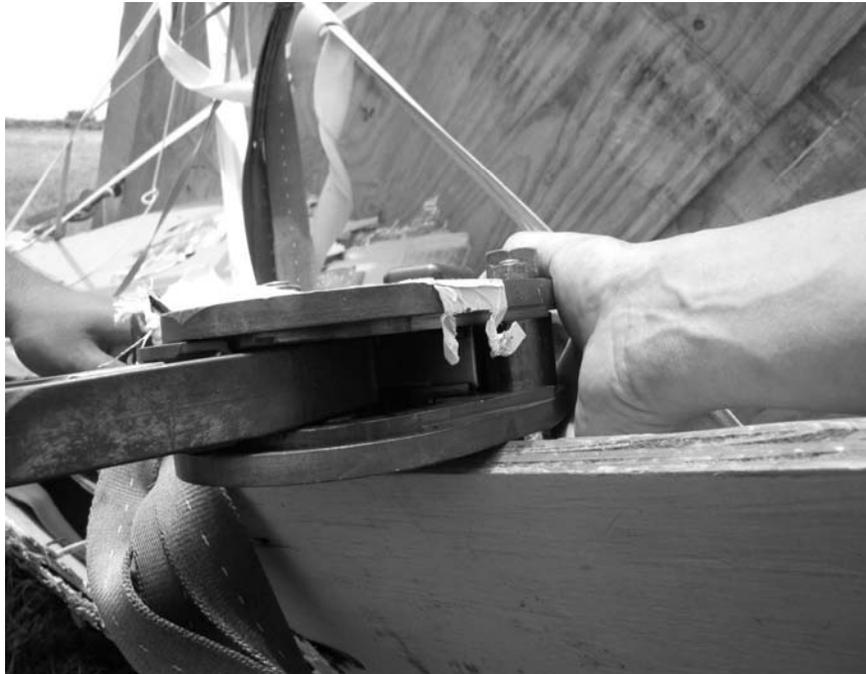
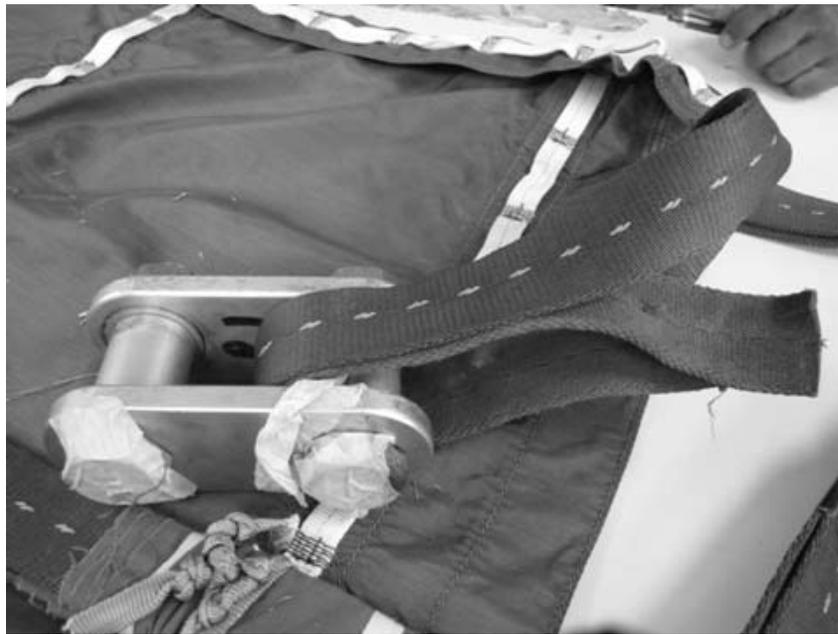
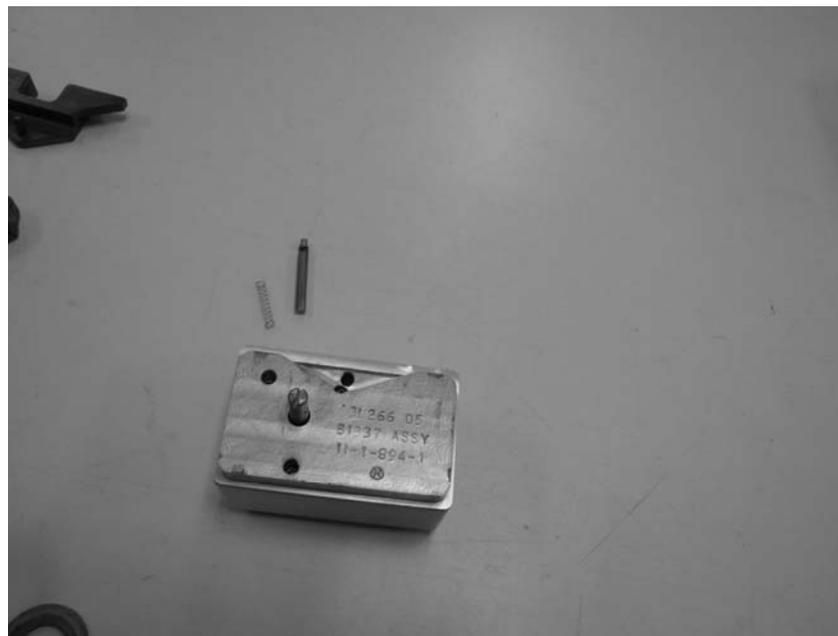
HE7_20110815_156AW_G12E_M1Fail_C130

The Suspected Cause: Mid air separation of the cargo parachutes from the release. Separation occurred during the deployment phase prior to the load stabilizing. The releases were properly attached and rigged IAW the proper rigging TO. Upon arriving at the Load, it was noticed that it impacted the ground at a 45 degree angle and buried itself about two feet with a eleven feet length. The forward end of the load had an indentation. There was no evidence of the load striking the aircraft. The load and all equipment were gathered after photos and the preliminary investigation was conducted at the DZ. A further investigation was conducted in a secure area of Aerial Port with the Aerial Deliver Review Panel (ADRP). It was noted the M-1 was inoperative after the malfunction. This could be as being damaged from the impact, as it was not conclusive that it could have struck the platform. The ADRP inspected the M-1 and noticed scrapes aware on the release and the upper sling. The M-1 timer components were completely was broken. The ADRP determined the suspected cause was a faulty M-1 release as all procedures were accomplished by the JAI's and Riggers. As a precaution all JAI's and Riggers were emphasized to properly check the M-1 Release System.

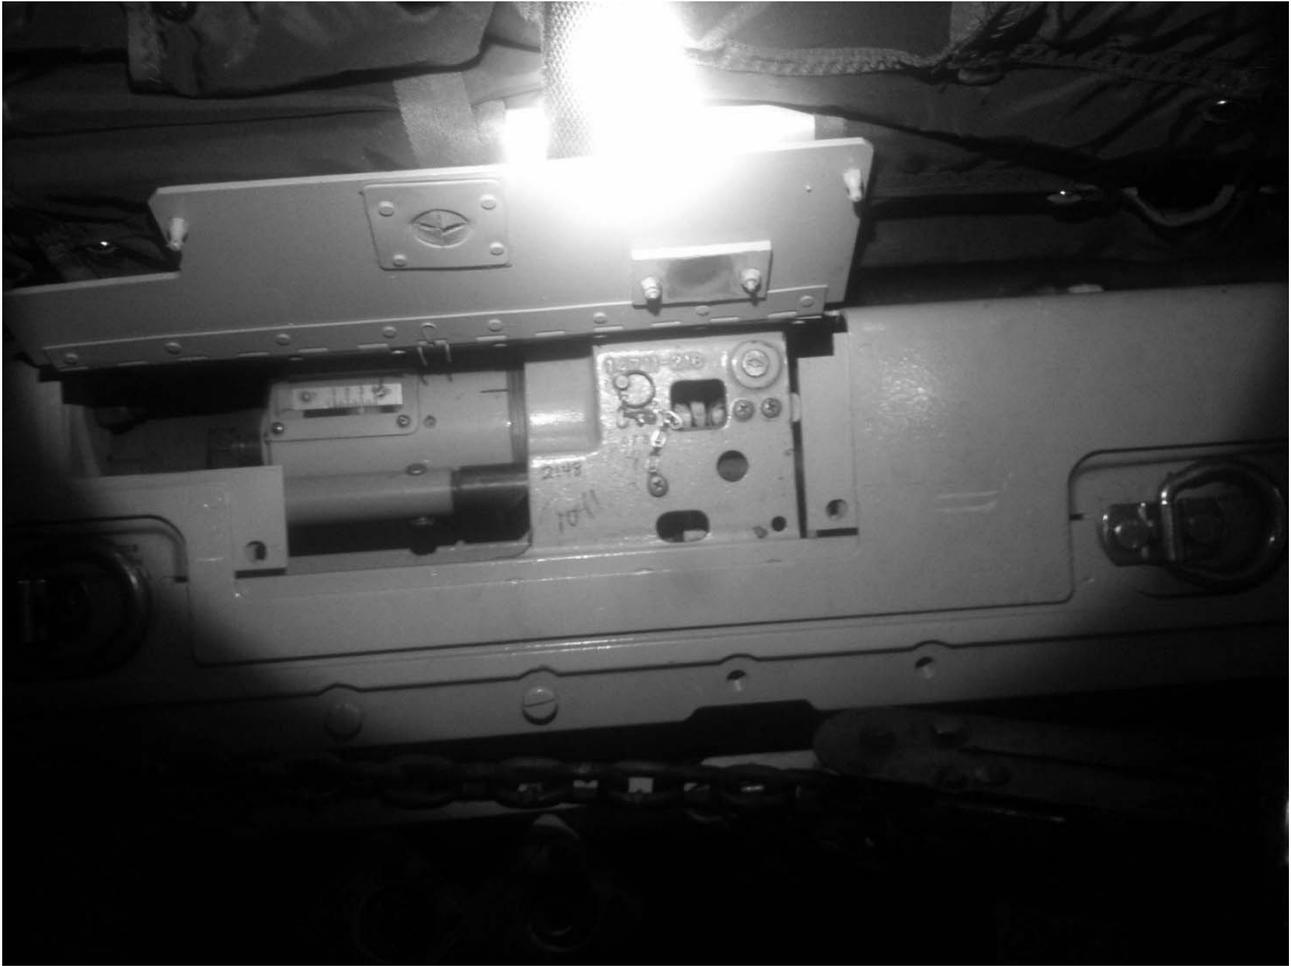
ACFT1_201100705_314OG_LoosePlatform_C130

After removing the left hand locks during the in-flight portion of the pre-slowdown checklist, the flight crew noticed the platform move aft. Emergency restraint was applied to the platform by using aircraft tie down chains and left hand locks were engaged.

Suspected Cause of Malfunction - Incident: faulty lock and lock tension setting.

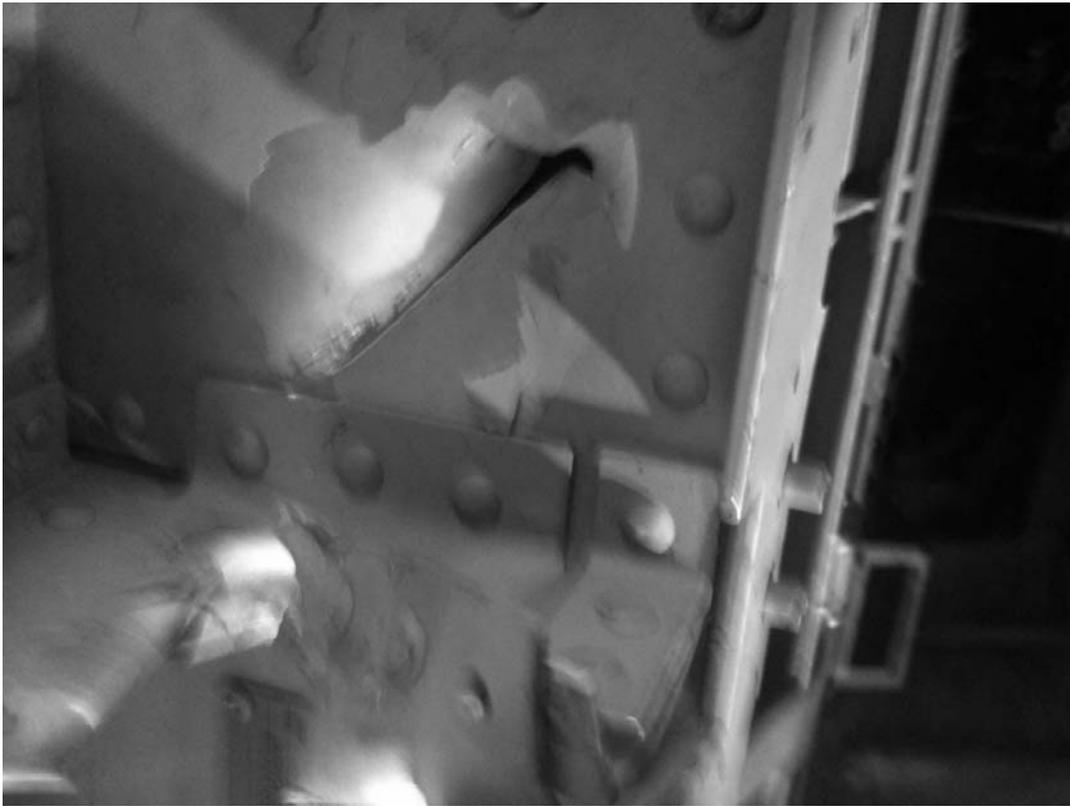
ACFT2_201100718_314OG_TowPlateFail_C130J

Suspected Cause of Malfunction - Incident: Drogue jettison strike pin.

Recommendations: replace enhanced tow plate
