135th TRIANNUAL AIRDROP REVIEW and MALFUNCTION SAFETY ANALYSIS BOARD

Feb 8-10, 2011

MALFUNCTIONS / INCIDENTS REPORTED

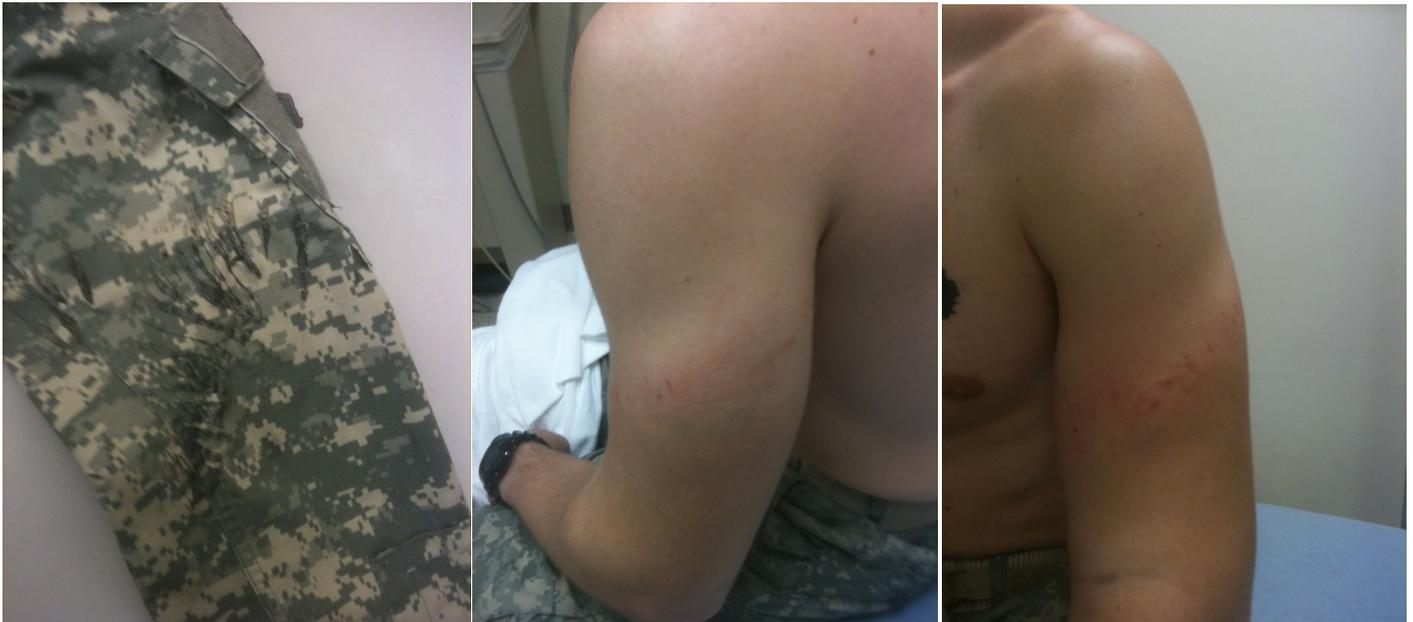
SL5_20100915_1MARSPECOPS_MC7_Towed_Paratrooper_UH-1H

Description of Suspected - Malfunction - Incident - Damaged Incurred: jumper's combat equipment became entangled with the aircraft's skid causing a towed jumper.

Suspected Cause of Malfunction - Incident: loose shoulder strap on combat equipment.

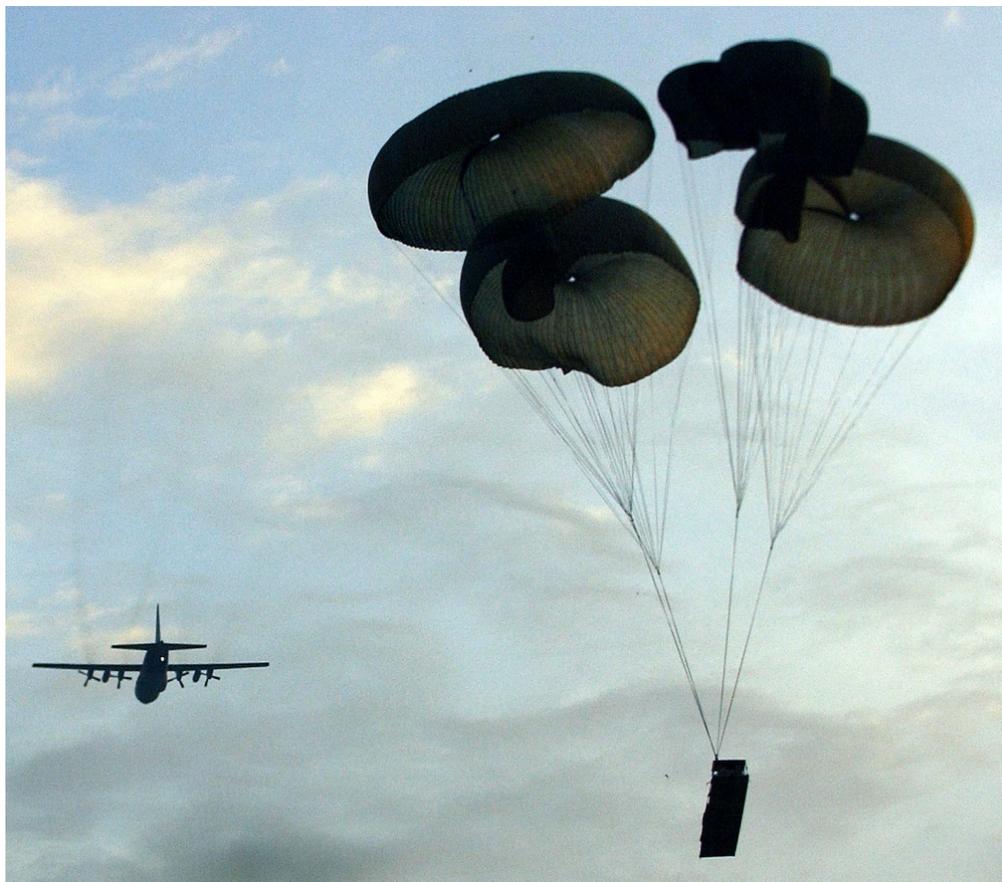
HE1_20101005_62AW_G-12E_Failed_to_Deploy_C17

Description of Suspected - Malfunction - Incident - Damaged Incurred: COHO 52 was middle jet of a 3 ship drop. The 3 ship performed their first drop of heavies without any incident when they came around for the second drop of heavies. The second ship COHO 52 released his drogue it opened stayed out for 5-8 seconds then fell away releasing the extraction chute it opened correctly. As soon as the extraction chute opened the heavy came out of COHO 52 and nosed into the ground. As the heavy was heading to the ground you could see that the 3 point was released from EFTC system like its suppose to but the 1/4 inch cotton webbing just wouldn't break the large clevis free. Inspected the 15 ft drogue and extraction chute no broken lines or blown out panels. There was damage to the platform and the 12x12 railroad ties we use but all the other rigging material survived.

Suspected Cause of Malfunction - Incident: The only thing I could come up with that there wasn't enough force exerted onto the extraction 15ft chute to pop the 1 turn double pieces of 1/4 inch cotton webbing breaking free the large clevis in-turn cutting the type VIII letting the G12E chutes to free up and inflate. I also think that the heavy was released or it might of popped the locks before any true force could of been applied to the 15 ft extraction chute and without that force gravity took over and sent the heavy into the ground and the 15 ft extraction chute was just fluttering in the wind as it came down unable to do its part in the sequence.

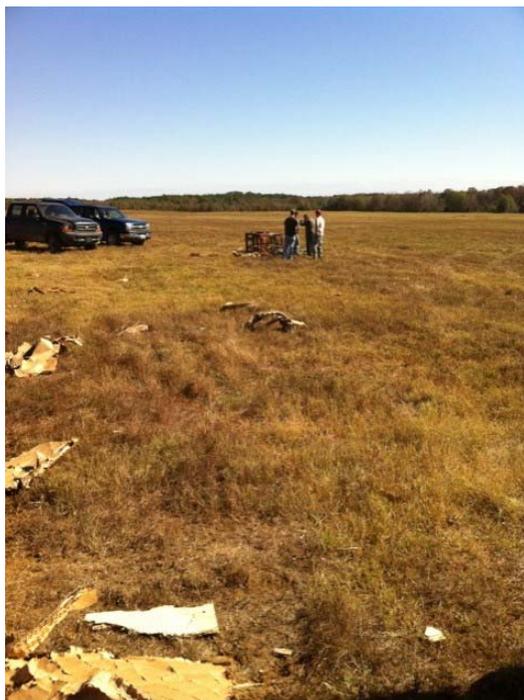
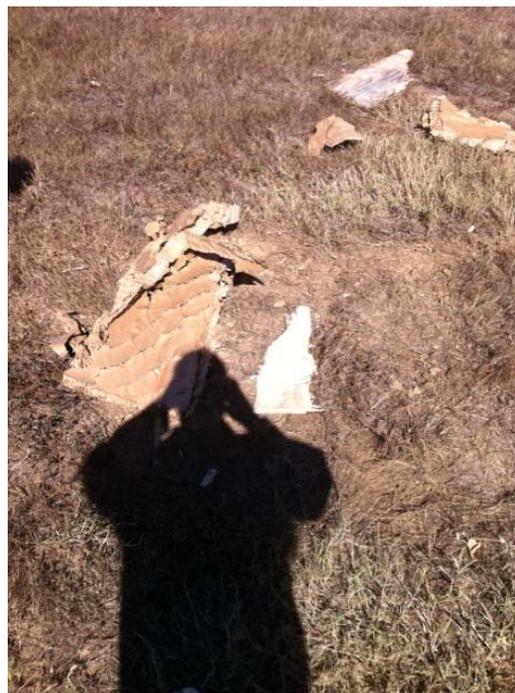
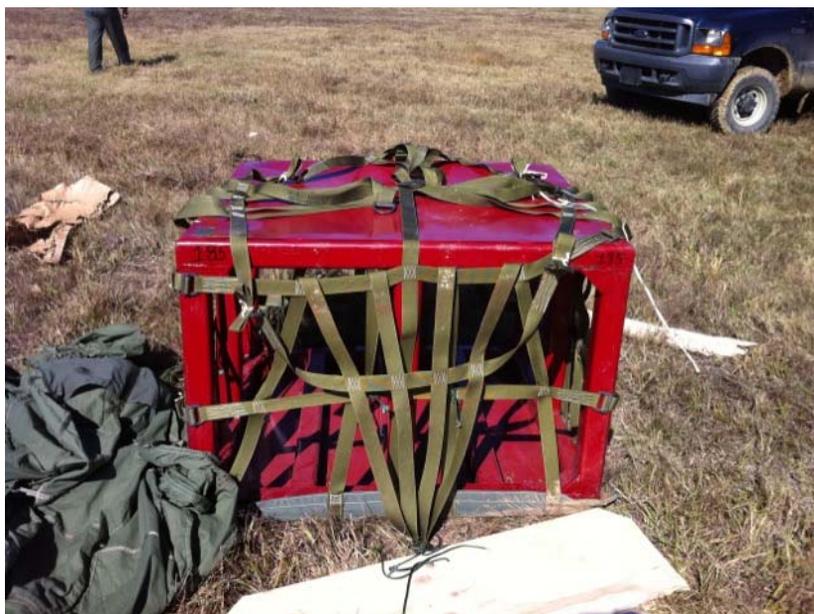
Description of Suspected - Malfunction - Incident - Damaged Incurred: The CDS deployed from aircraft with no incident. On chute deployment, the chute failed to properly inflate and cigar rolled, causing high speed impact. CDS cage bounced approx 28yds from initial impact point destroying the gorilla cage.

Suspected Cause of Malfunction - Incident: The suspected cause could not be fully determined due to LRS Drop Zone de-rigging the chute and preparing it for transport. This being the first CDS bundle out the ramp on a centerline 4 mass drop we suspect a rigging error since the LRS kept saying it was "air starvation". We are continuing our investigation.

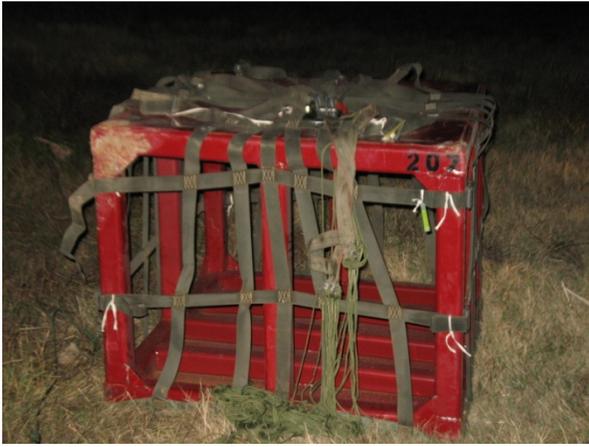
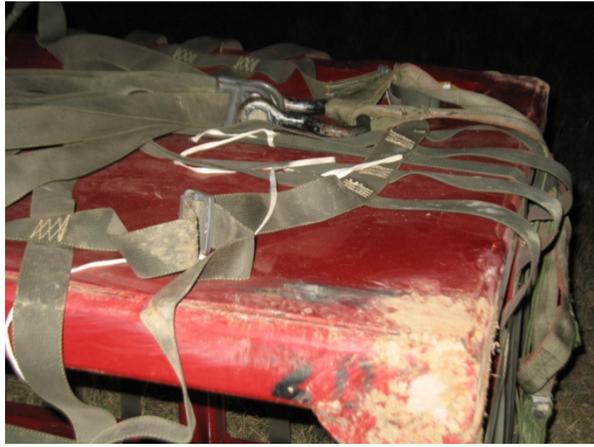
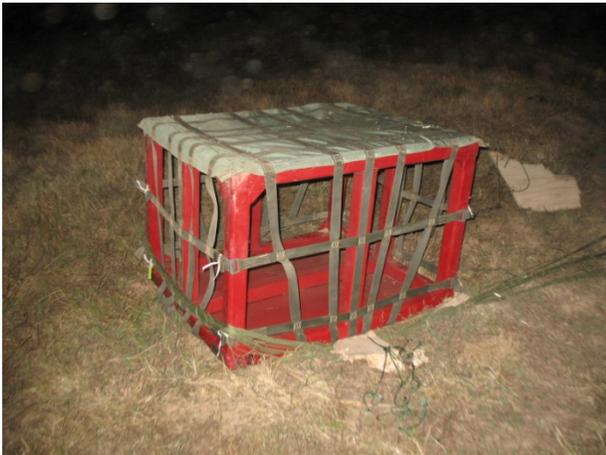
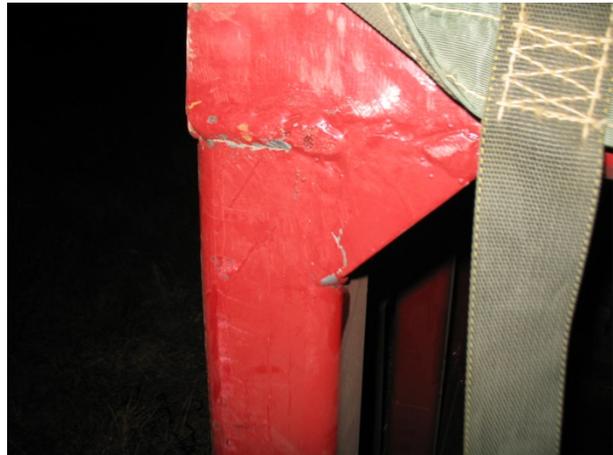
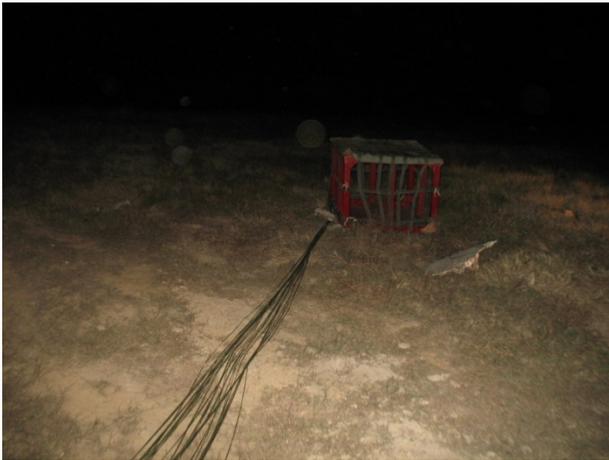
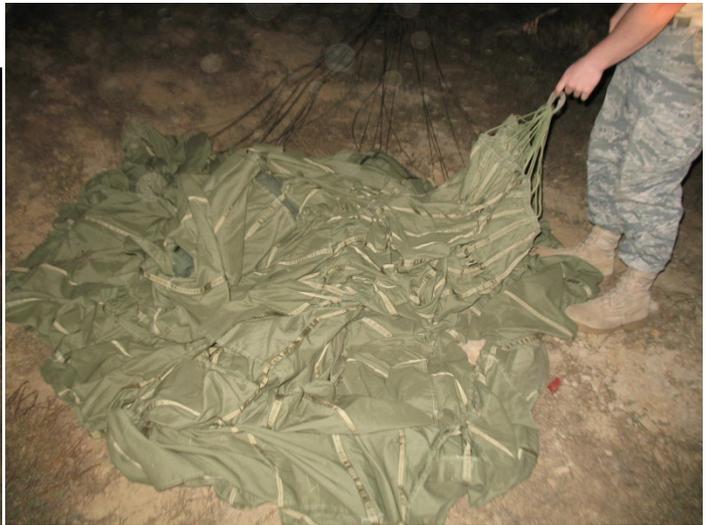
CDS4_20101026_19LRS_26_Foot_High_Velocity_Failed_to_Deploy_C130

Description of Suspected - Malfunction - Incident - Damaged Incurred: First CDS bundle on stick of 4 centerline loaded and the chute failed to open properly, resulting in a cigar roll and high speed impact on DZ. This was a night drop so no video evidence to show details. CDS cage total loss as well as CDS sling.

Suspected Cause of Malfunction - Incident: This was the second CDS malfunction of the day and again suspected cause was possible rigger error.

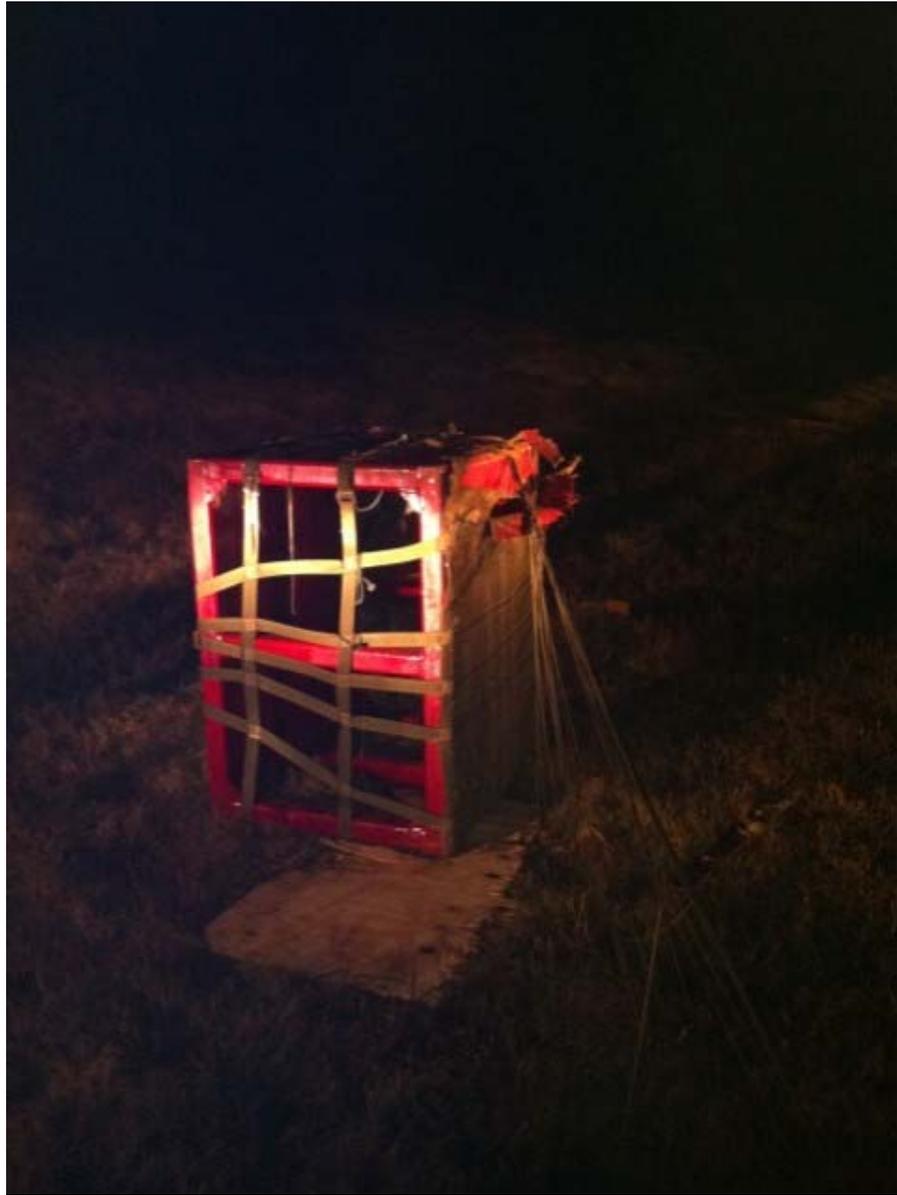
CDS6_20101109_ Double Zodiac_2 G-12E_Parachute_Seperated_C-130

Either faulty equipment (M1 release) or training/rigging, that in the AC after JAI that the lanyard was pulled out prematurely.

Send results to USASOC, and QM school to look at the .142

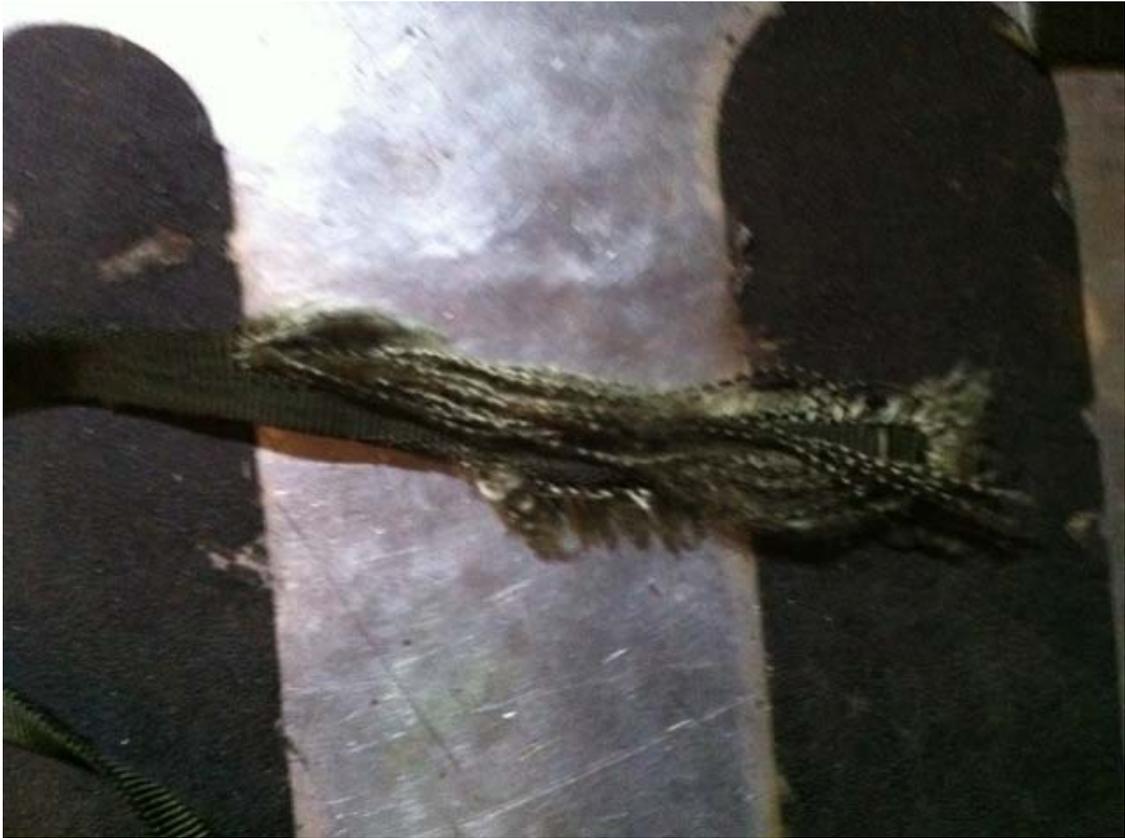
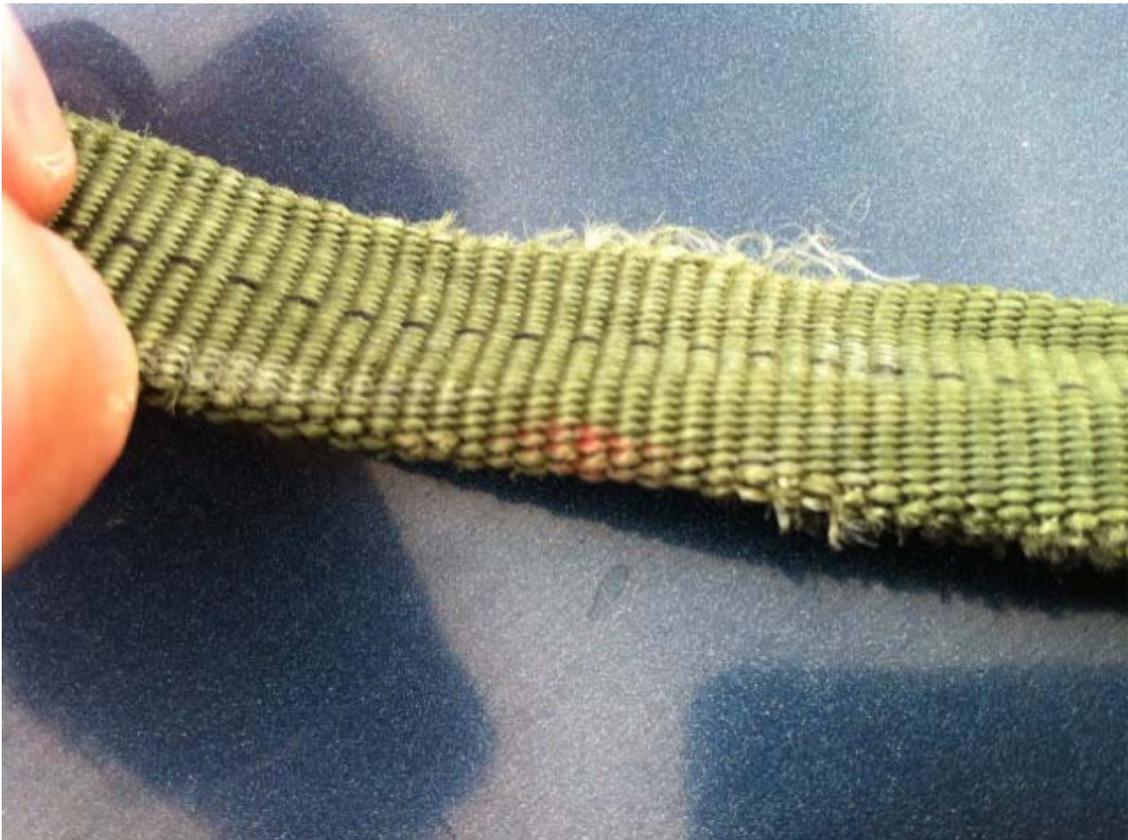
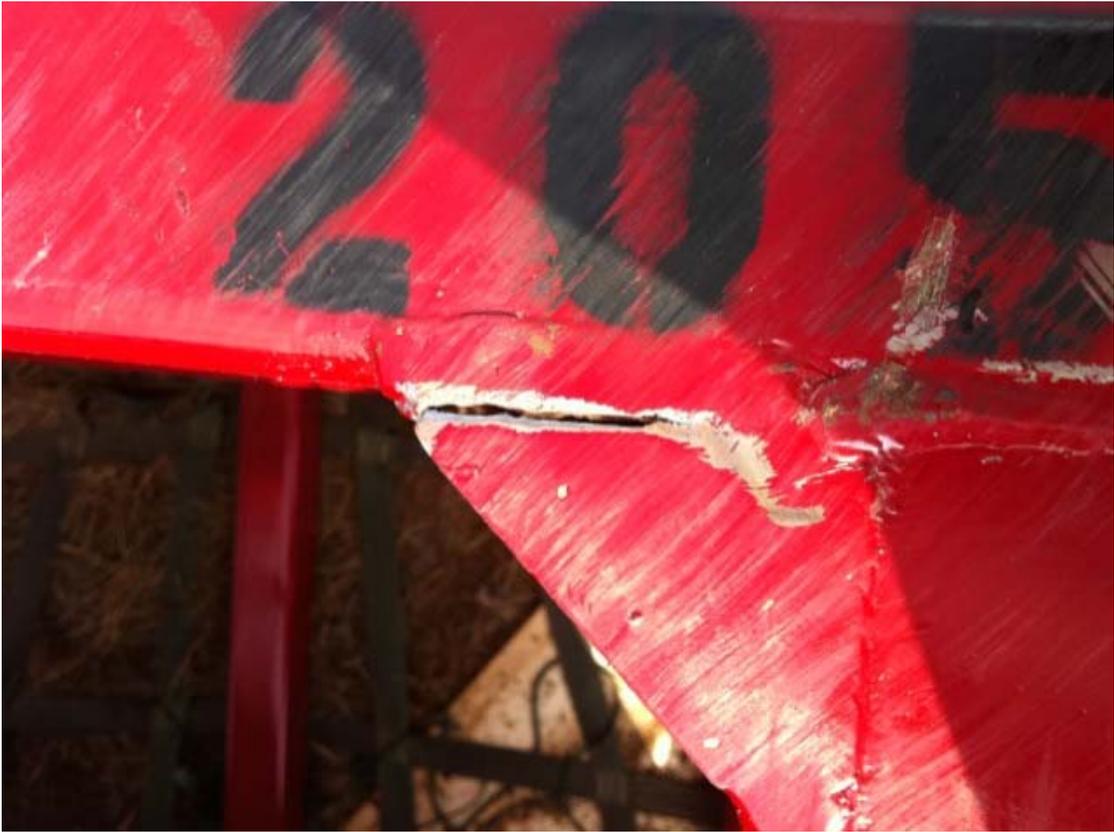
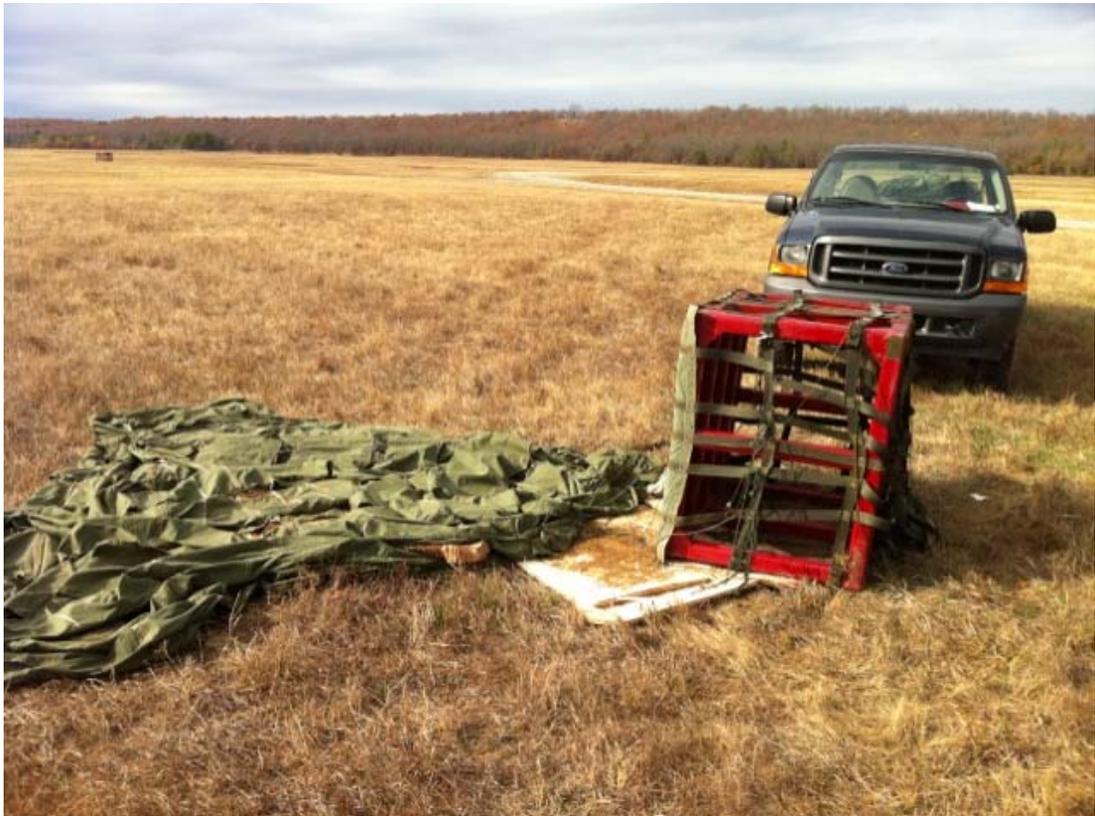
CDS7_20101228_19LRS_26_Foot_High_Velocity_Failed_to_Deploy_C130

Description of Suspected - Malfunction - Incident - Damaged Incurred: Single CDS bundle wt 950lbs left acft without incident. Chute only partially deployed resulting in high speed impact of DZ. CDS had numerous cracked welds and warping.

Suspected Cause of Malfunction - Incident: Rigger error in gore fold is suspected and likely cause

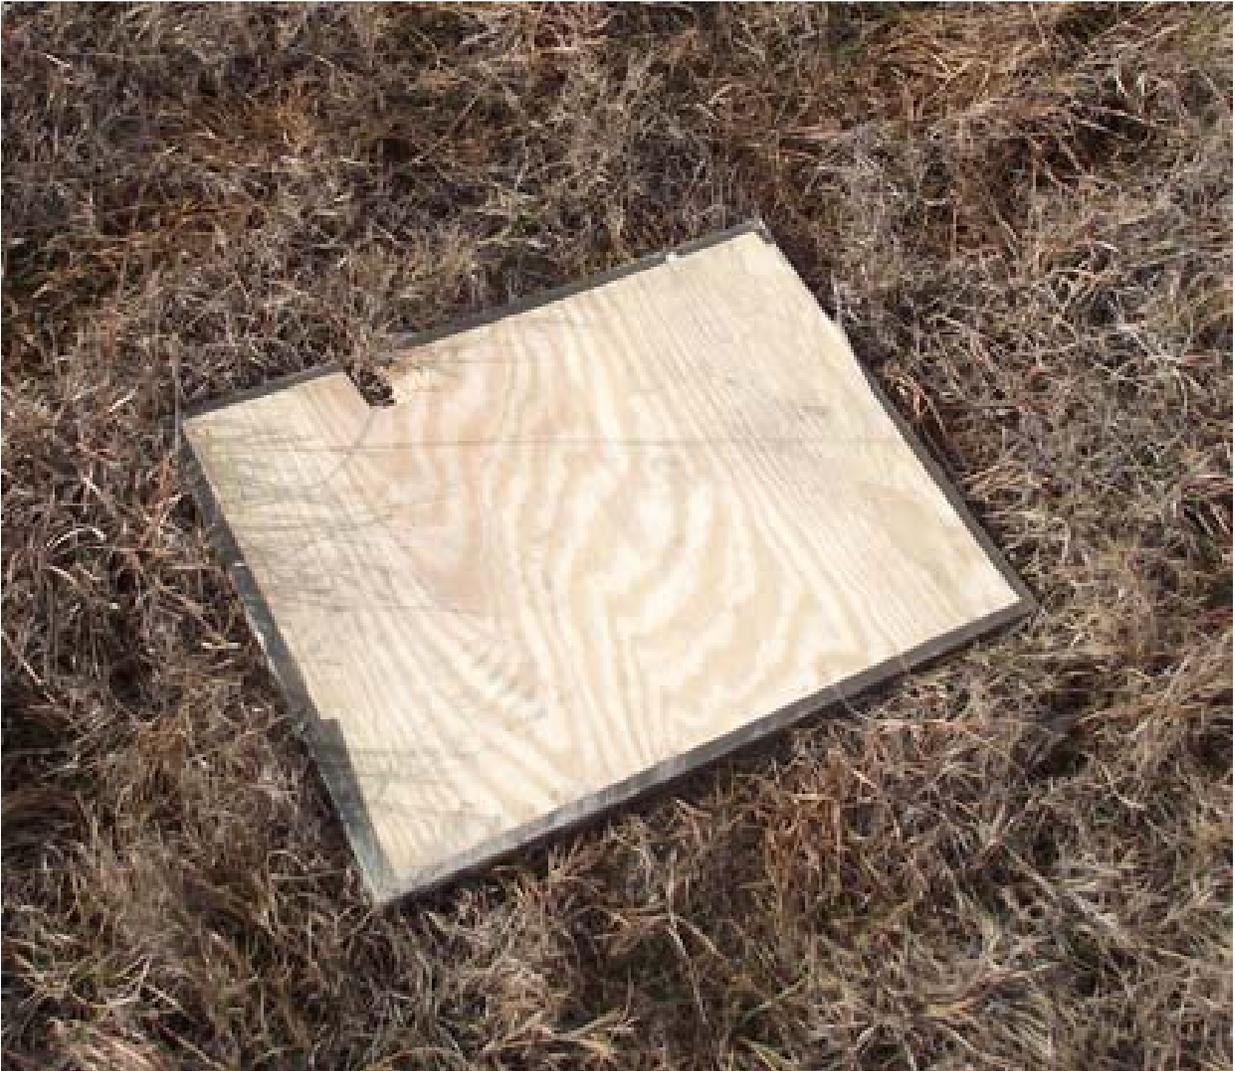
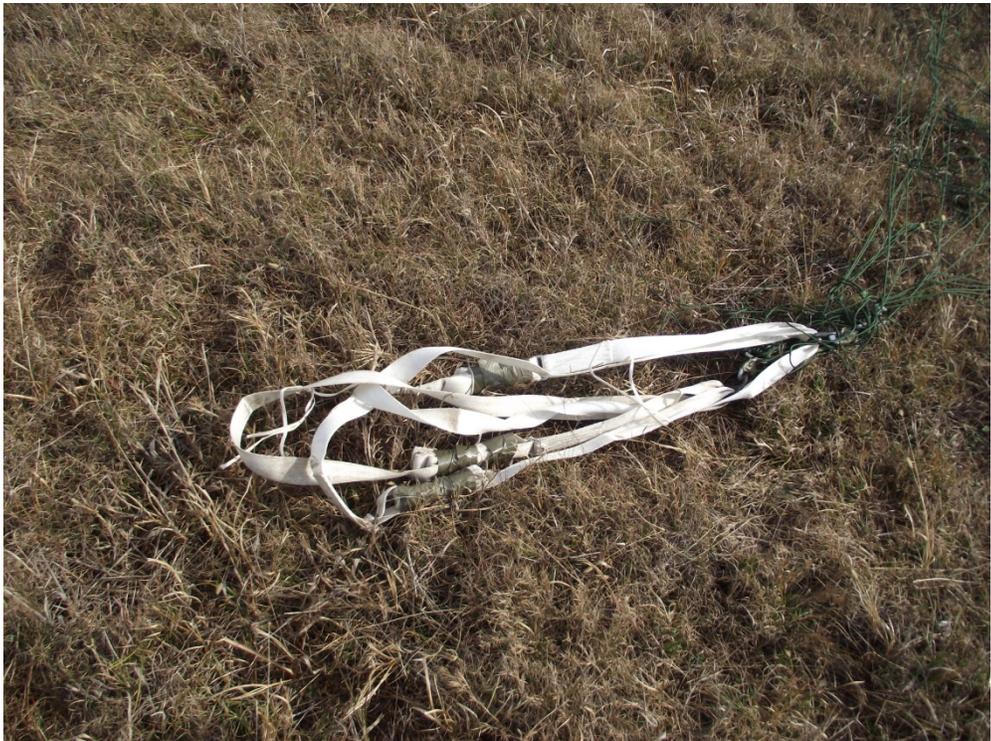
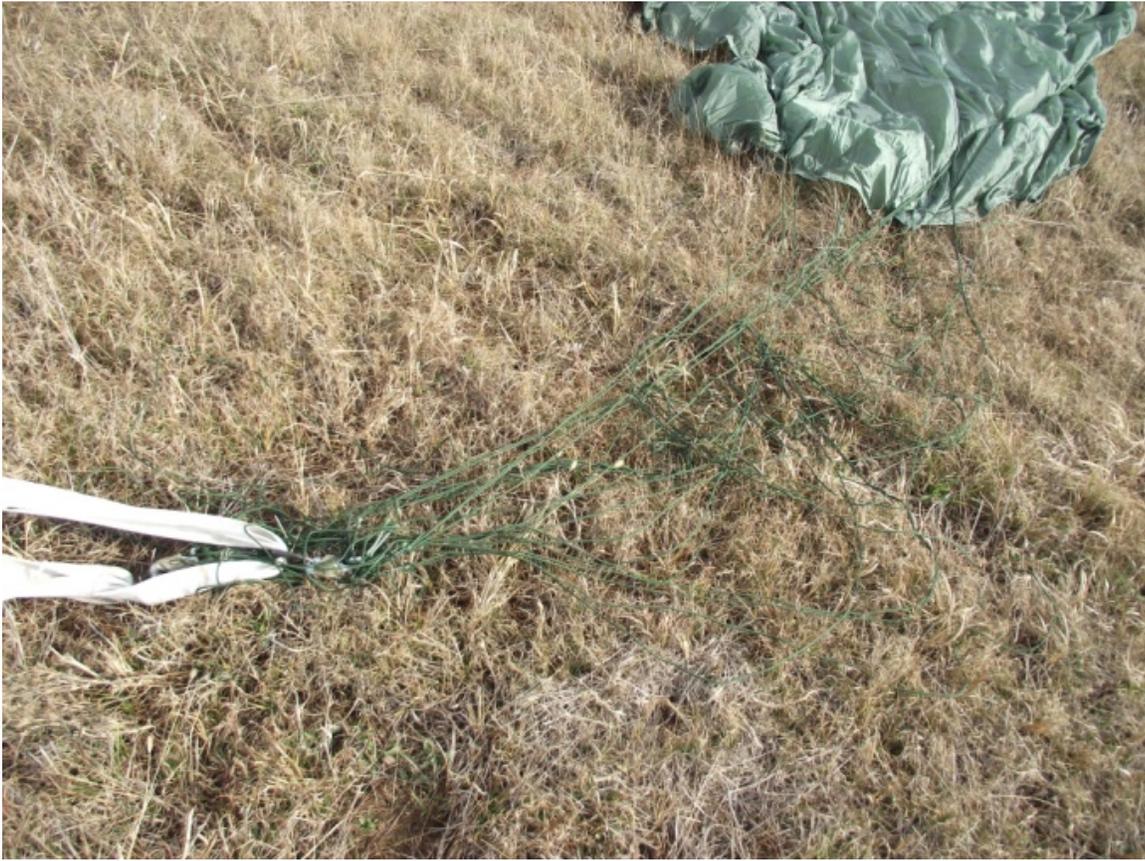
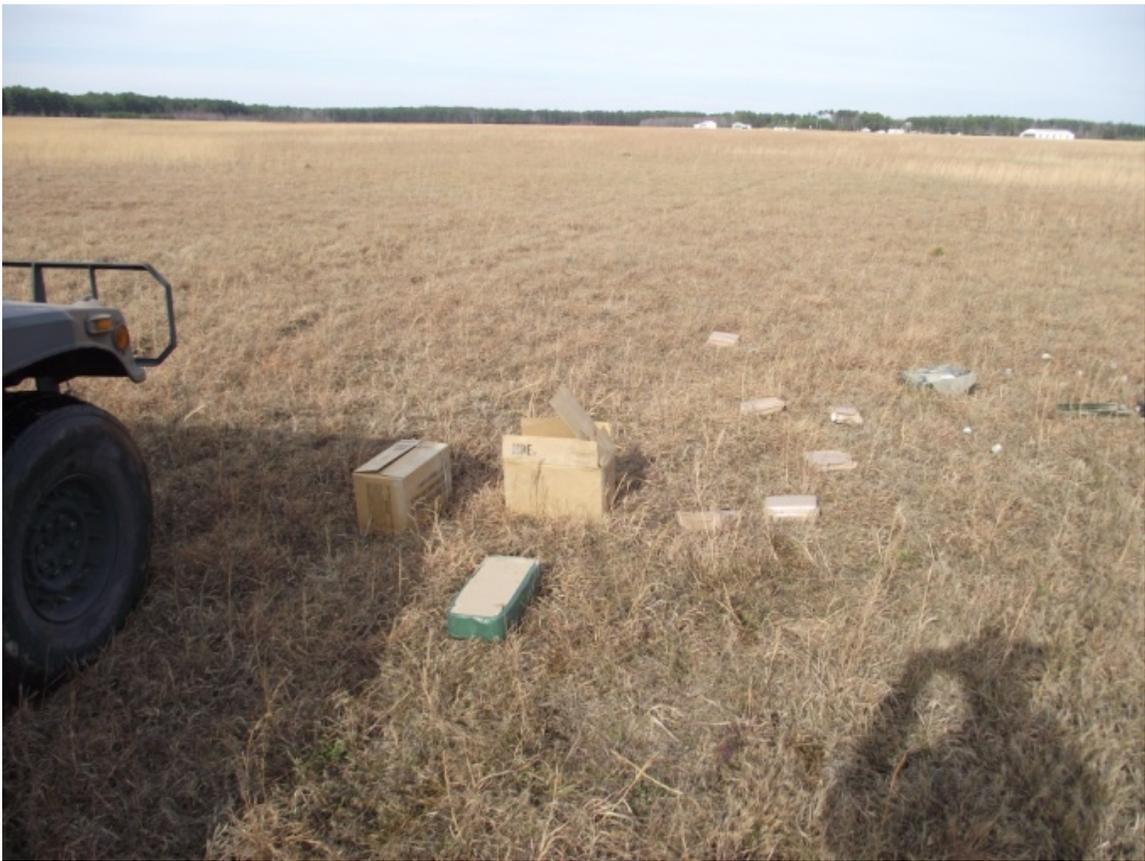
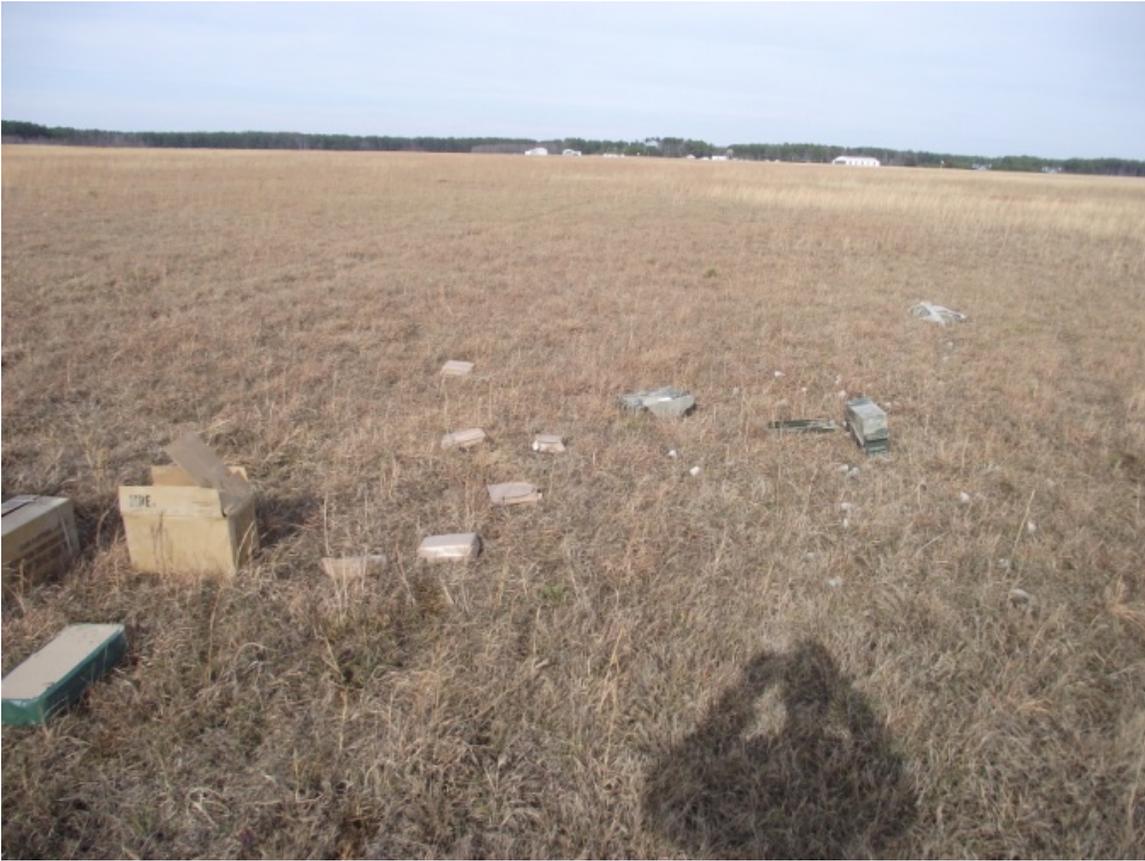
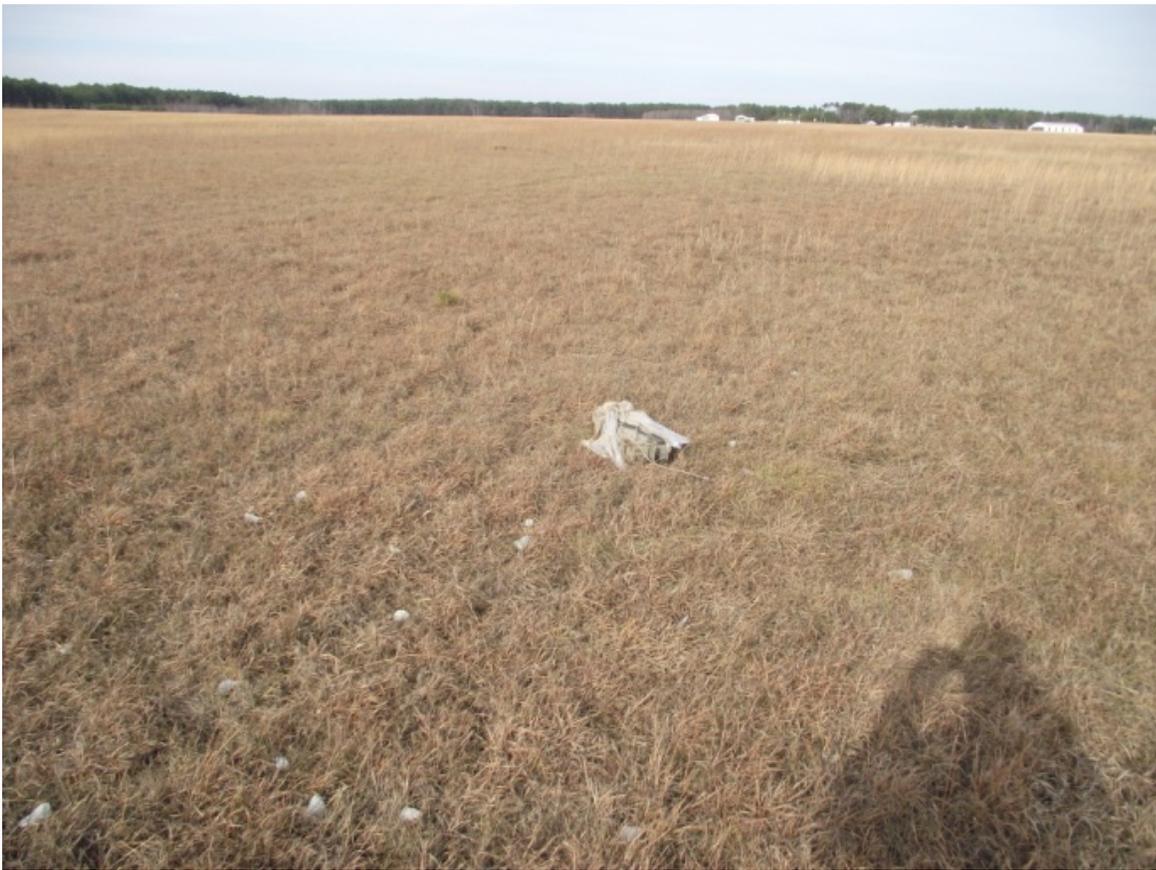
CDS8_20100212_ADFSD_24-foot_LCLA_Strap_failure_C23

Description of Suspected - Malfunction - Incident - Damaged Incurred: A strap on a LCLA load weighing 207 lbs off the load scattering the contents of MRE's and ballast along the flight path. The main part of the load landed 360 feet north of the PI and the parachute landed 42 feet north of the PI 120 feet from the load. There was no loss of equipment or to personnel waiting for resupply. There was no damage to the parachute or the straps holding the load.

Suspected Cause of Malfunction - Incident: One piece of ¾- by 18- by 24-inch plywood had a broken square in it where the strap should have been running, we do not know if it was top or bottom piece and this could be why the strap was loose. The strap may have not been tight or came loose during transportation to the airfield.
