136th TRIANNUAL AIRDROP REVIEW and MALFUNCTION SAFETY ANALYSIS BOARD

June 21-23, 2011

MALFUNCTIONS / INCIDENTS REPORTED

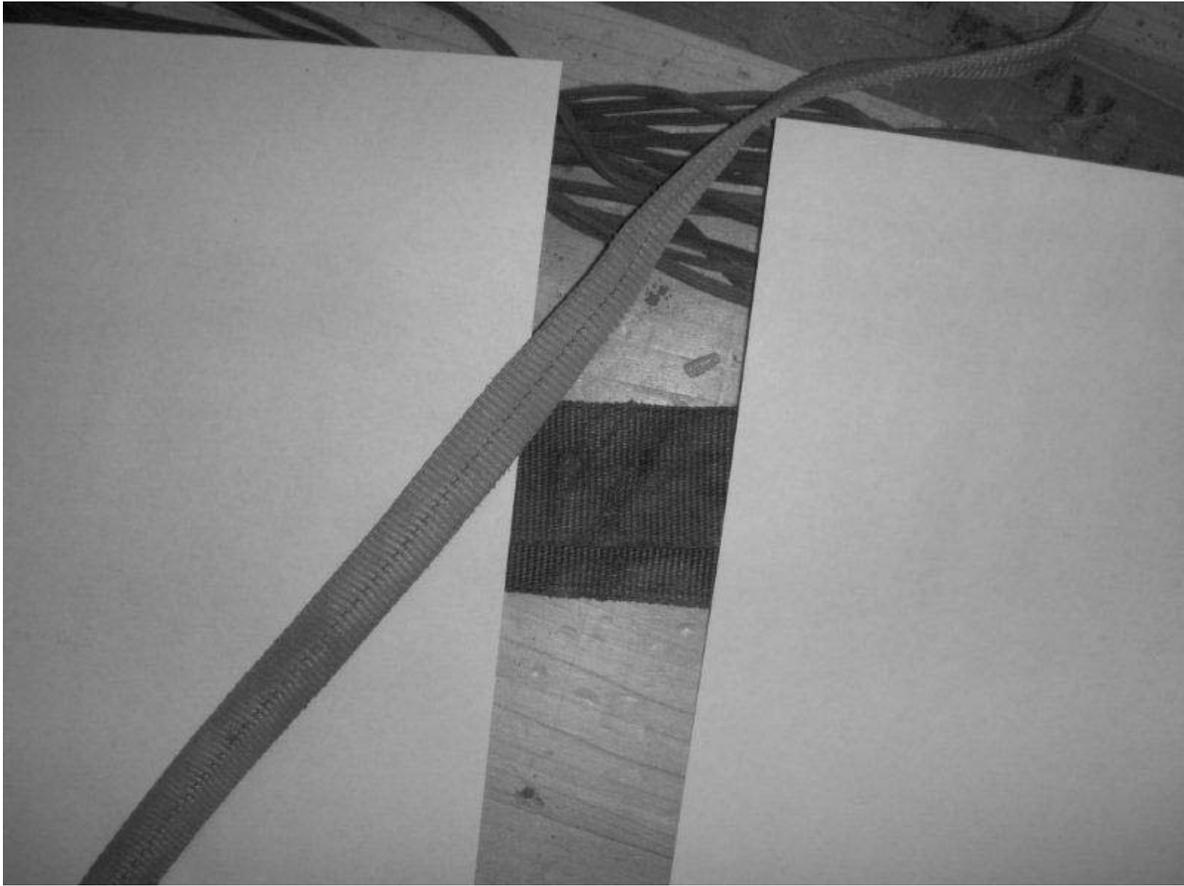
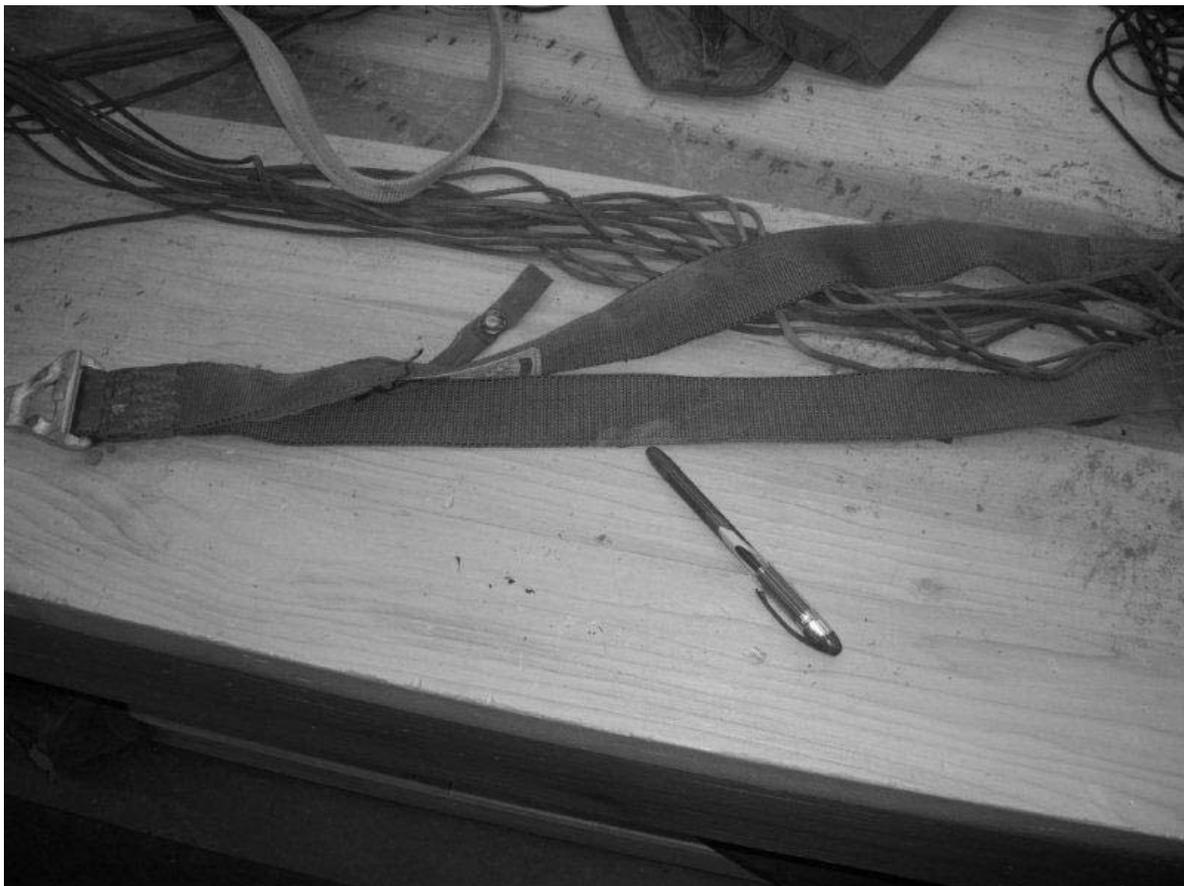
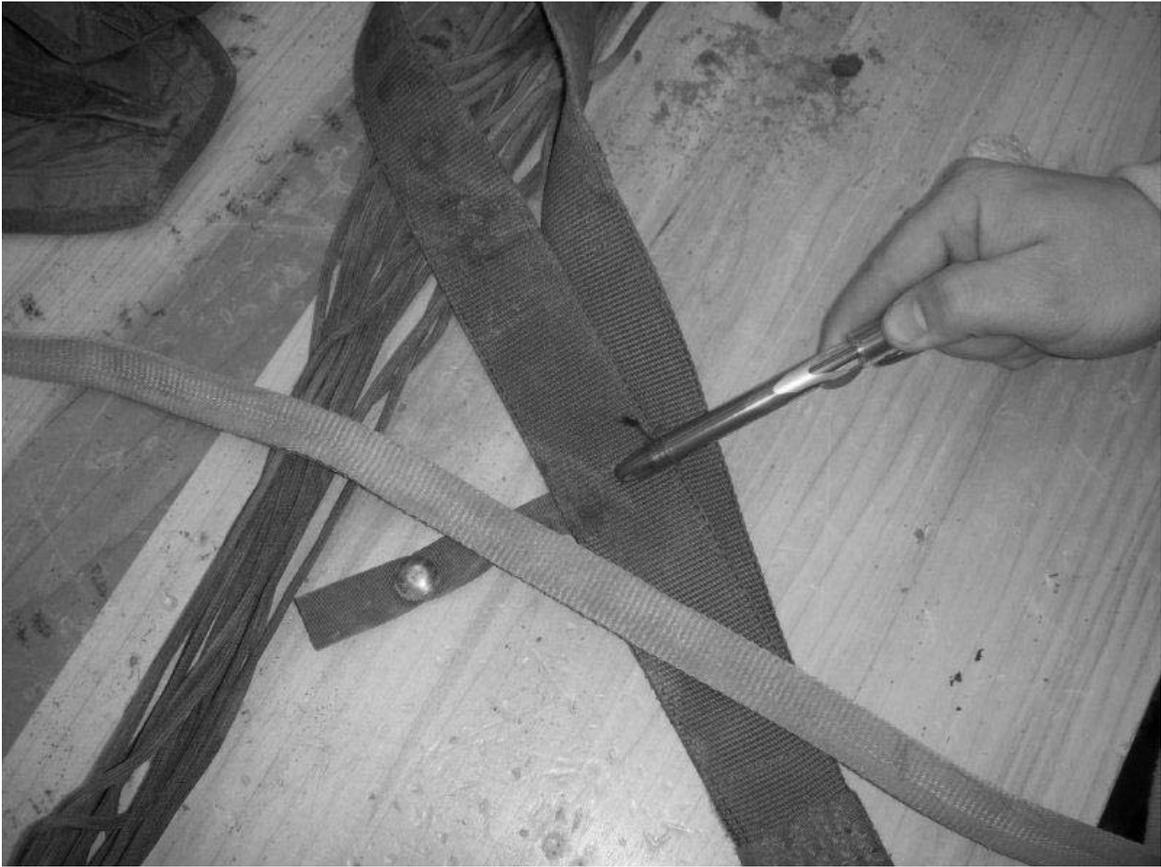
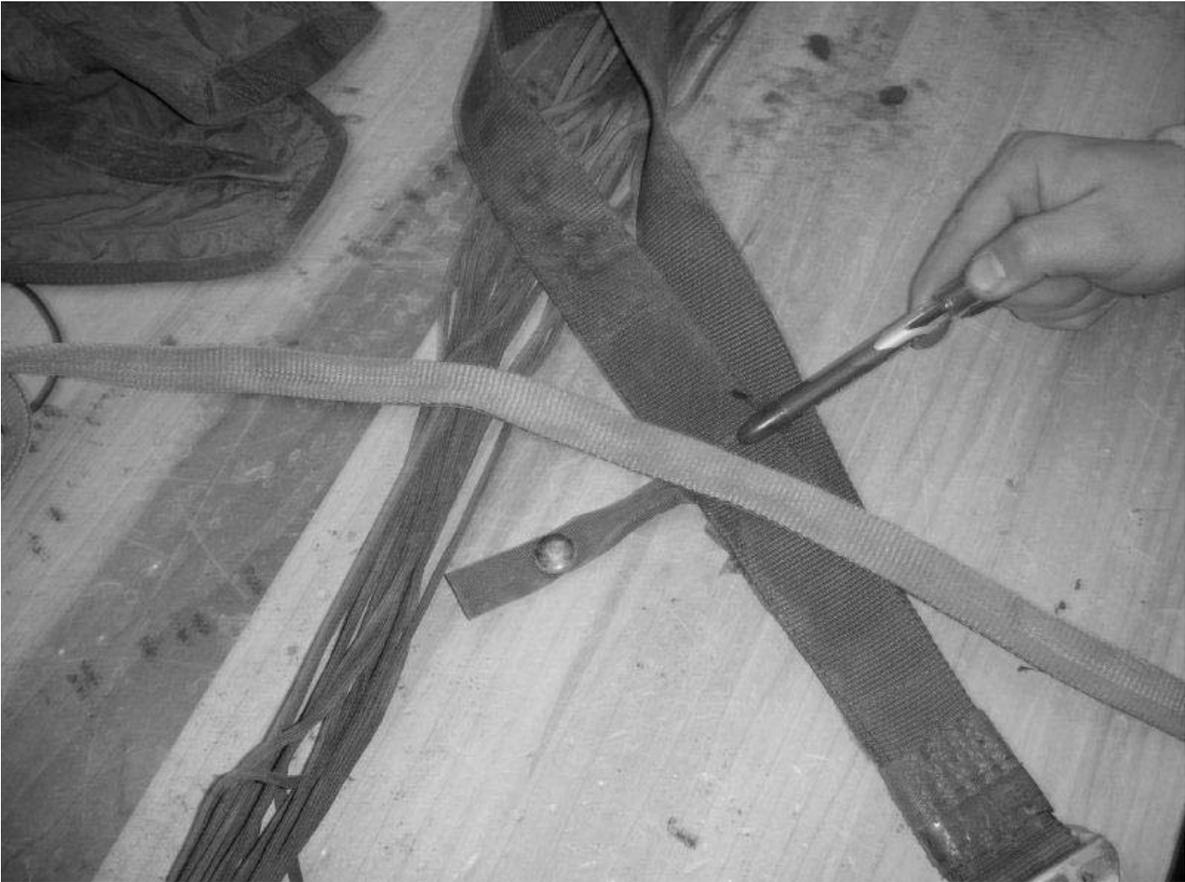
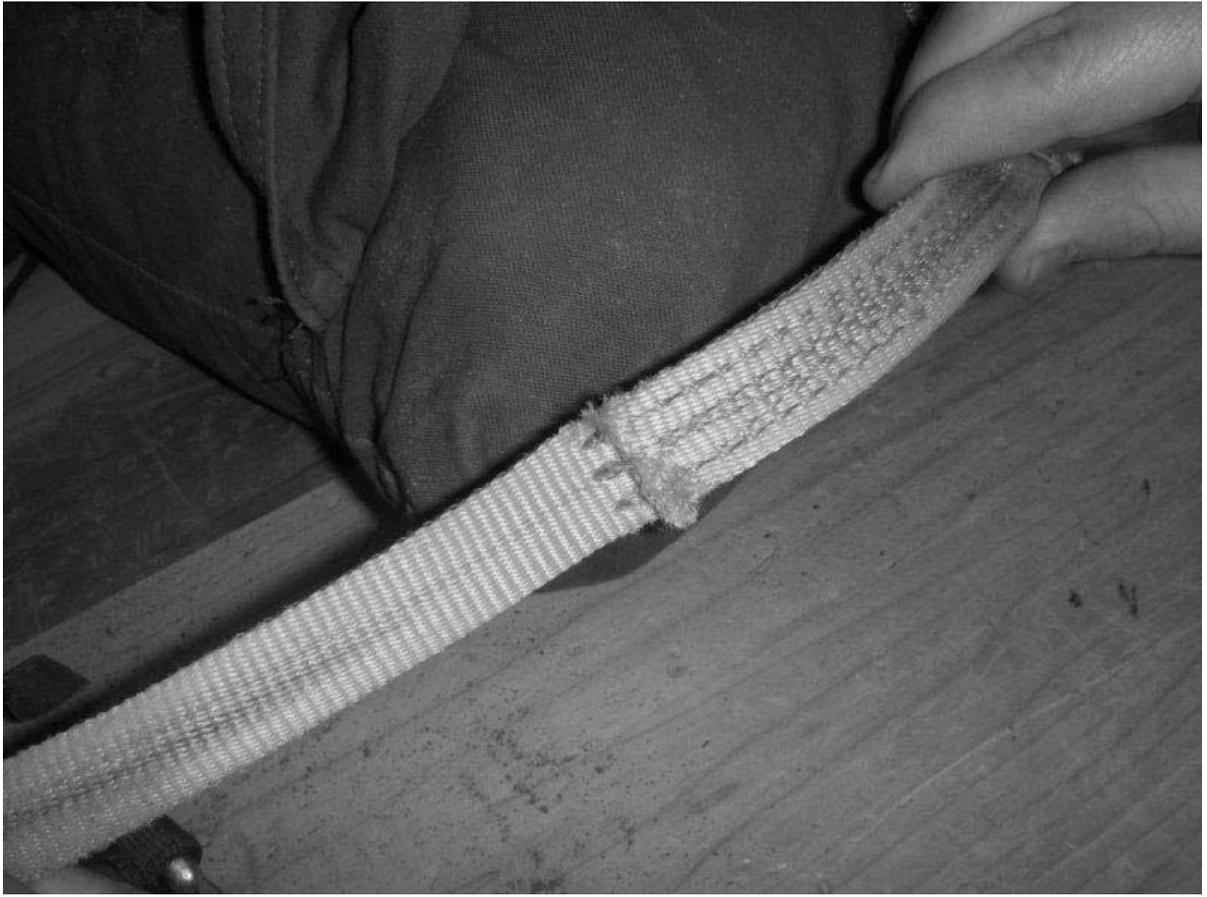
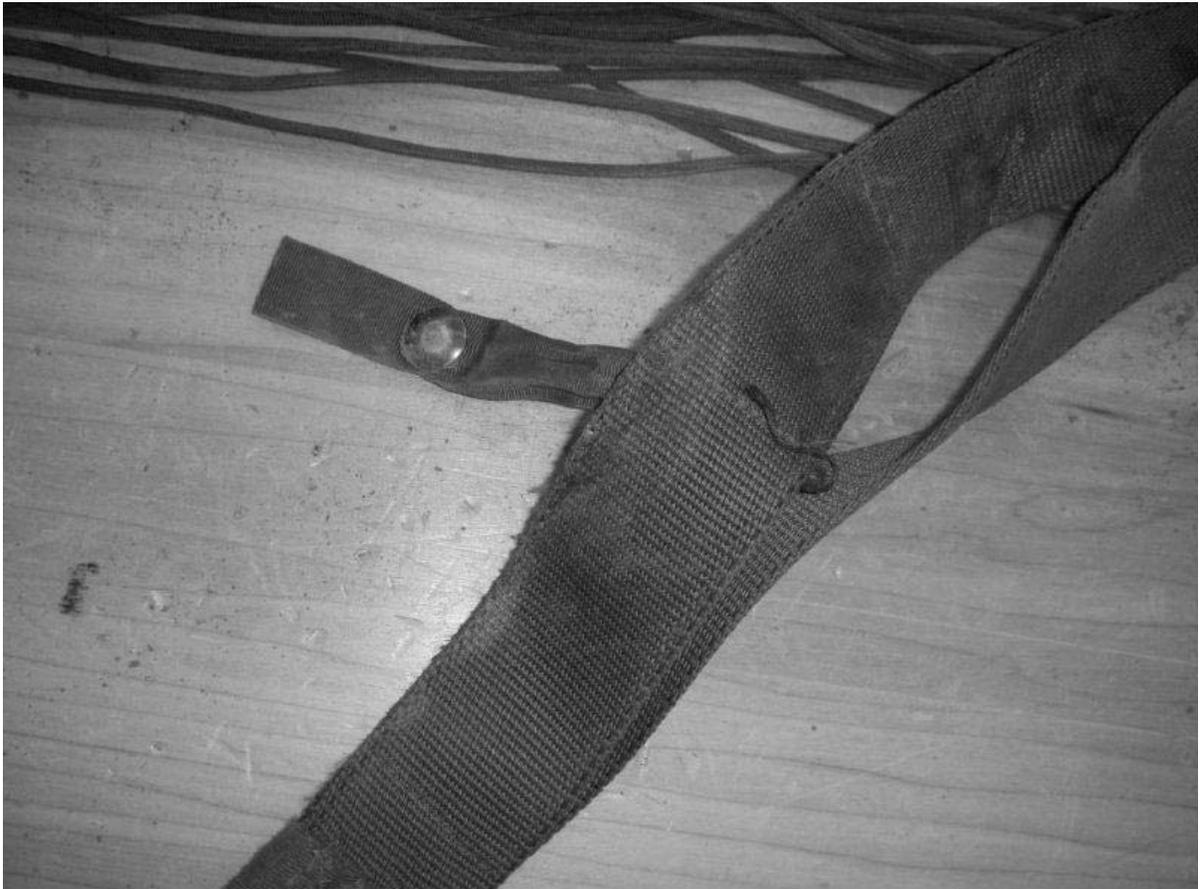
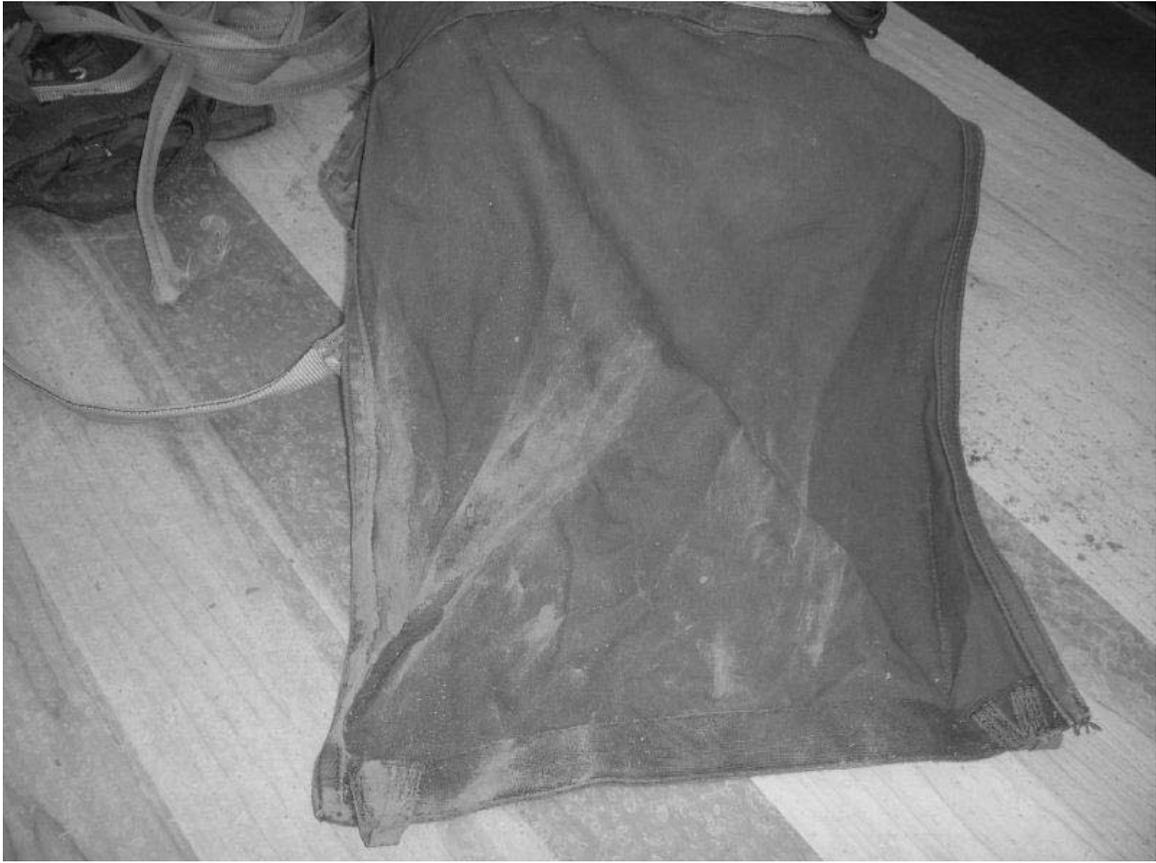
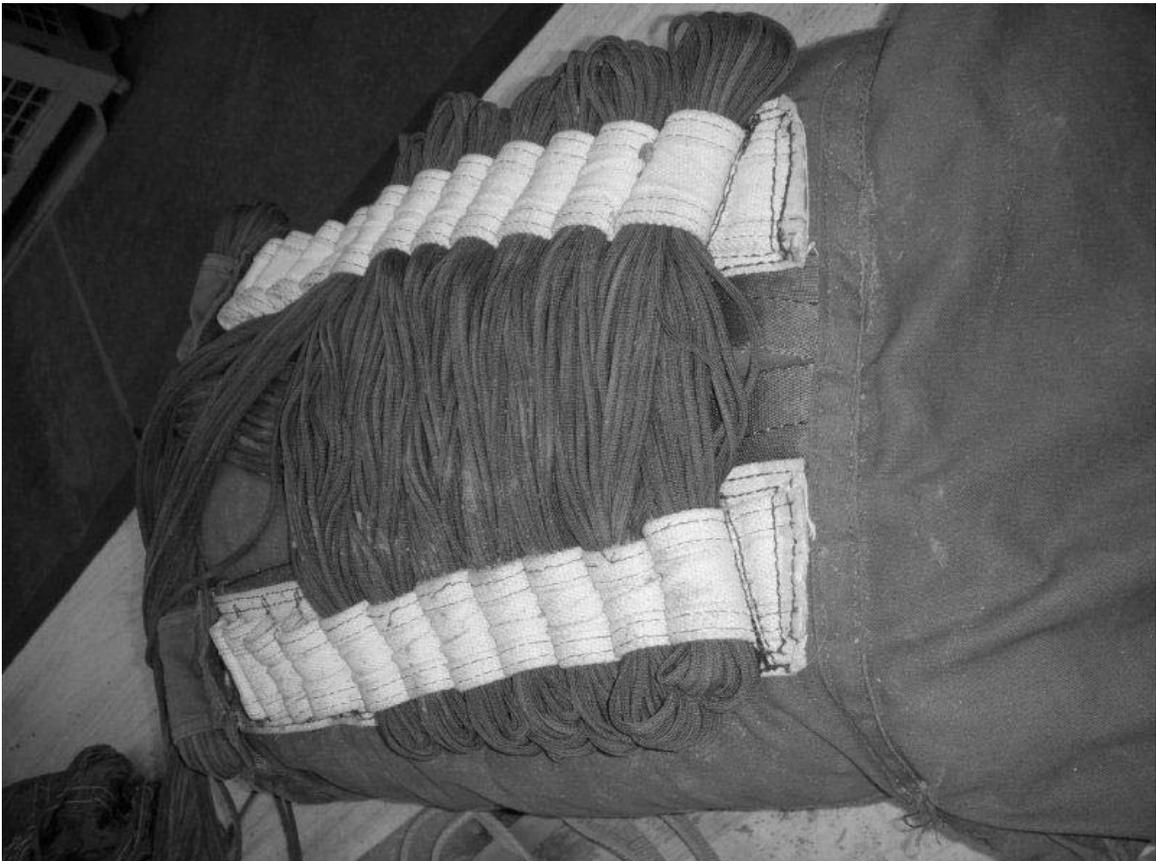
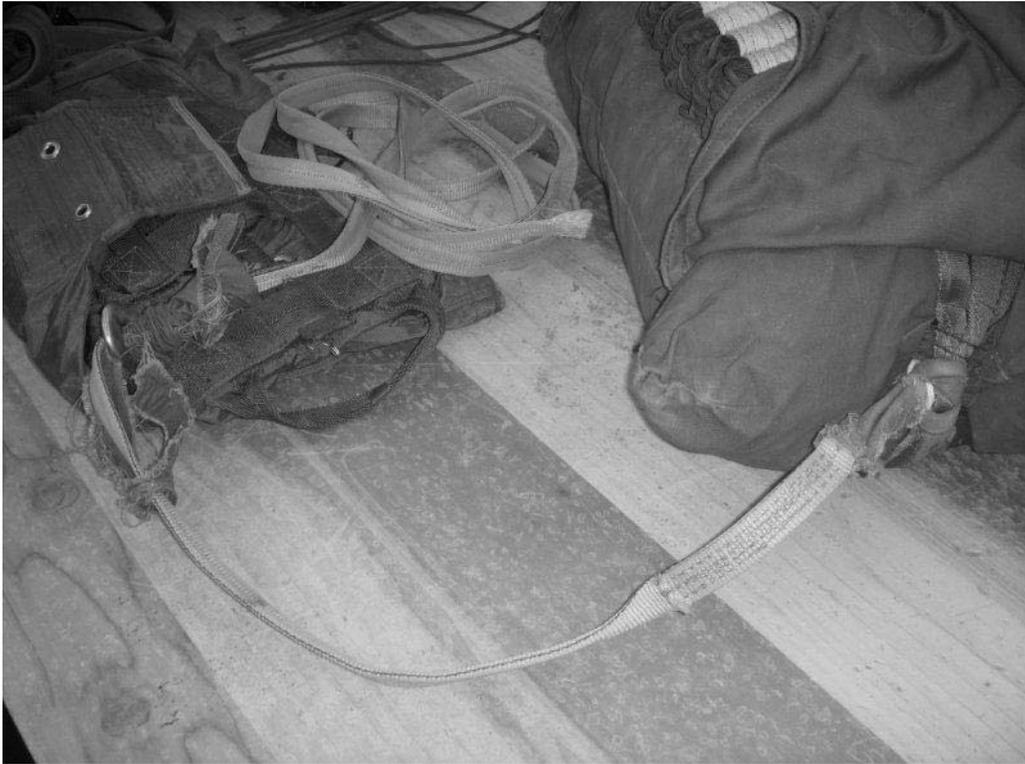
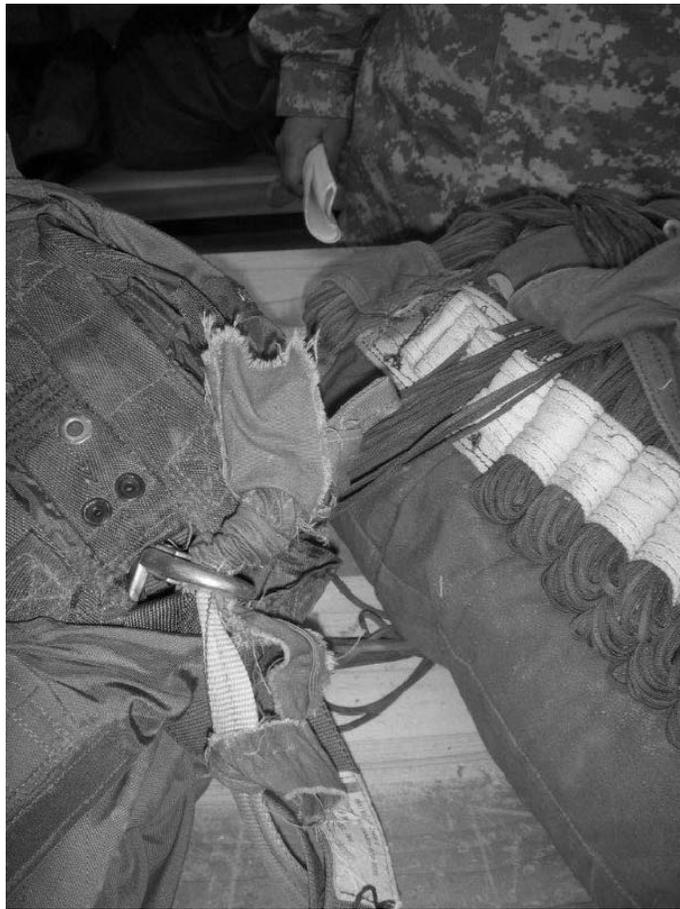
SL1_20110202_507PIR_Broken_USL_C130

Extensive burns on the right set of risers (rear outside) width of USL from the Male Fitting Canopy release extending to 9 1/2 inches down the risers

Burns on the right rear outside & right front inside

SLCP left connector snap tie is broken, the retaining strap is not assembled and the slot has extensive damage, Static line sleeve is shredded; Cotton buffer is also extensively damaged

Right Main lift web has burns and searing between the CRA and equipment D-ring

Waist band has burns approx 5 inches from the pack tray behind the SLCP Left waistband retainer

Suspected Cause of Malfunction - Incident: The Universal Static Line was misrouted under the right set of risers. As the jumper exits, this is what causes the initial violent jerk to the jumpers right as the jumper begins to be towed by his USL which is misrouted under/behind his right set of risers, he is being thrown vertical and horizontal which causes his USL to become routed through his left connector snap.

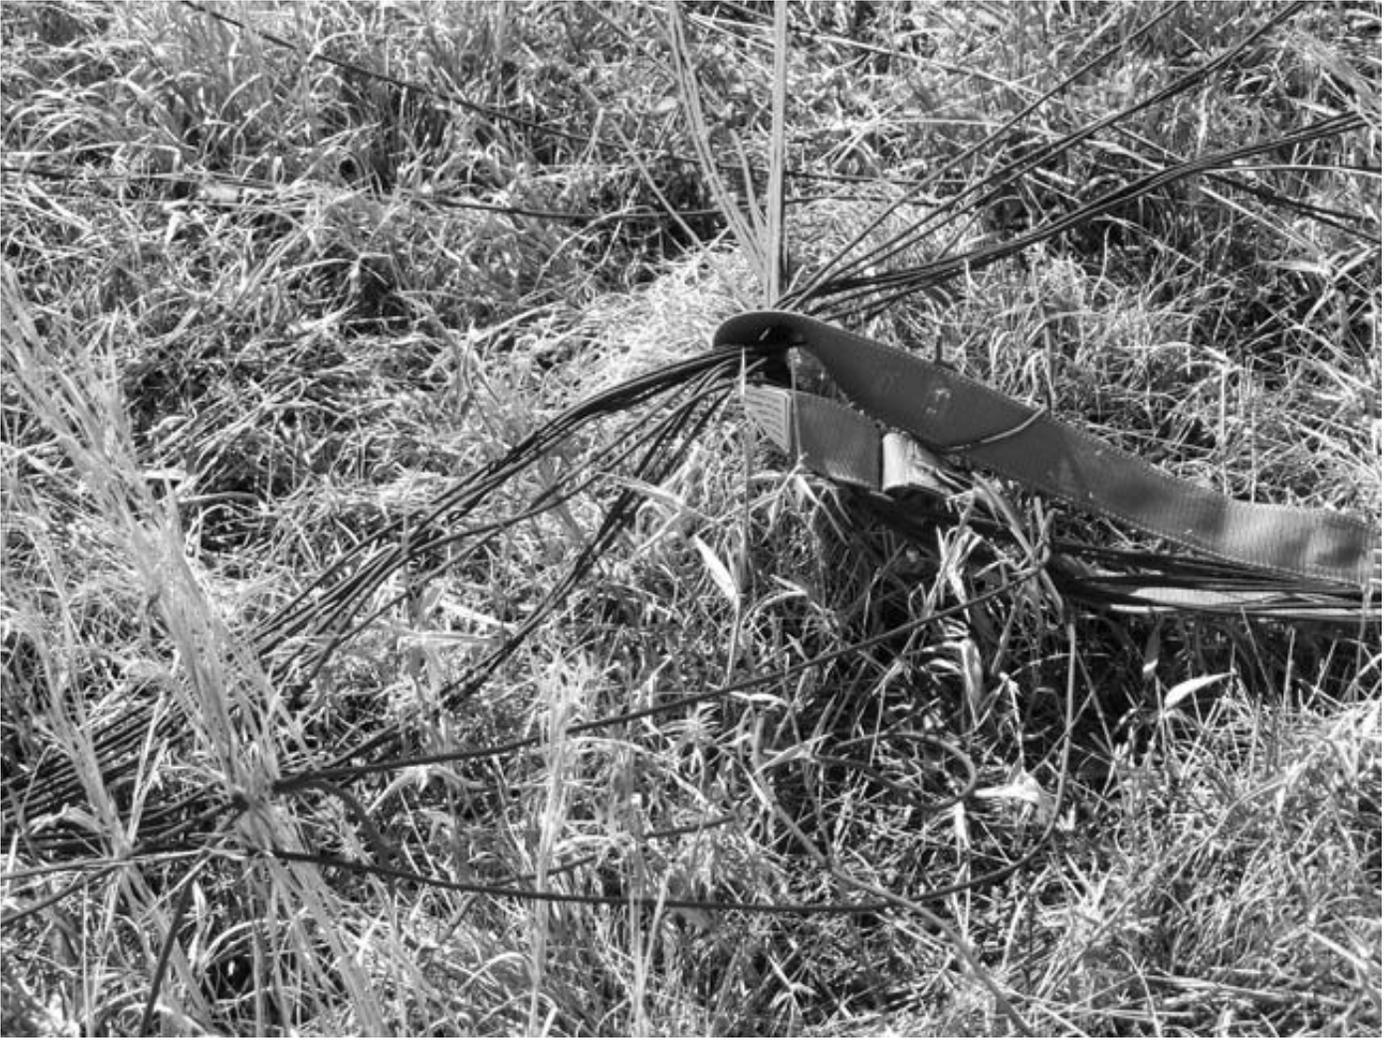
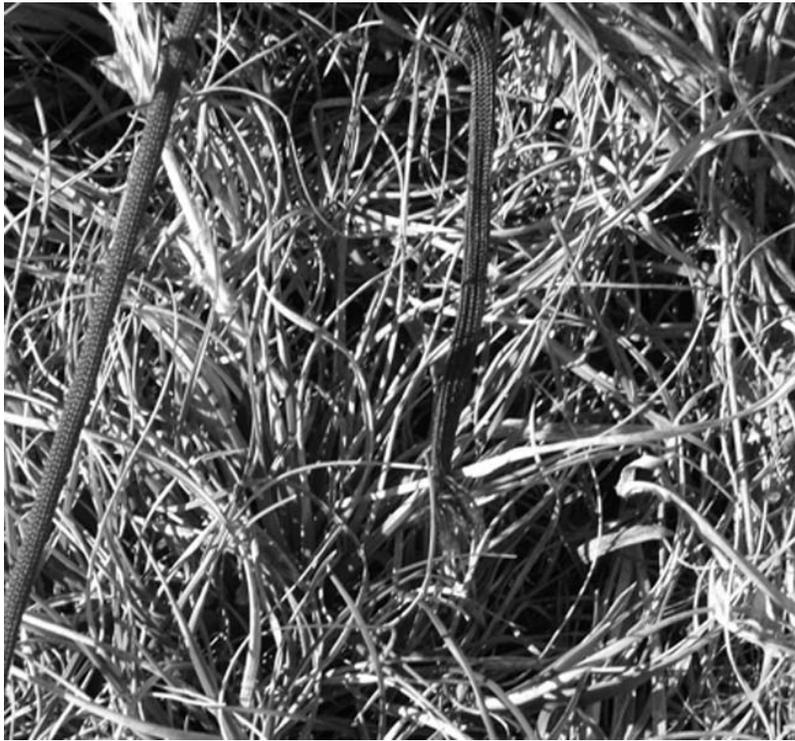
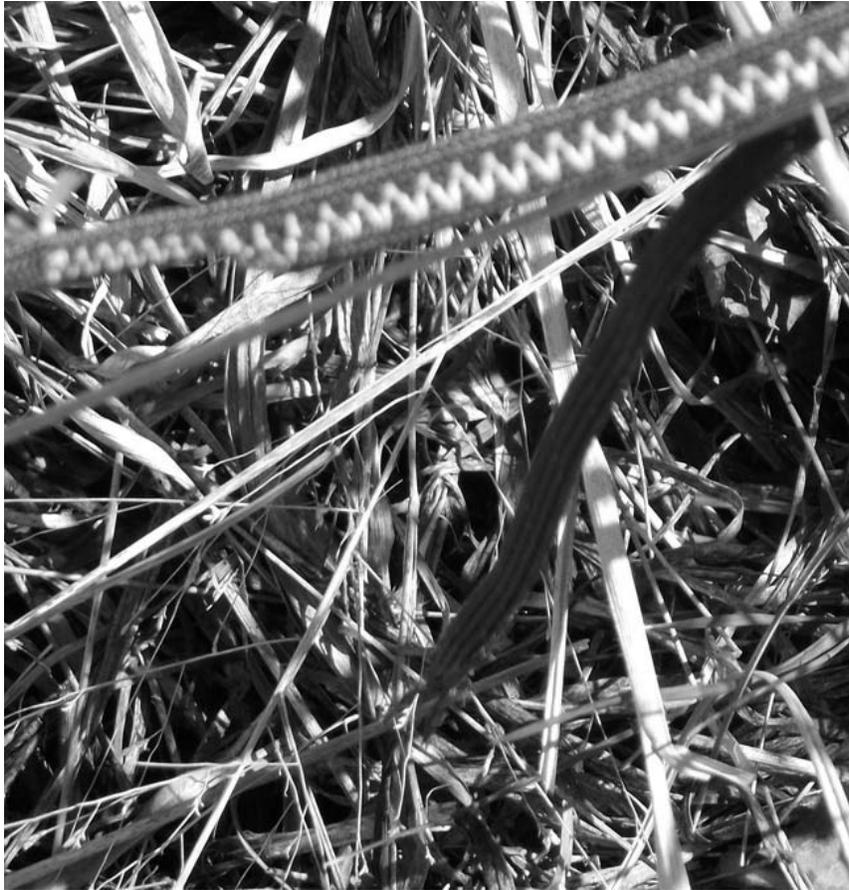
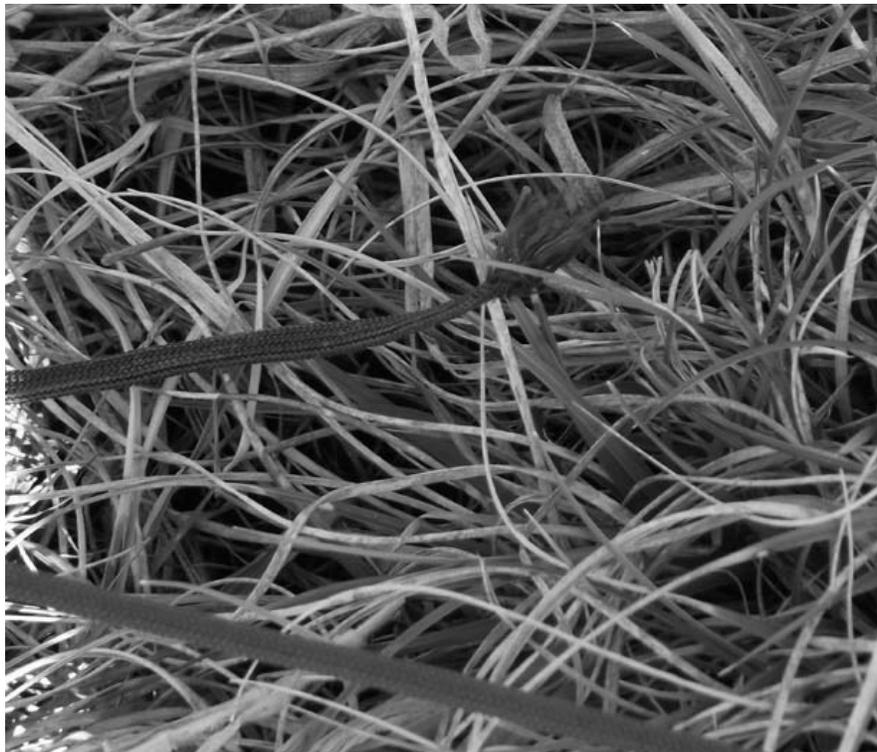
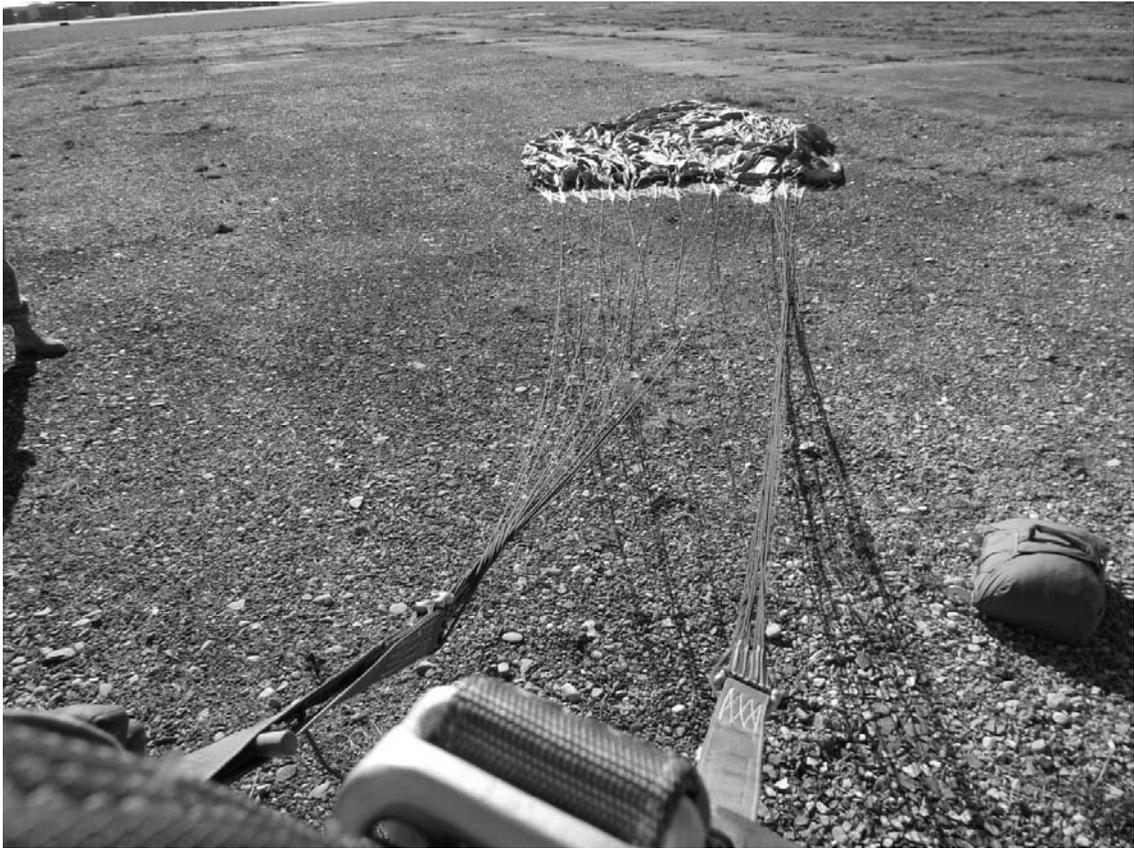
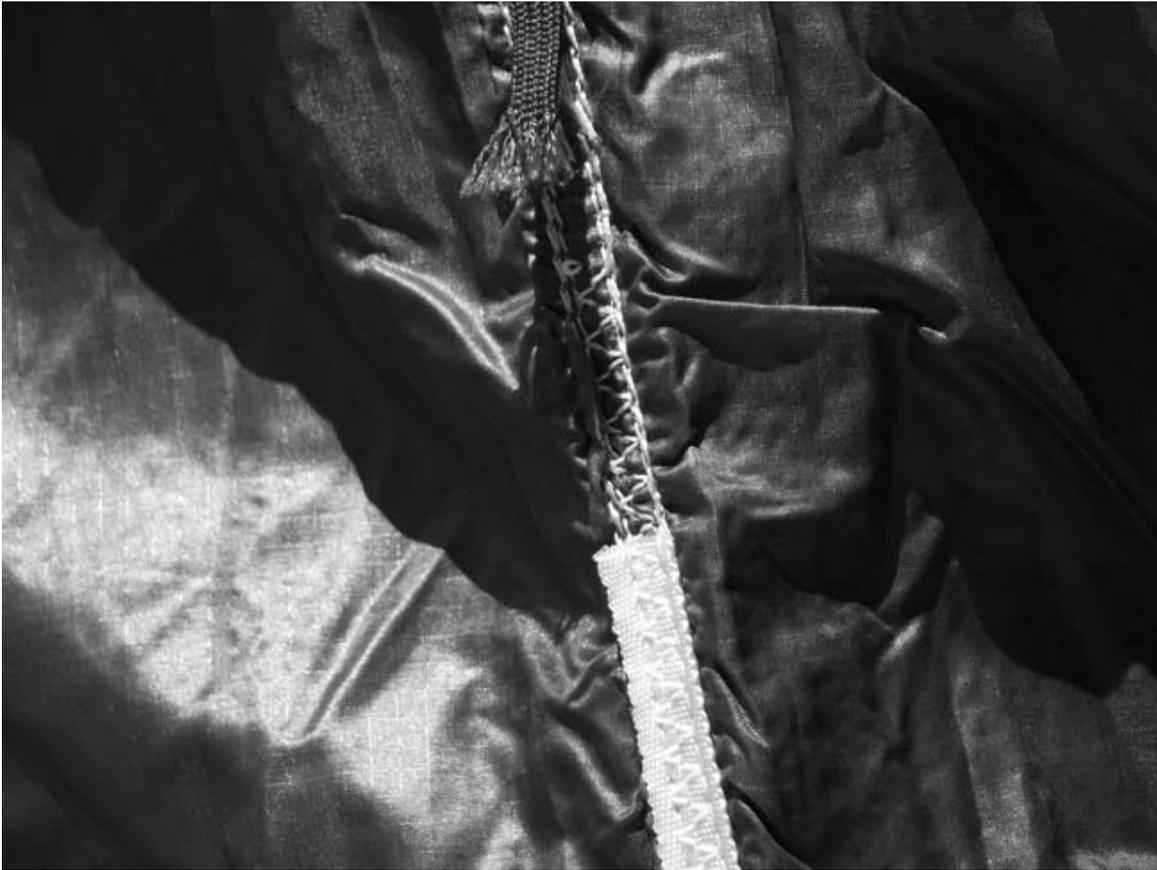
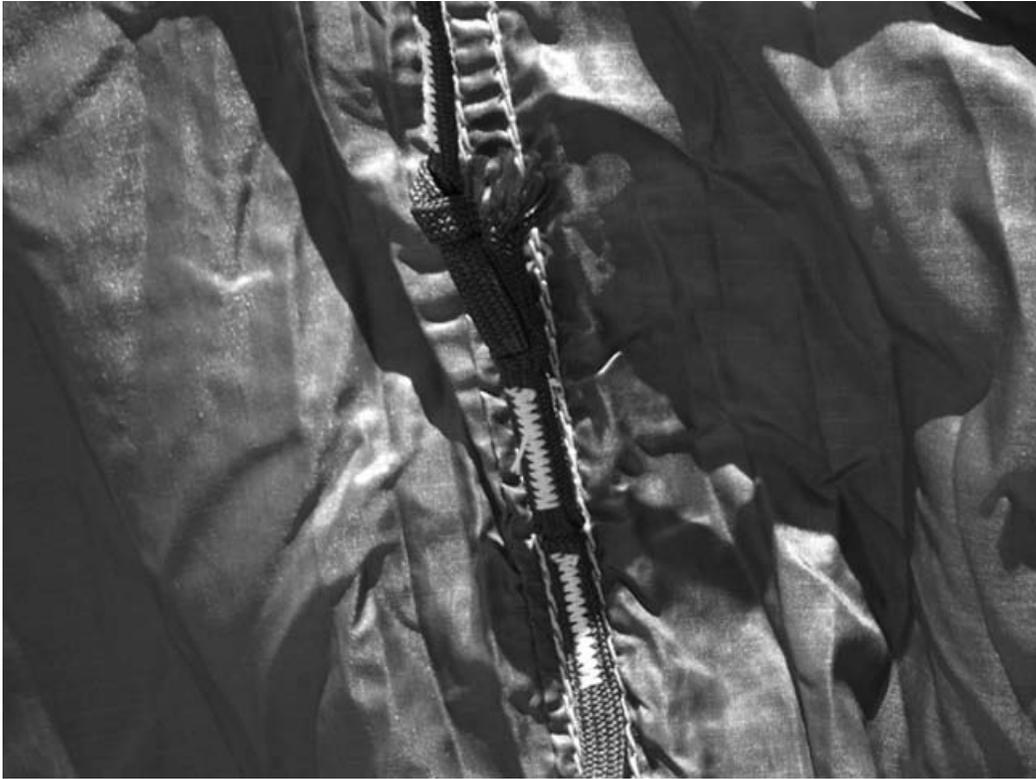
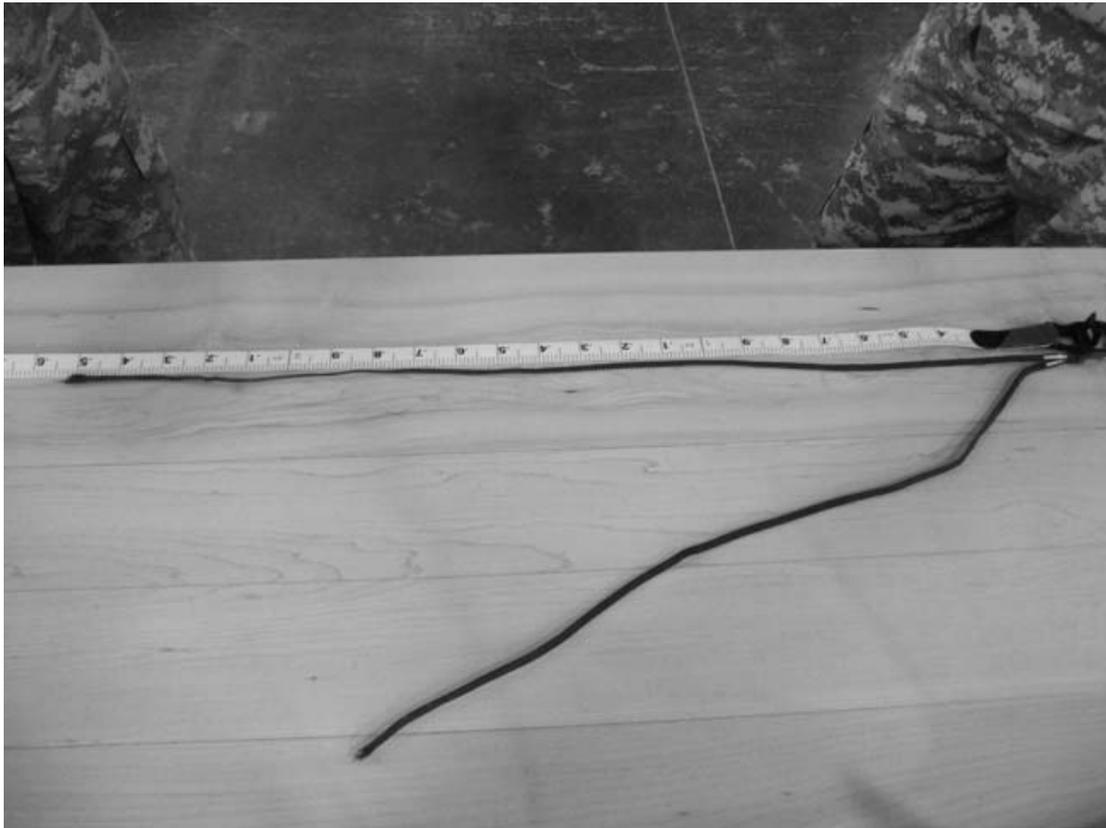
SL4_20110317_ADFSD_MC6_Broken_Control_Line_C130

Description of Suspected - Malfunction - Incident - Damaged Incurred: After exiting the aircraft, during his second point of performance when he checked canopy he had one full twist which he bicycled out of then re-checked his canopy and grasped his toggles. The right control line had no tension it and the jumper followed it up and seen that it had broken. He used his right rear riser and left control line to maintain a holding descent to the ground. There was not visible damage to the canopy material from the broken control line. The damage was to the middle control line that broke.

Suspected Cause of Malfunction - Incident: Improper clearing of the middle control lines and placement in the air channel on lines 23 and 25. This caused the middle control lines to have excess friction on the lower control line which lead to the middle control line to burn and break. Pictures of the damage are available.

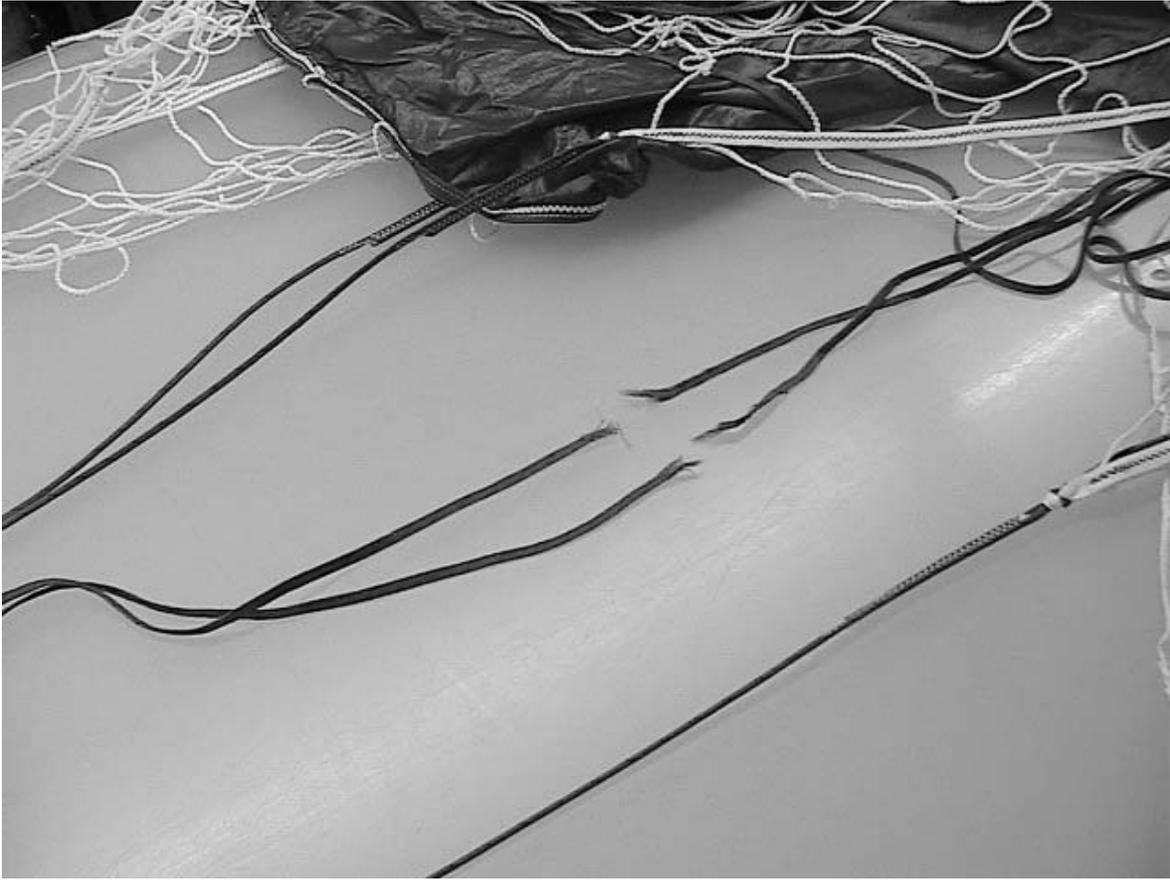
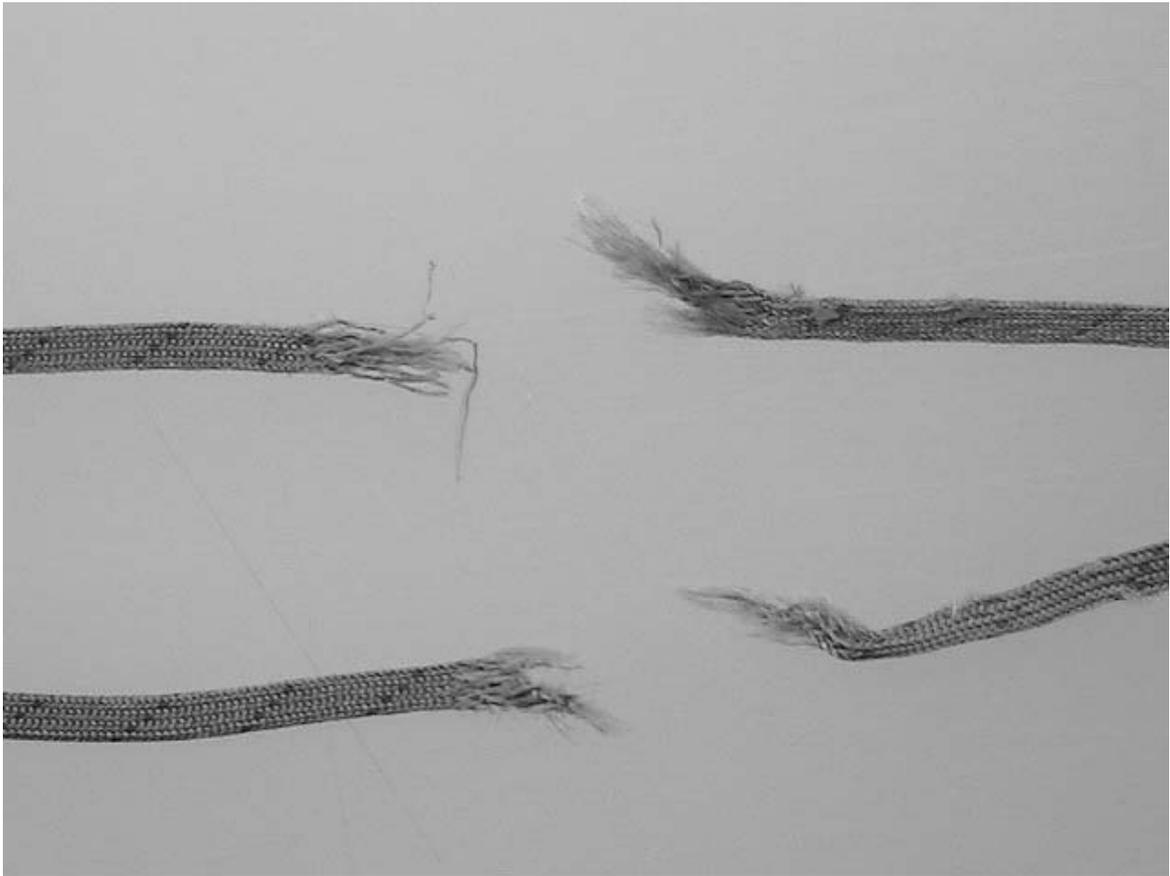
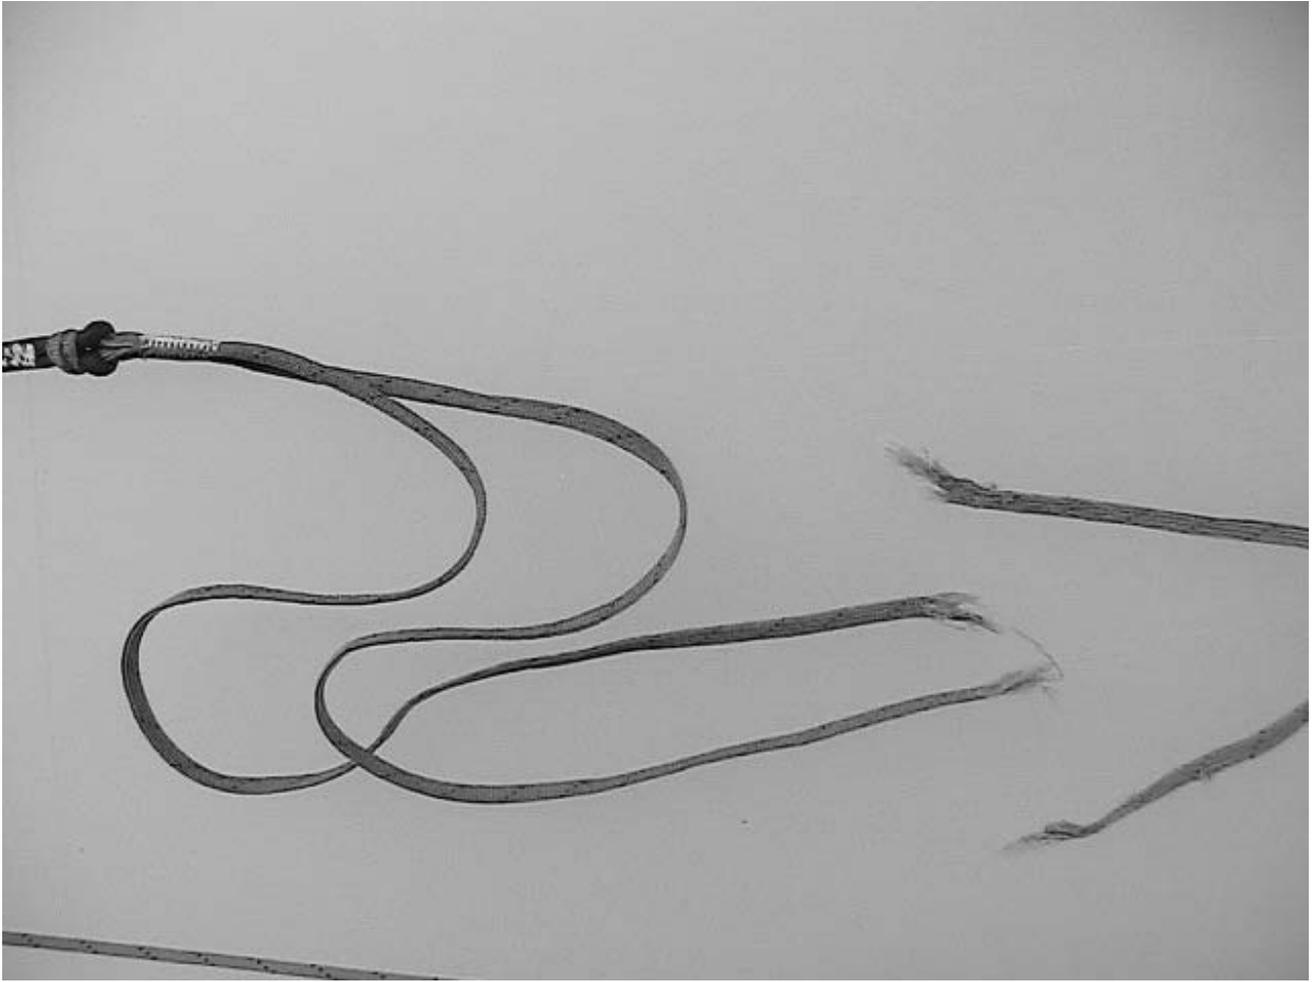
SL5_20110323_3SFG_MC6_BROKEN_CONTROL_LINE_C212

Description of Suspected - Malfunction - Incident - Damaged Incurred: SM did not notify to anyone he had a broken control line until 24 hrs after the jump. a parachute was found with a left broken control line at the lower section. TRI was performed and no further damage was found. control line measurement is 286 in, 4 in longer than the requirement.

Suspected Cause of Malfunction - Incident: after unit analysis it was determined that control line broke due to faulty design
