136th TRIANNUAL AIRDROP REVIEW and MALFUNCTION SAFETY ANALYSIS BOARD

June 21-23, 2011

MALFUNCTIONS / INCIDENTS REPORTED

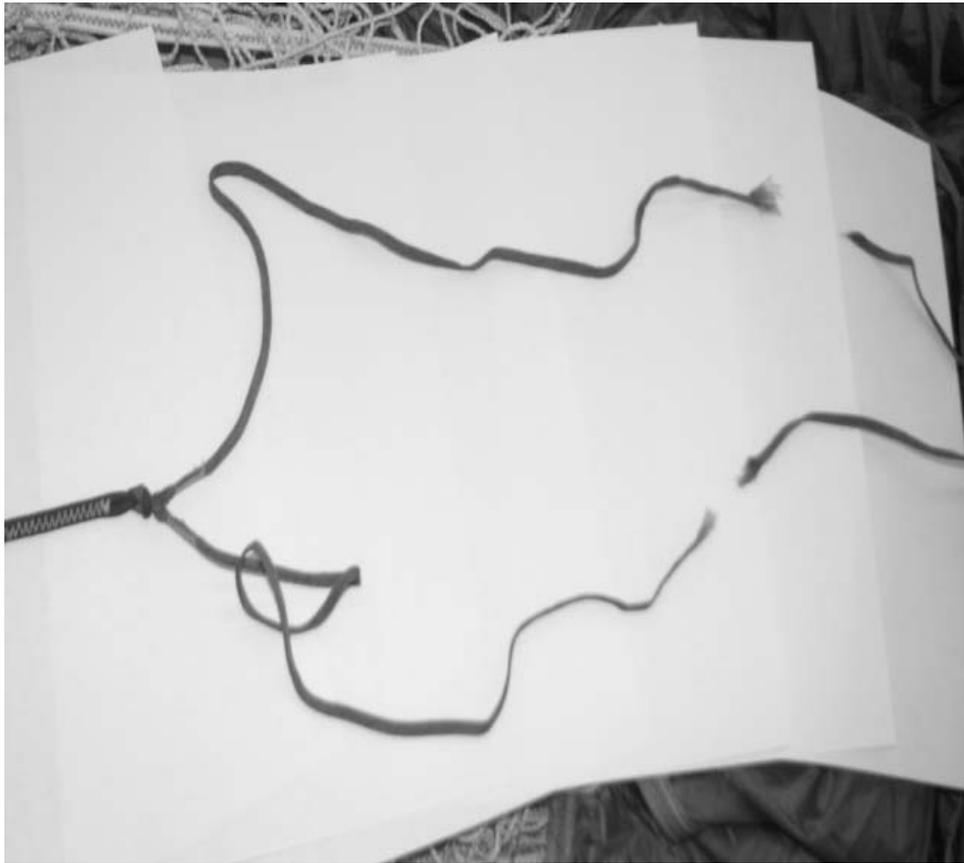
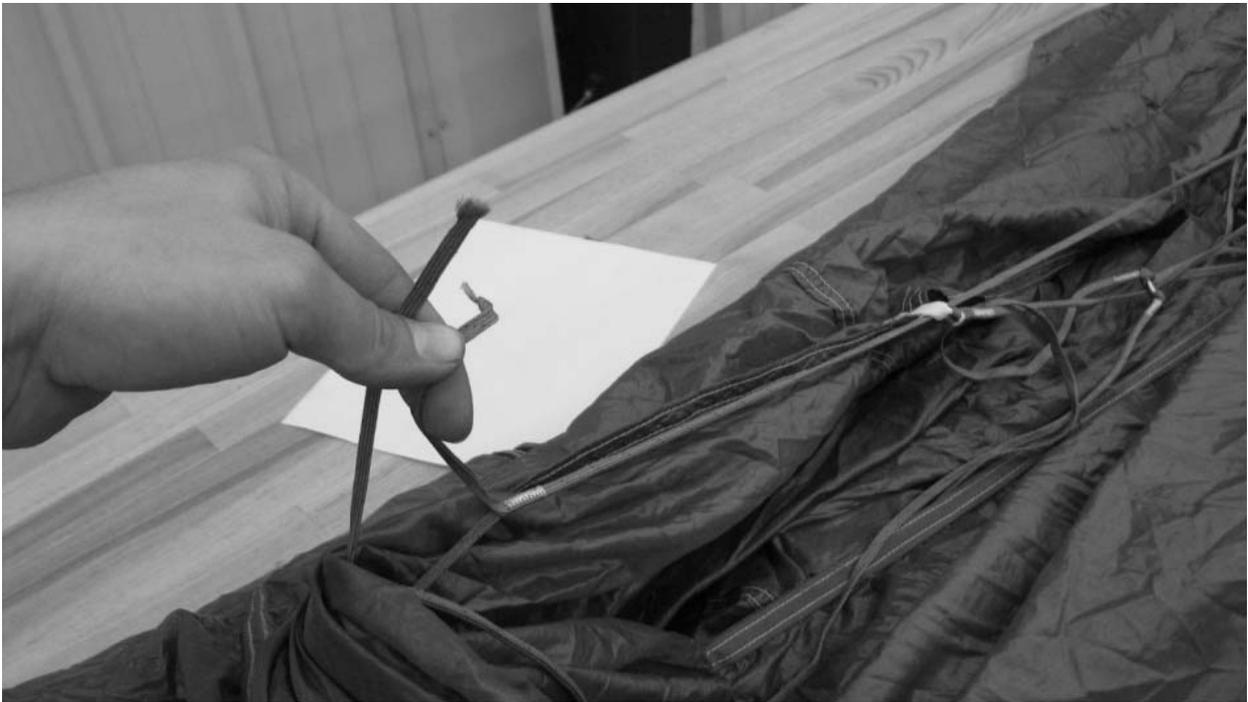
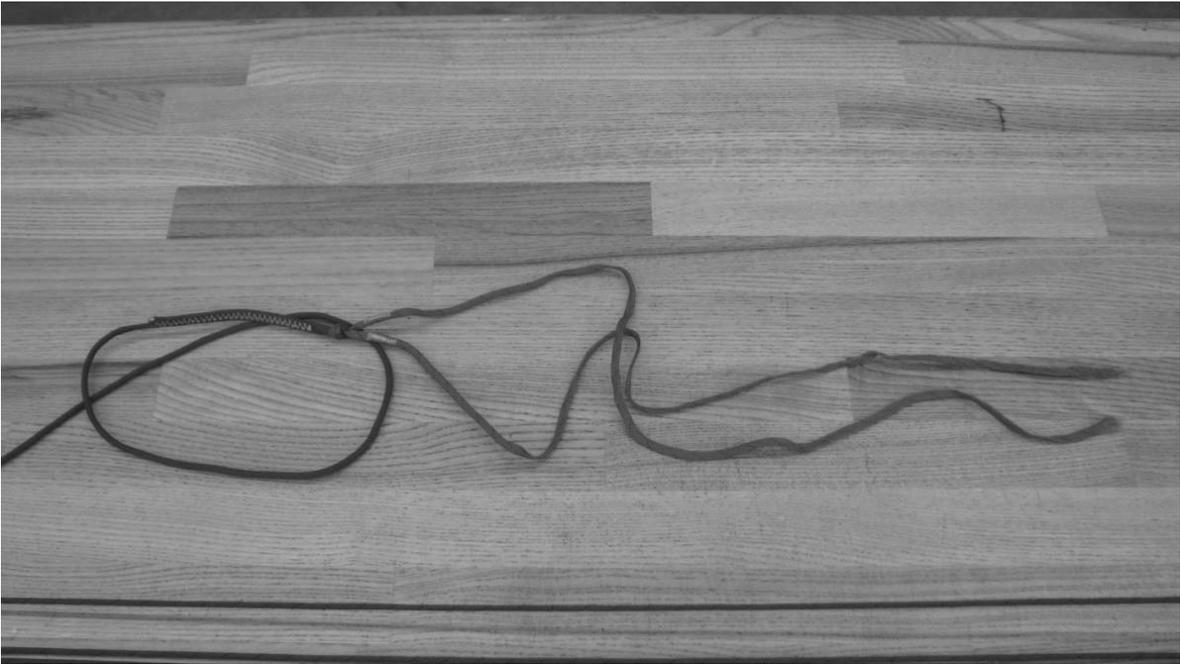
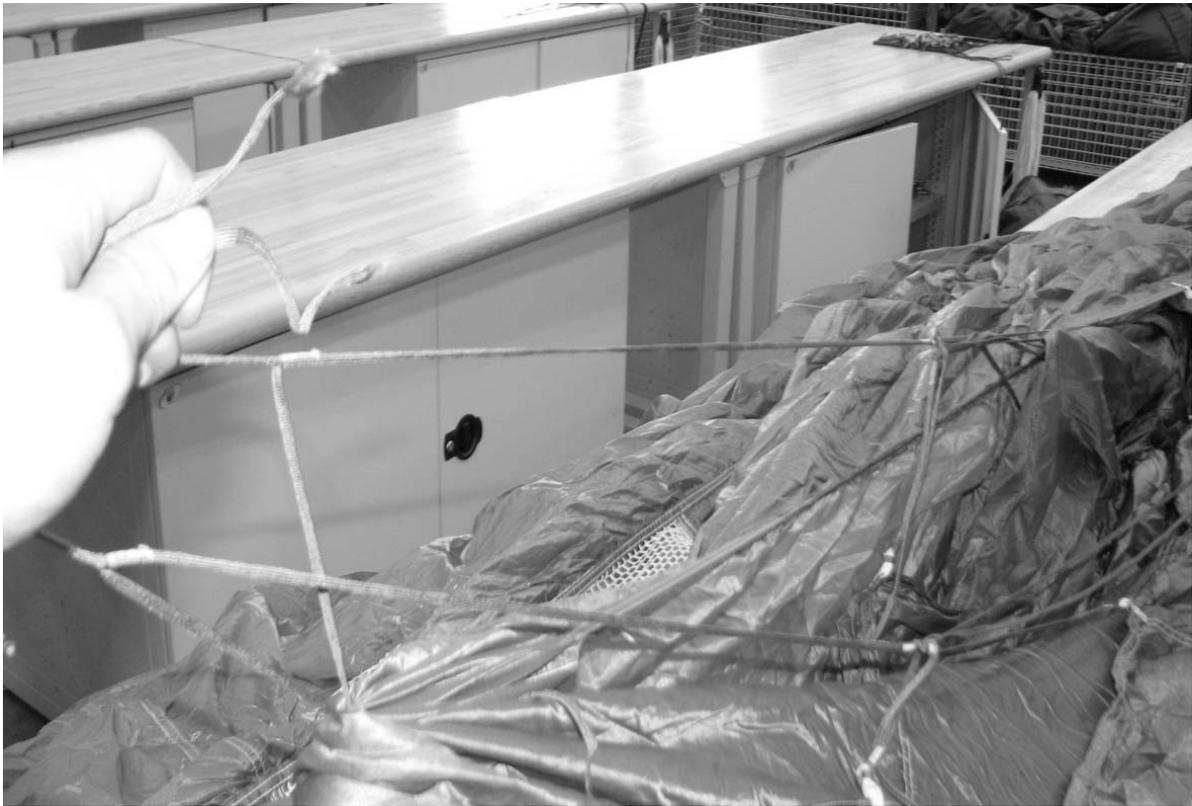
SL6_20110323_1SWTG_MC6_BROKEN_CONTROL_LINE_C17

Description of Suspected - Malfunction - Incident - Damaged Incurred: On the 24th of March, 2011 at 1100, JFKSWCS-NCOA was conducting airborne operation on Luzon Drop Zone from a C-17. The aircraft was traveling at 130 knots and was flying at approximately: 1500 ft AGL. The 15th jumper in the 1st pass weighed 190lbs and was wearing a 35lb ruck sack. After exiting the right side of the aircraft the jumper observed twist in his risers during his second point of performance. After grabbing both sets of risers and cycling out of the twists the jumper discovered that his right control line was broken. The same malfunction happened to the 5th jumper in the same stick with the opposite control line. Both jumpers used their risers to pull a slip and landed without injury.

Suspected Cause of Malfunction - Incident: Excessive twists in the suspension lines and risers prohibited the control line to move freely and fully extend causing it to snap.

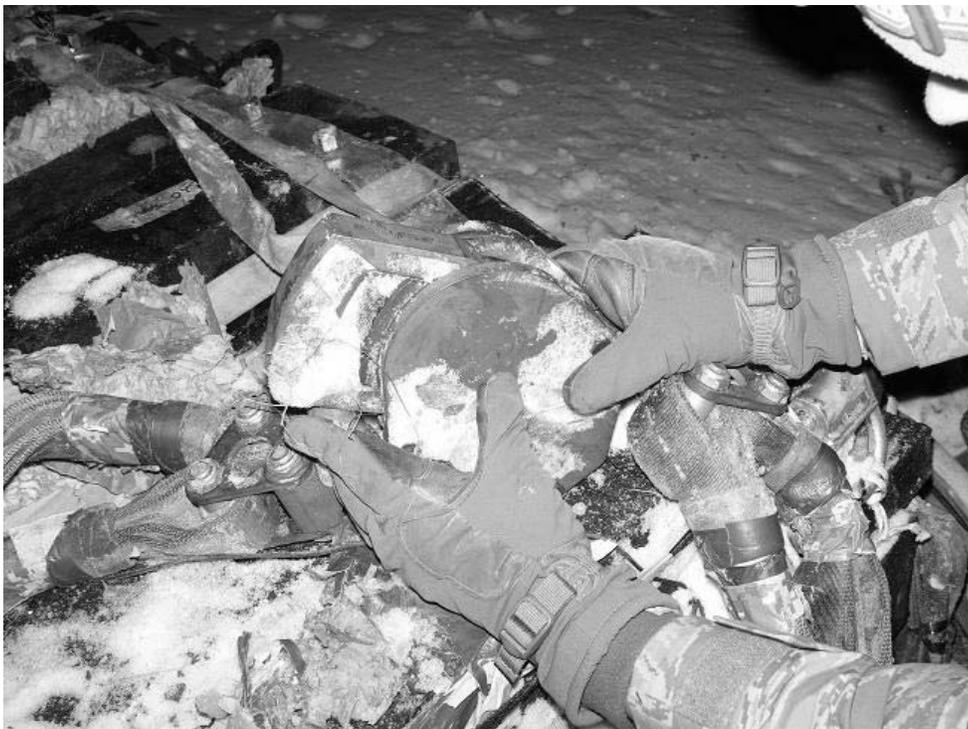
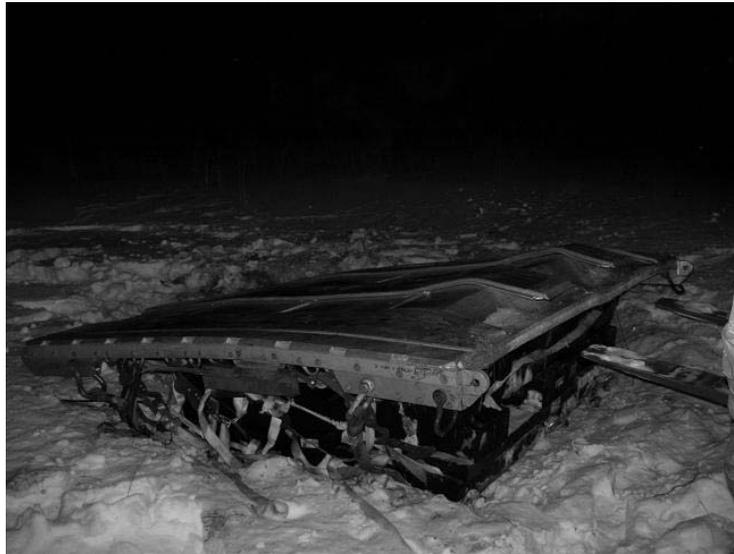
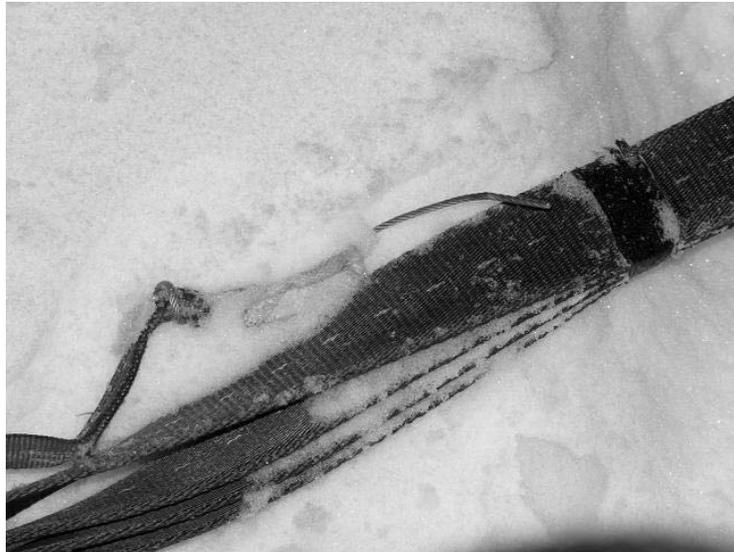
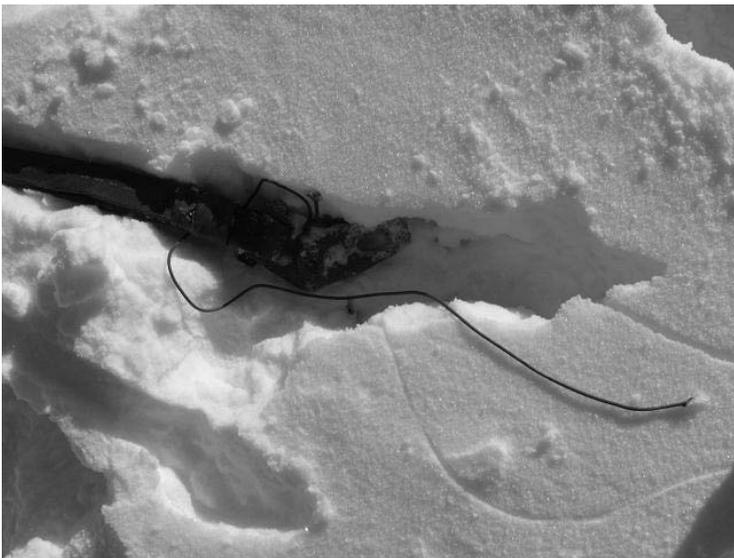
HE1_20101227_133AW_G12E_M1MidAirSeperation_C130

Description of Suspected - Malfunction - Incident - Damaged Incurred: During deployment phase the two G-12E cargo parachutes released from the M1 prematurely. The platform free fell to the ground. During a night drop the platform extracted from the aircraft without incident, the EFTC transferred from extraction to deployment phase without incident. During deployment phase after the cargo parachutes were fully extended from the platform, the parachute connectors released from the M1 device. The parachutes floated to the ground and the equipment platform free fell, Drop score; parachutes 177@ 6 and platform 160 @ 11.

Suspected Cause of Malfunction - Incident: Faulty M1 device / timer. The M1 was tested and worked as advertised. During Pre-slowdown checklist the Instructor Loadmaster visually checked the M1 and timer block and the keys were extended.

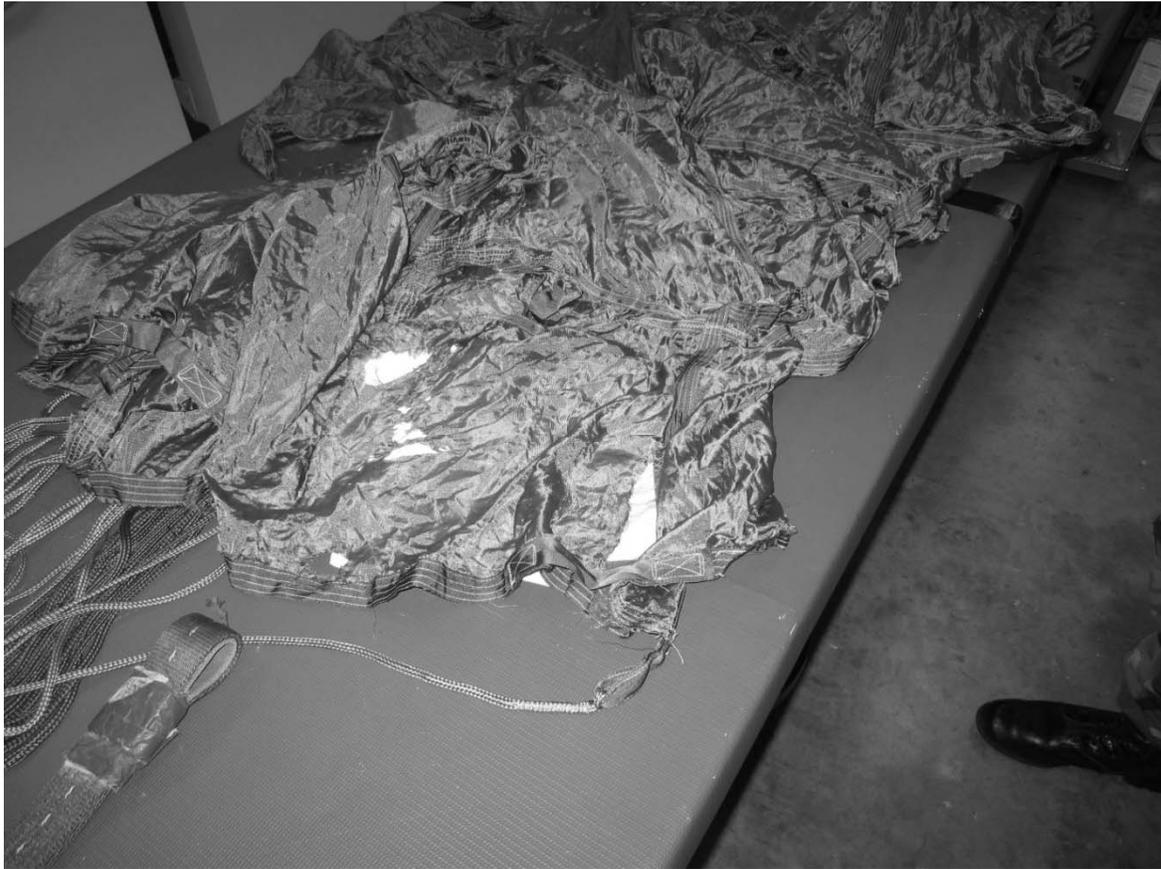
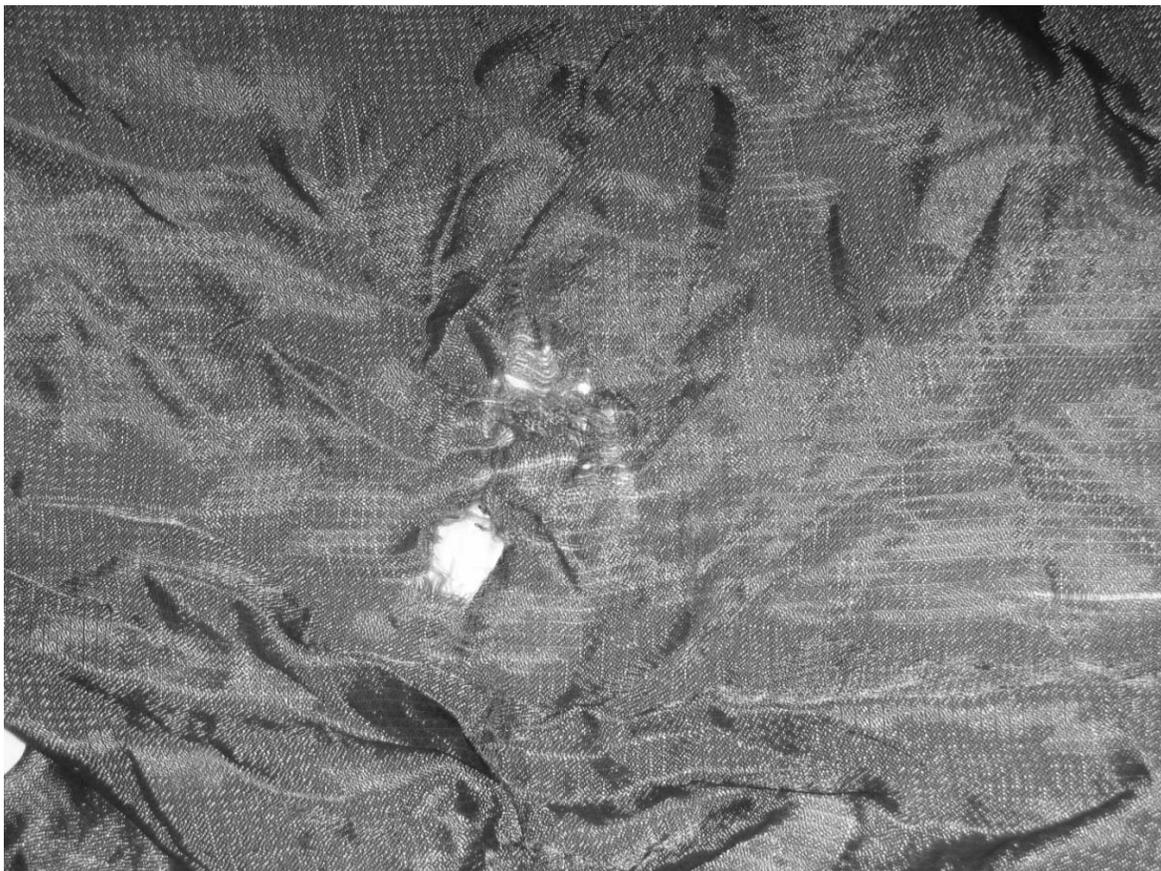
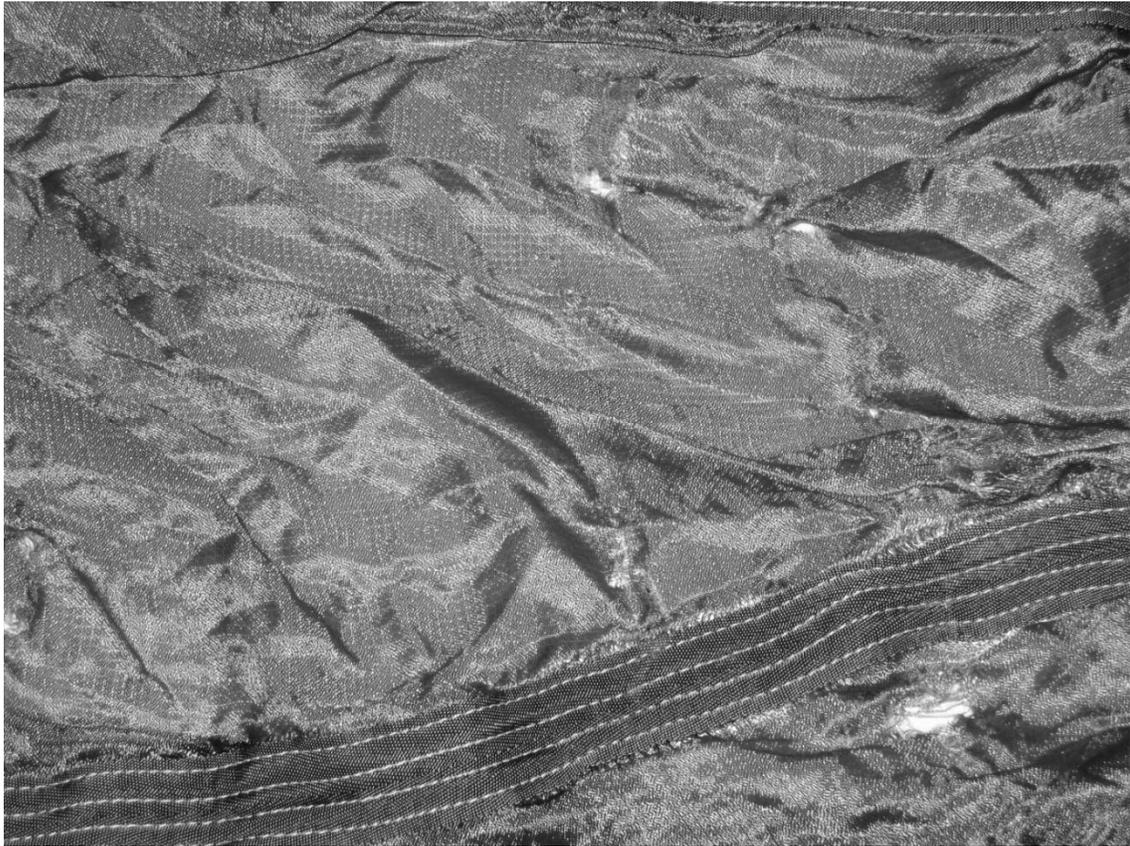
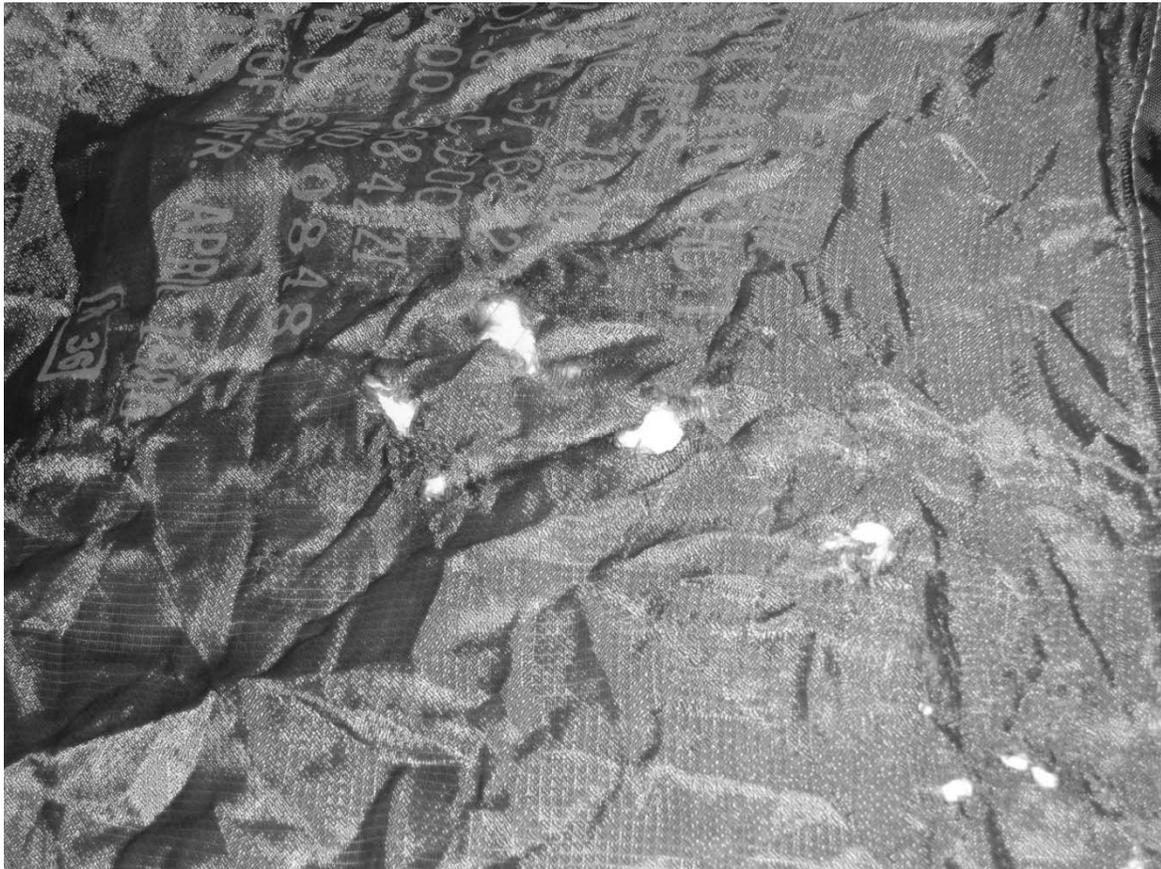
HE4_20110421_353SOG_15FT_Extraction_MC130H

Description of Suspected Malfunction/Incident/Damaged Incurred: At “green light” during the heavy equipment airdrop, the 15’ extraction parachute entered the slipstream normally but failed to achieve proper inflation. Crew members in the cargo compartment claimed that the extraction parachute appeared twisted and half inverted giving it a “figure 8” appearance. The load failed to release from right hand dual rail lock. As a result the secondary loadmaster called a “Malfunction”, and the crew began to run the proper malfunction checklist. As both loadmasters prepared to simultaneously place the emergency restraints on the load, the heavy equipment platform released from the right hand dual rail lock and the load exited the aircraft. The malfunction lasted approximately 7-10 seconds. The deployment and release phases of the drop went as normal. The load landed long, but on the DZ and no damage was caused to the aircraft or personnel.

Suspected Cause Of Malfunction/Incident: Improper packing of the 15’ extraction parachute was most likely the cause of the malfunction. Upon inspection of the extraction parachute, multiple gores between parachute lines 1 & 16 and 8 & 9 had rips and tears most likely from friction caused by parachute lines wrapping around the canopy. These tears support eye witness claims of a twisted looking extraction parachute. In addition, the right hand dual rail lock being used was properly configured I.A.W. T.O. 1C-130A-9. Upon RTB, the lock used was pulled from the aircraft and bench tested to ensure lock release was achieved under correct pressure. The test found that the lock was working properly.

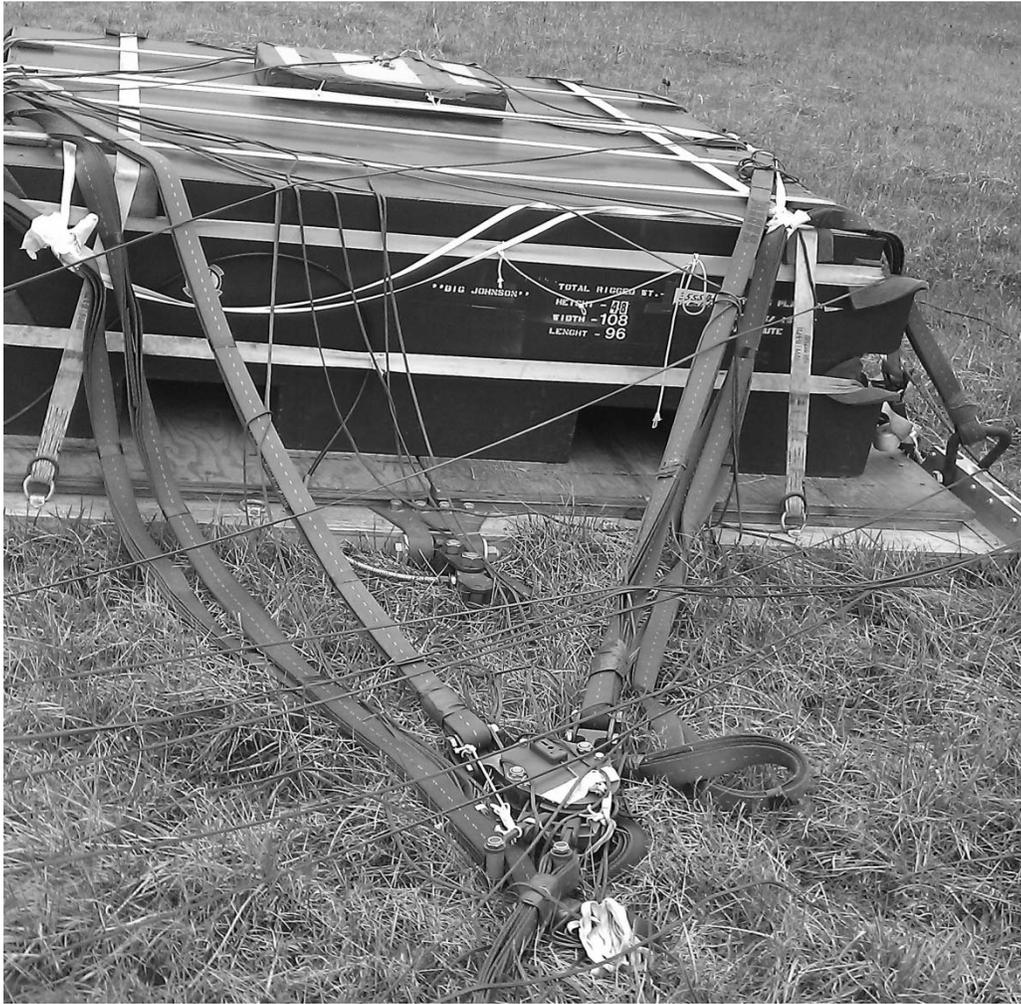
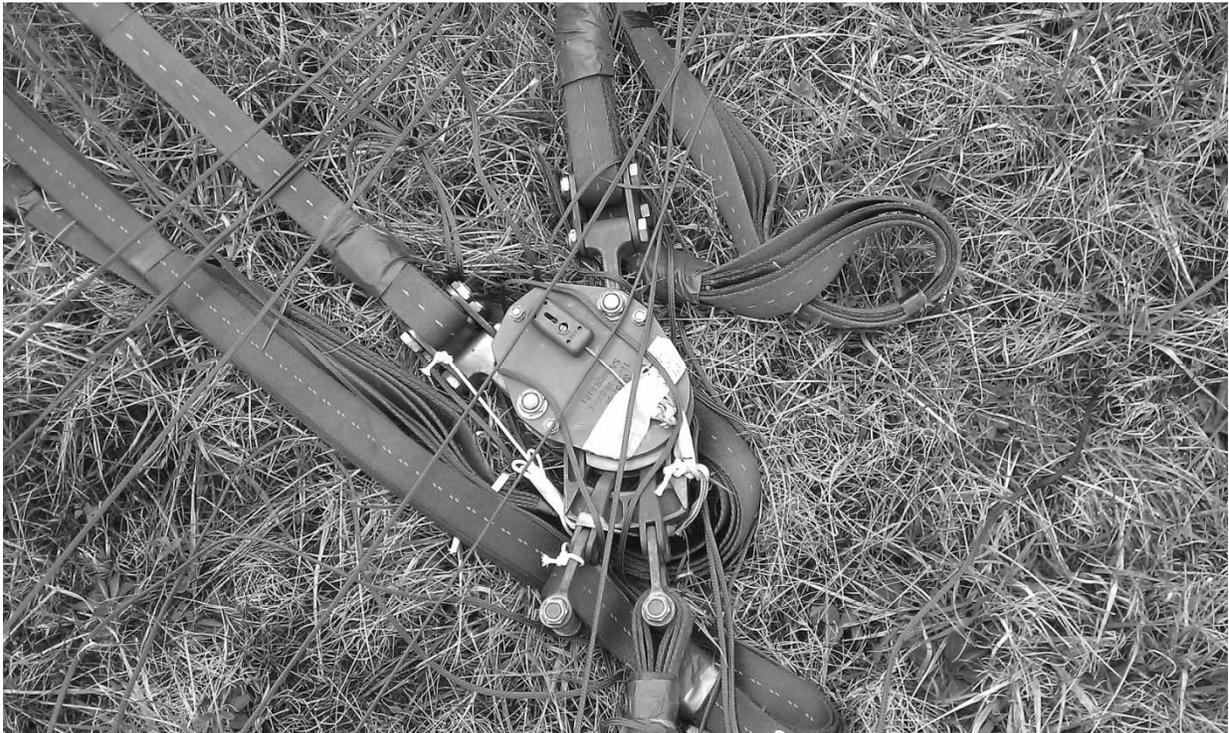
HE7_20110105_328AS_M1_FailedToRelease_C130

Description of Suspected - Malfunction - Incident - Damaged Incurred: Two G-12 parachutes failed to release from the M-1 after landing on the drop zone. Parachute release connectors remained in upper suspension link. Arming wire was still installed in the M-1 and the arming wire lanyard was not connected to the parachute carrying handle.

Suspected Cause of Malfunction - Incident: Found the arming wire lanyard was either not tied to the G-12 carrying handle or it was not tied properly and did not pull out the arming wire from the M-1.

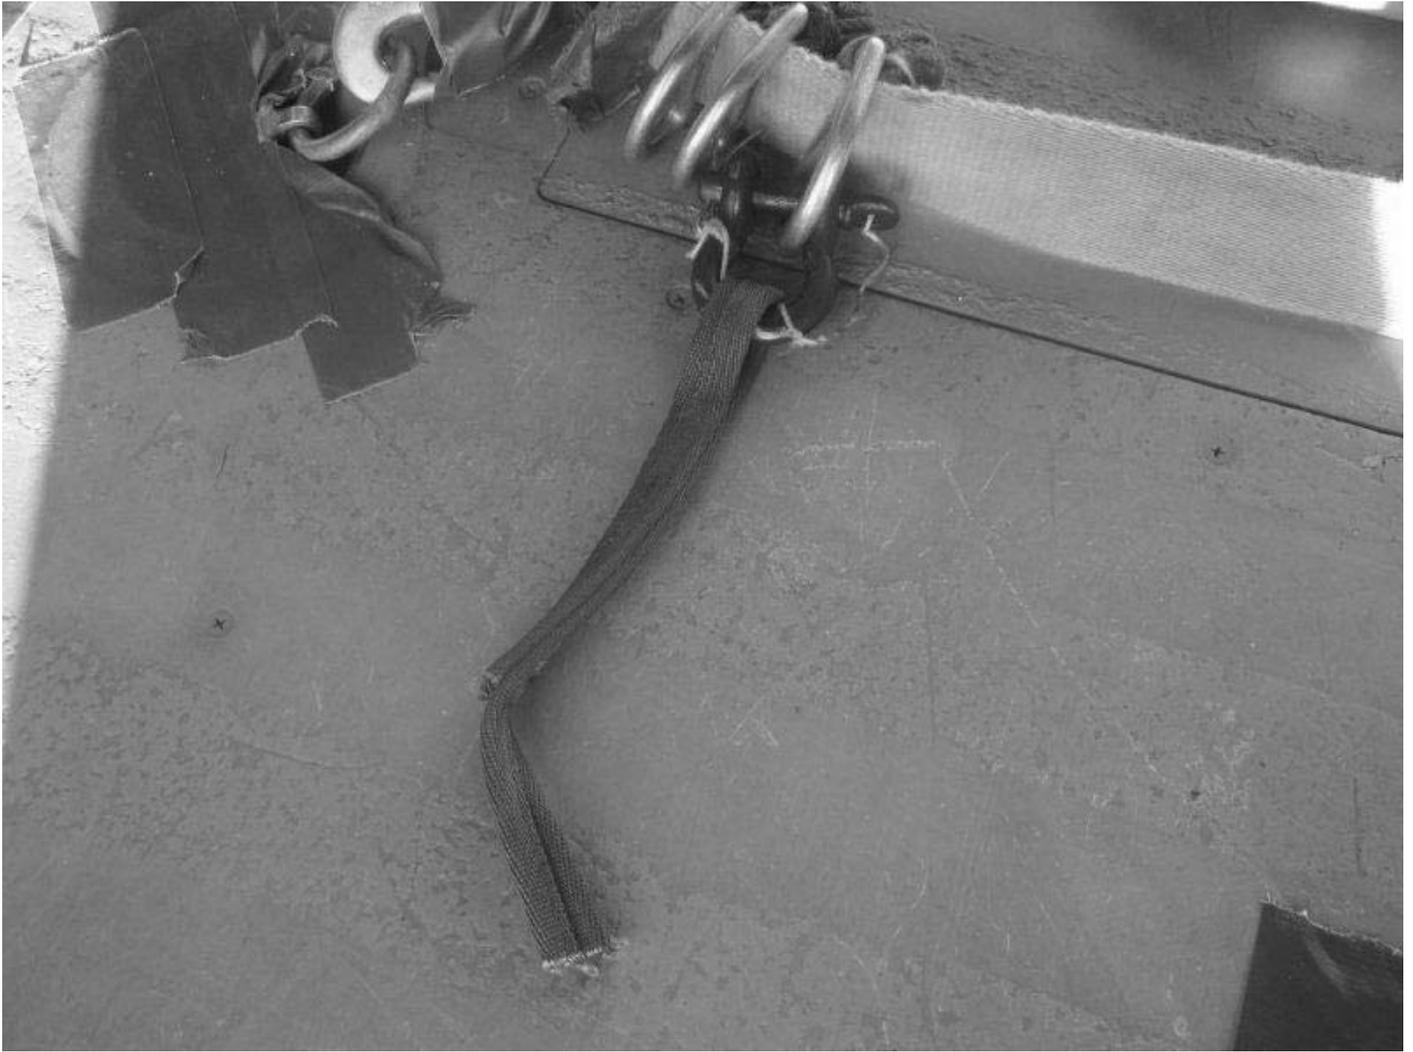
CDS1_20100108_1/507PIR_68" Pilot Chute_C130

Description of Suspected - Malfunction - Incident - Damaged Incurred: 1 A7A (3) strap load was built by Pathfinder Branch cadre to be dropped for their night insertion operation. They requested a non-break away pilot parachute for the load, and the 68 inch pilot they drew was marked as such. Over the third pass over Liberty Drop zone the JM attempted to draw the deployment bag back in the aircraft and noticed resistance, he then did a clear to the rear and observed the door bundle riding up the side of the aircraft door with the parachute extracted and the bundle being towed. The bundle began to make its way up in the direction of the rotor, so he immediately cut the bundle free. The 68 inch opened with the deployment bag still attached landed approximately 150 meters off the trail edge of the drop zone. The bundle was towed less than 2-5 seconds before it was cut free.

Suspected Cause of Malfunction - Incident: The inspection of the pilot parachute revealed it was marked for non-breakaway however it was internally rigged for break away. Where ticket number 5 should have been used to form the break cord tie, the pilot chute bridle was use to attach to the deployment bag attaching loop causing the load to be towed upon exit.

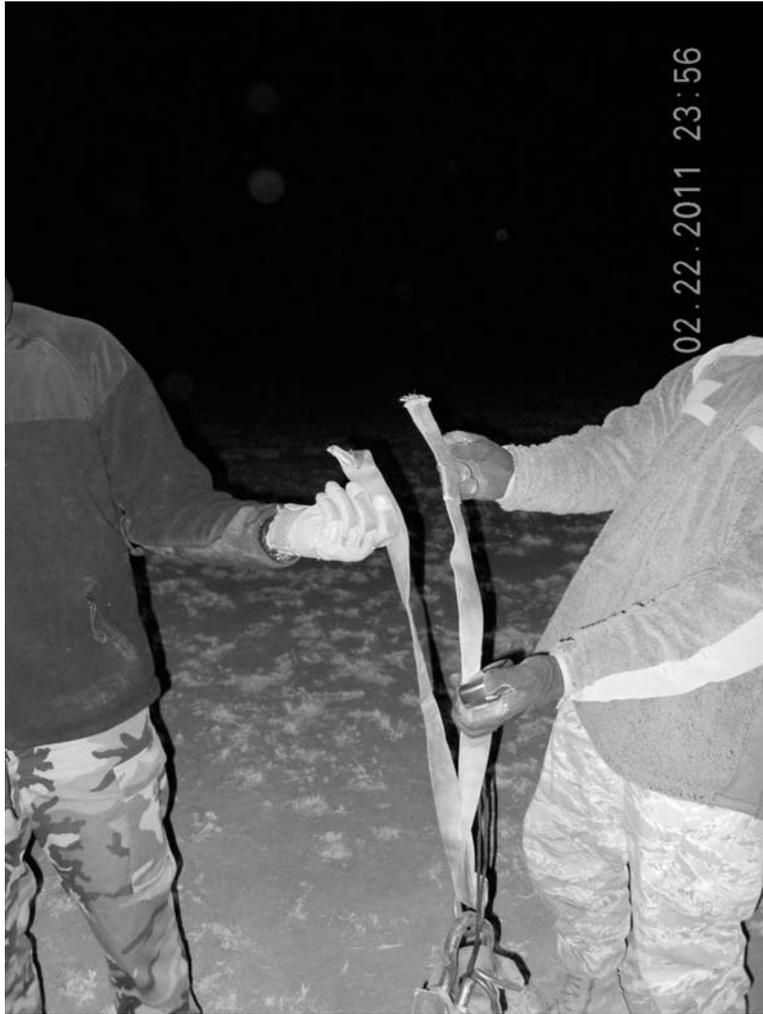
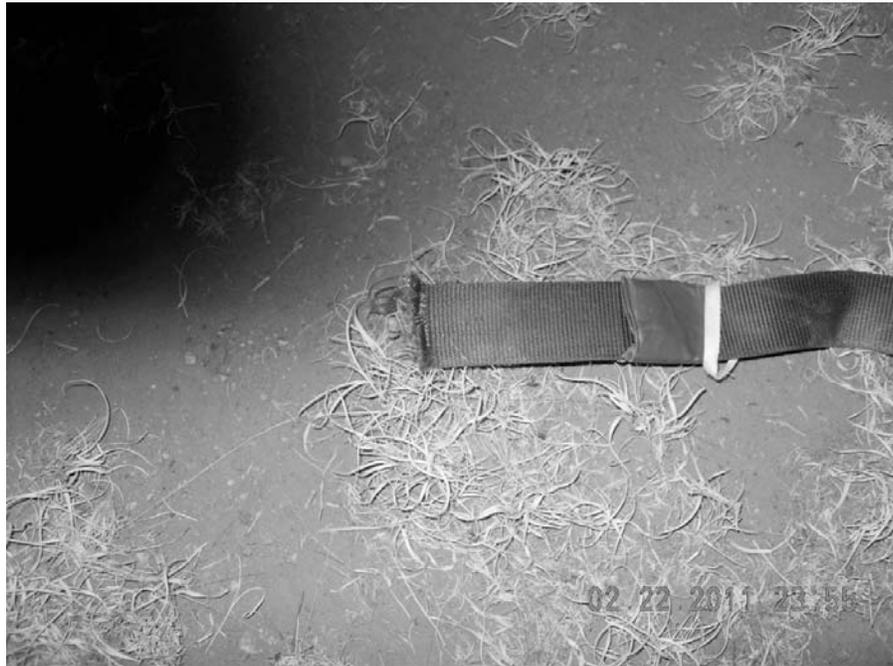
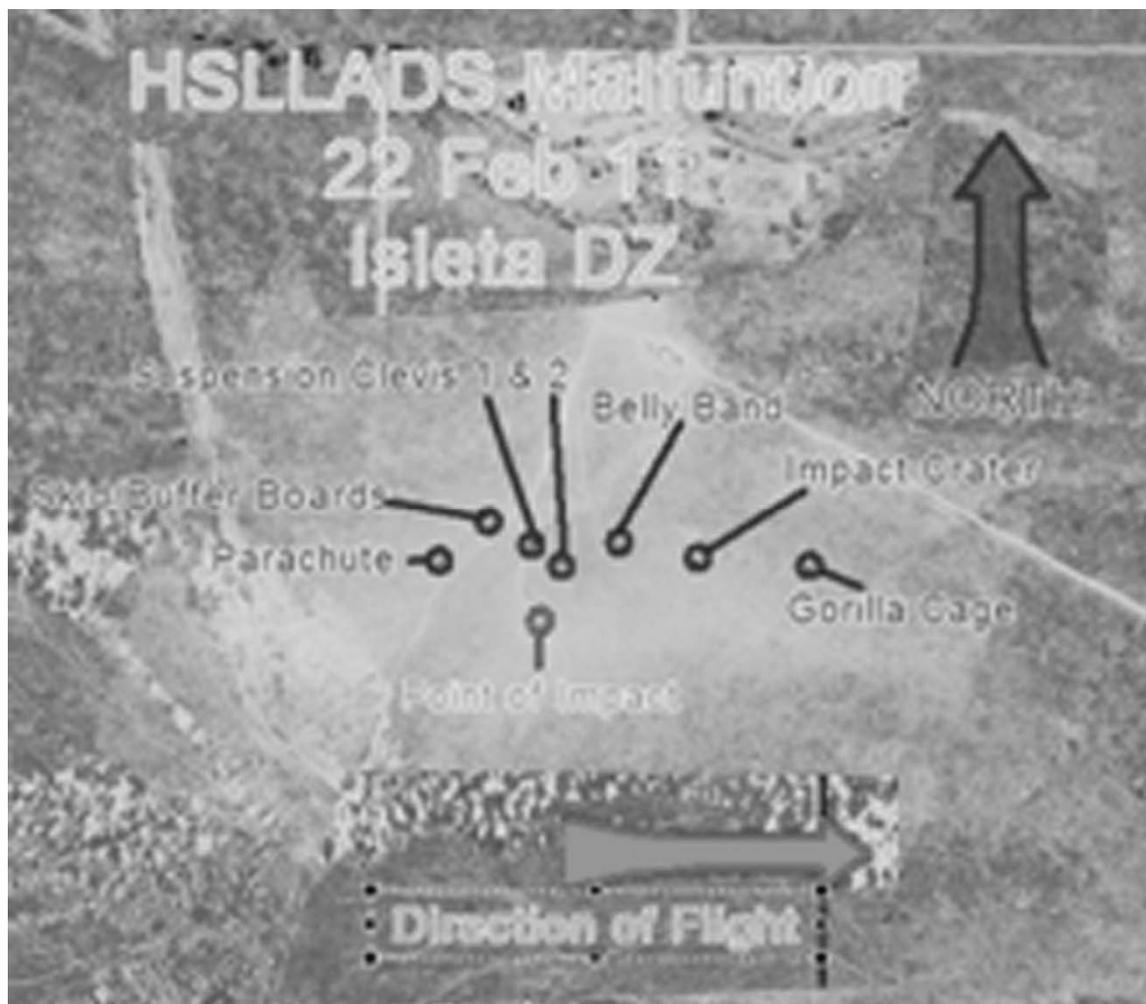
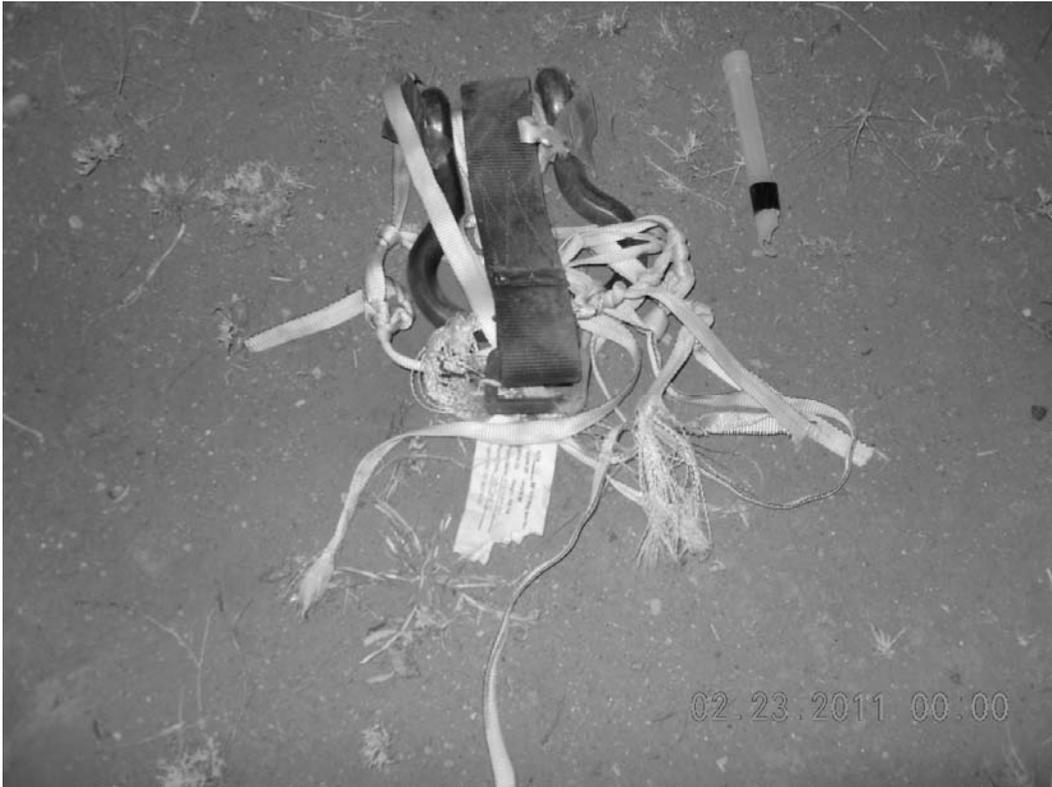
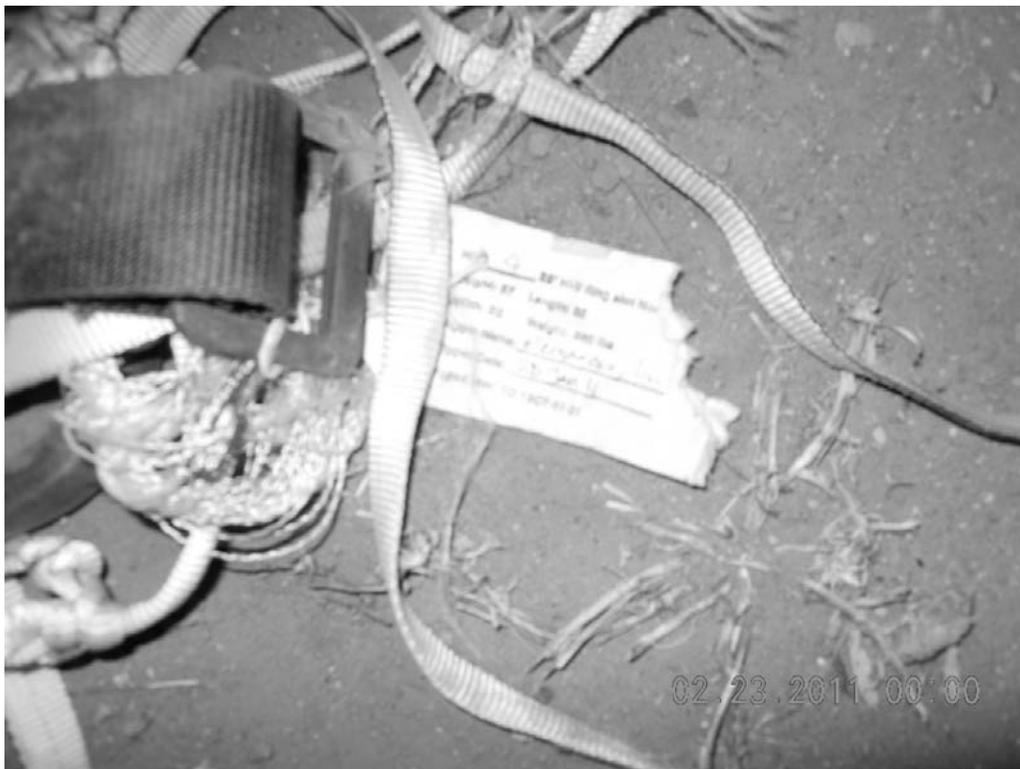
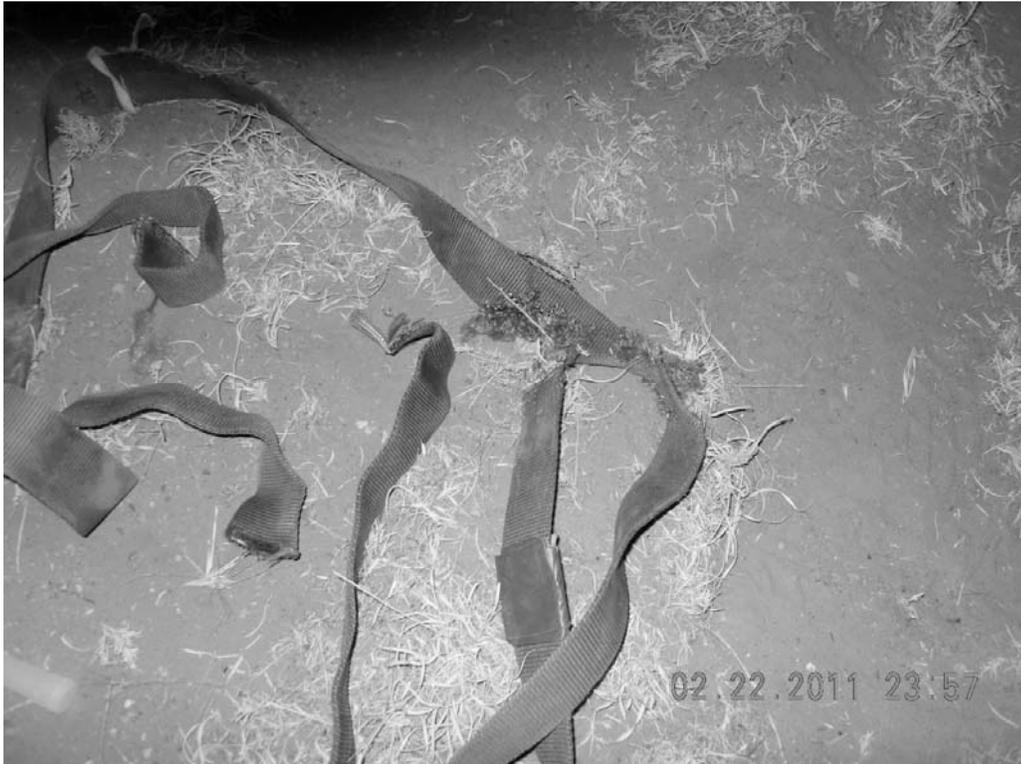
CDS3_20110222_58OSS_HSSLADS_BROKE_APART_C130

Suspected Cause Of Malfunction/Incident: Upon closer inspection of the load, a friction adapter (stock number AN6517) was found broken, with the middle slide bar missing. Furthermore, FM/T.O 13C7-51-21 calls for the use of Friction Adapters with a stock number of MS20440-2. These adapters are sewn into a 10 inch strap that is locally manufactured, and prescribed by the rigging manual. The modified A-21 container experienced a catastrophic failure upon failure, during opening shock, due to the use, and failure, of unauthorized hardware. Fabrication personnel are, at this time, being retrained in the proper fabrication of critical parts.
