136th TRIANNUAL AIRDROP REVIEW and MALFUNCTION SAFETY ANALYSIS BOARD

June 21-23, 2011

MALFUNCTIONS / INCIDENTS REPORTED

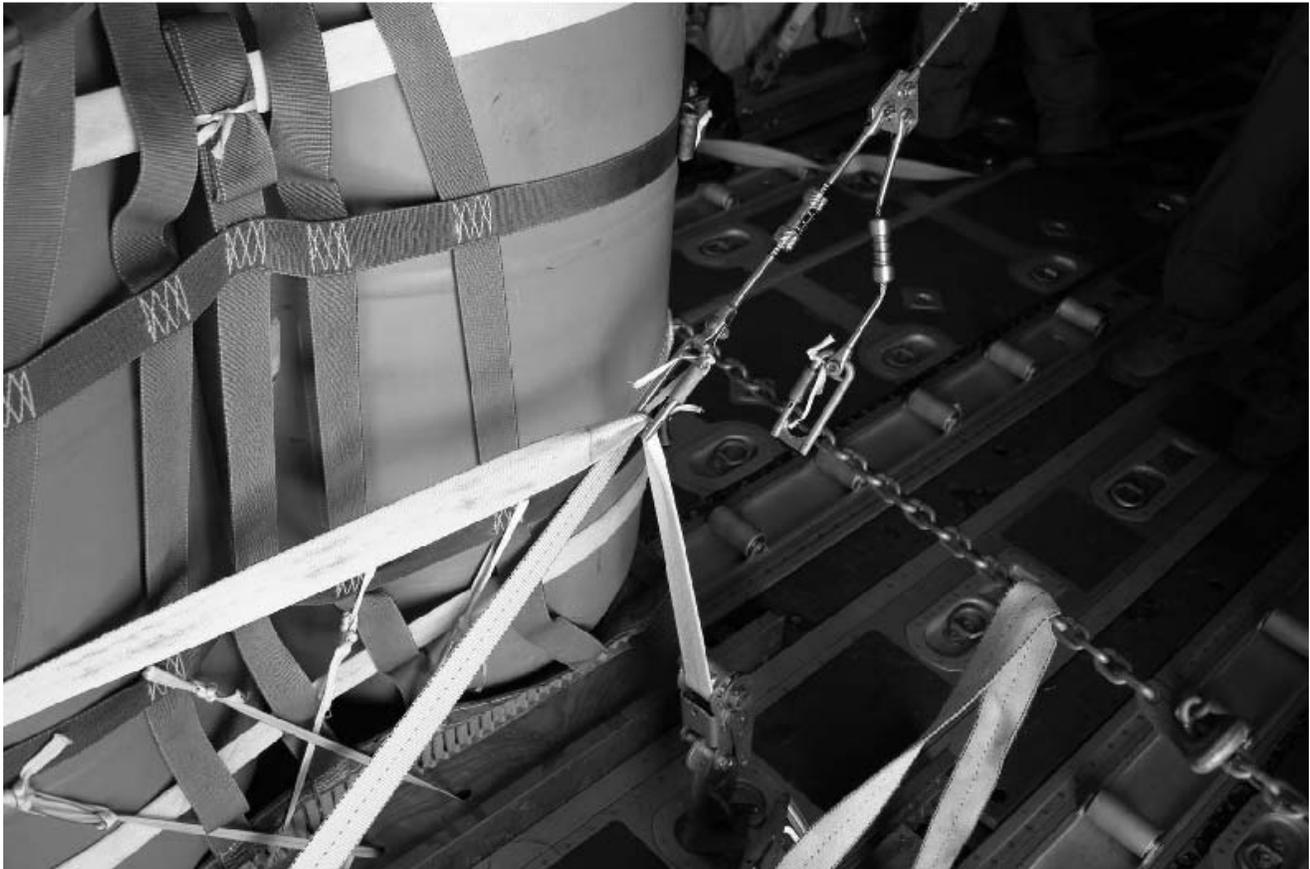
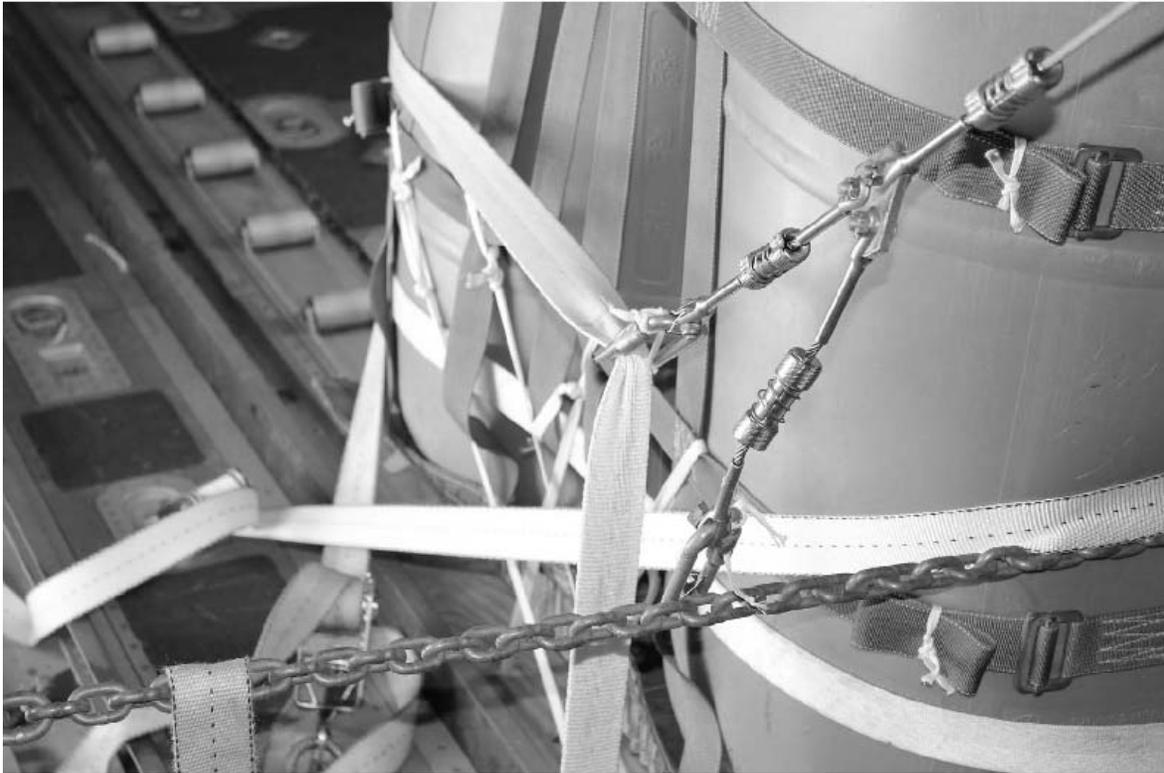
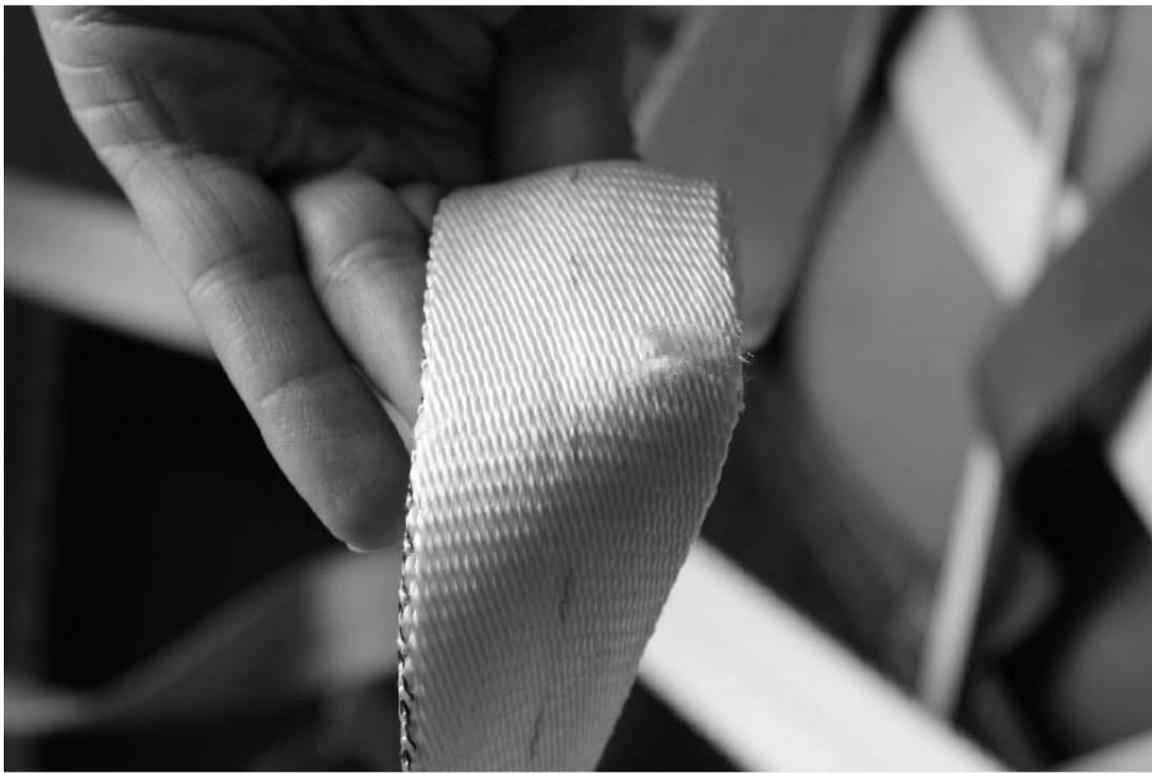
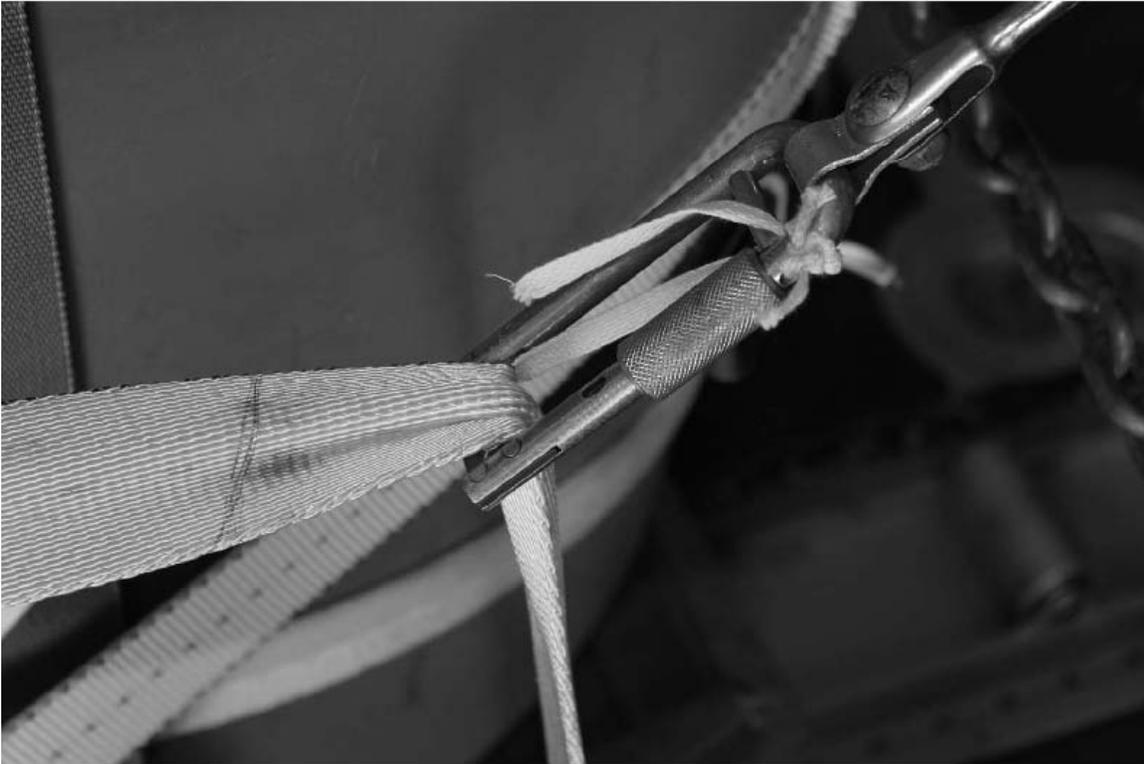
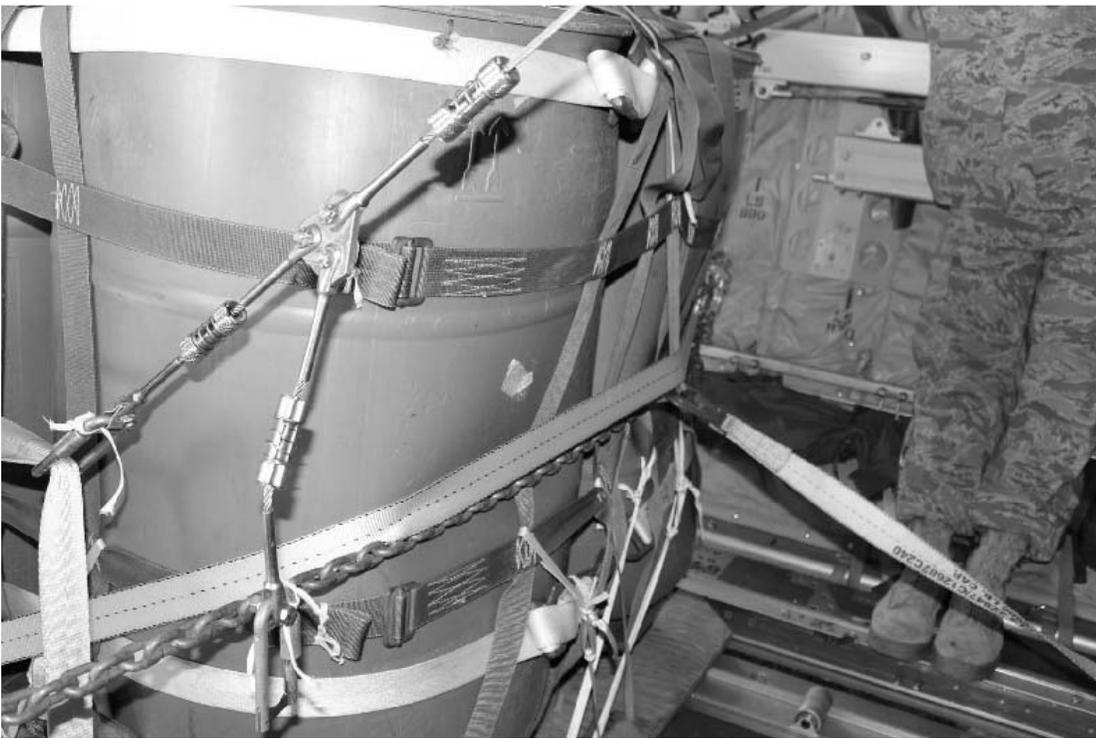
CDS4_20110301_815AS_GATE_FAILED_TO_CUT_C130

Description of Suspected - Malfunction - Incident - Damaged Incurred: Training load consisting of 2 CDS bundles weighing 800# each, rigged as double-stick with Y-knife. At green light, static line retriever retracted as advertised, but only the right gate cut. After the right hand bundle was clear, loadmaster called "malfunction" and complied with malfunction procedures. Left CDS bundle did not move; barrels on the forward side of the bundle showed evidence of collapsing under pressure of the chain gate. Aircraft RTB with no further incident.

Suspected Cause of Malfunction - Incident: Dull knife, possible fatigue in barrel wall allowed barrel to collapse on static line retraction.
