140th TRIANNUAL AIRDROP REVIEW and MALFUNCTION SAFETY ANALYSIS BOARD

Feb 26- 27, 2013

MALFUNCTIONS / INCIDENTS REPORTED

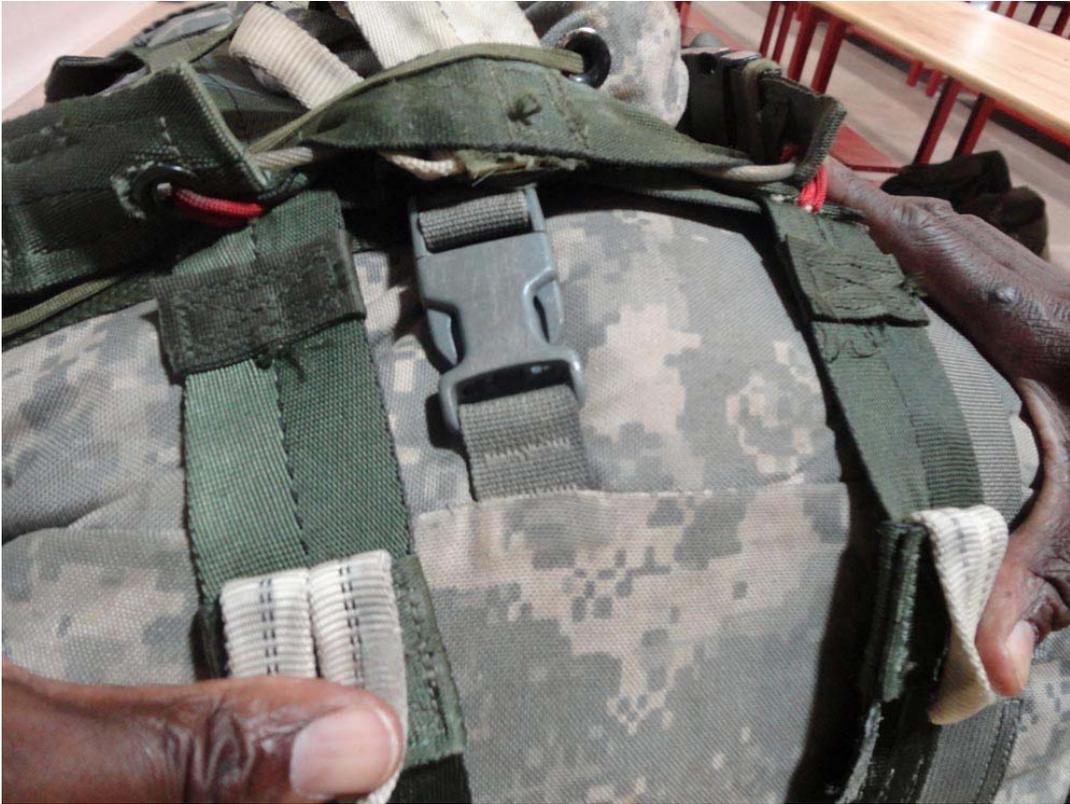
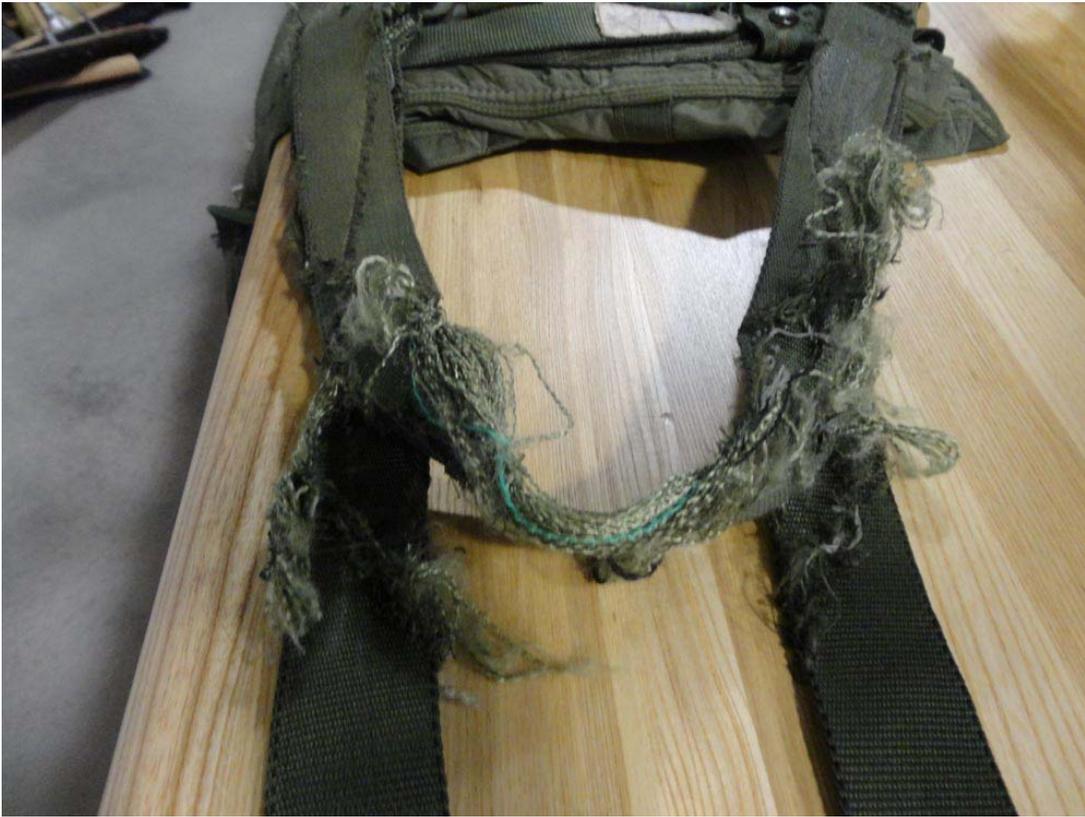
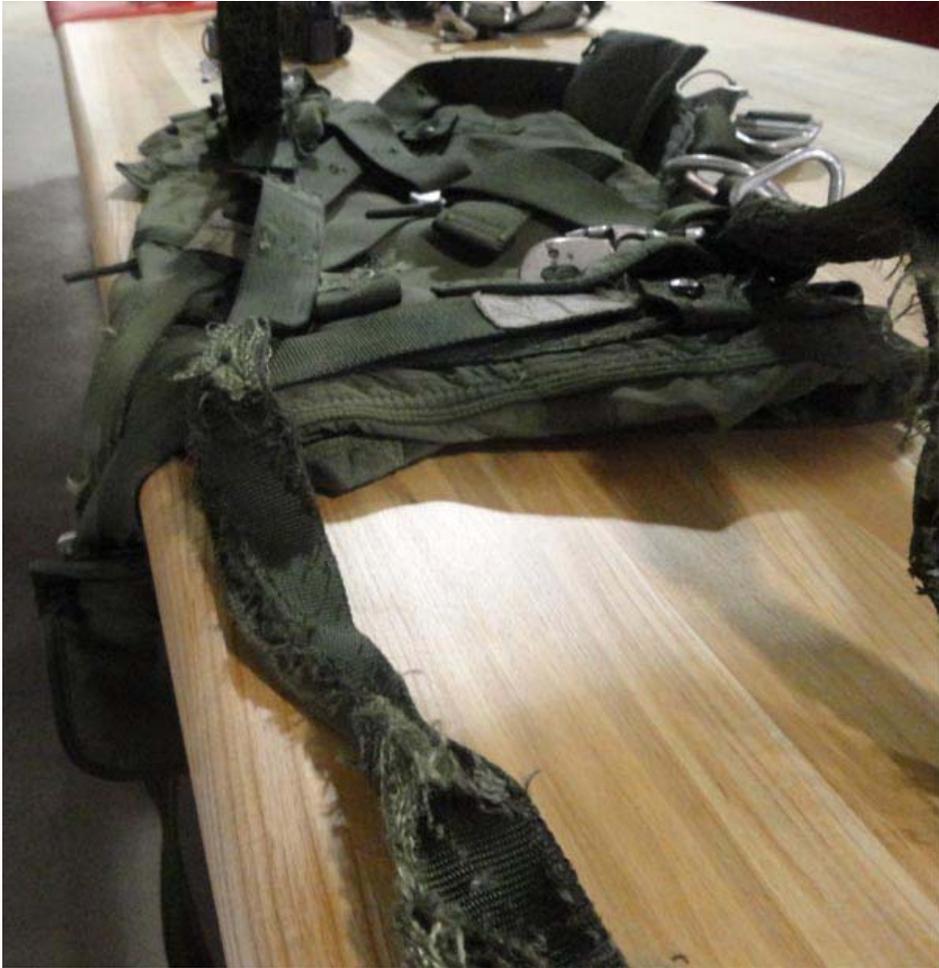
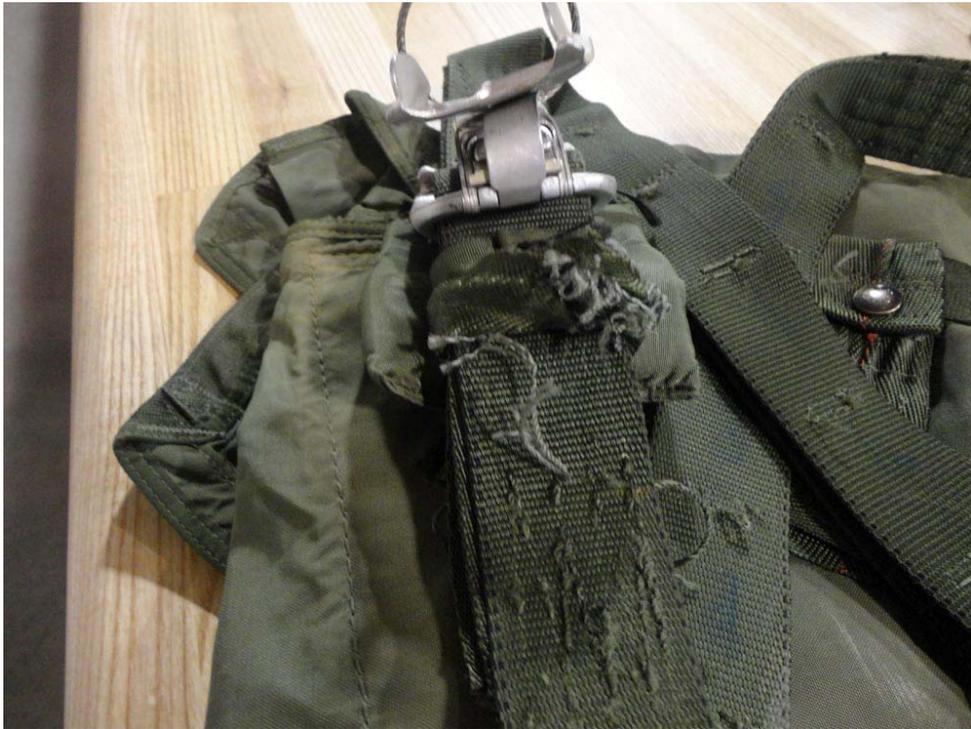
Suspected Cause of Malfunction - Incident: The suspected cause of the incident is a combination of the 90lbs MOLLE and the jumper's weak exit from the aircraft. Once the green attaching loops separated from the HSPR the MOLLE was lowered by the lowering line which traveled in an upward motion making contact with the suspension lines and the D-bag. There were no deficiencies noted in the aircraft. The following damage was noted from the jumper's equipment. The green attaching loops on the HPT lowering line were missing. The lowering line was burned and ripped approximately 12 inches from the ejector snap. All suspension lines had burns and were seared approximately 5-6 feet from the parachute connector link. There was a hole in the deployment bag that appears to be caused by the MOLLE getting stuck between the suspension lines. The diagonal back strap keepers were ripped from the pack tray.

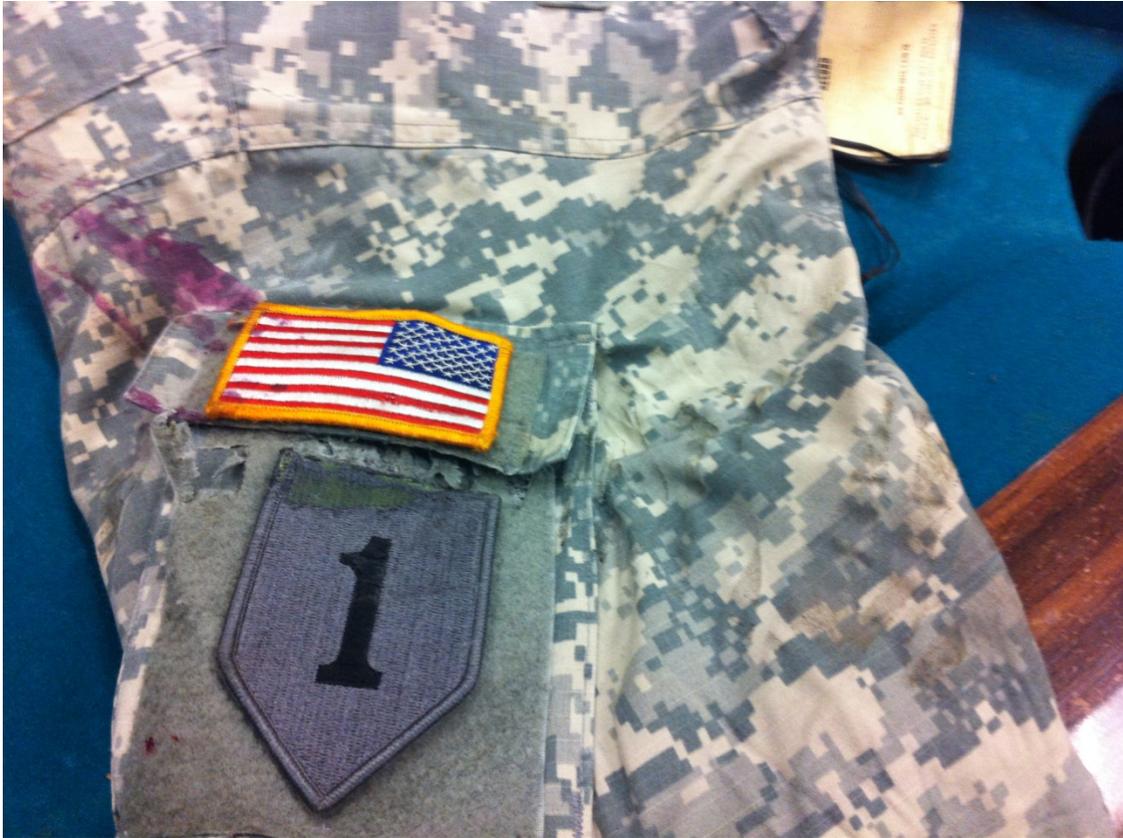
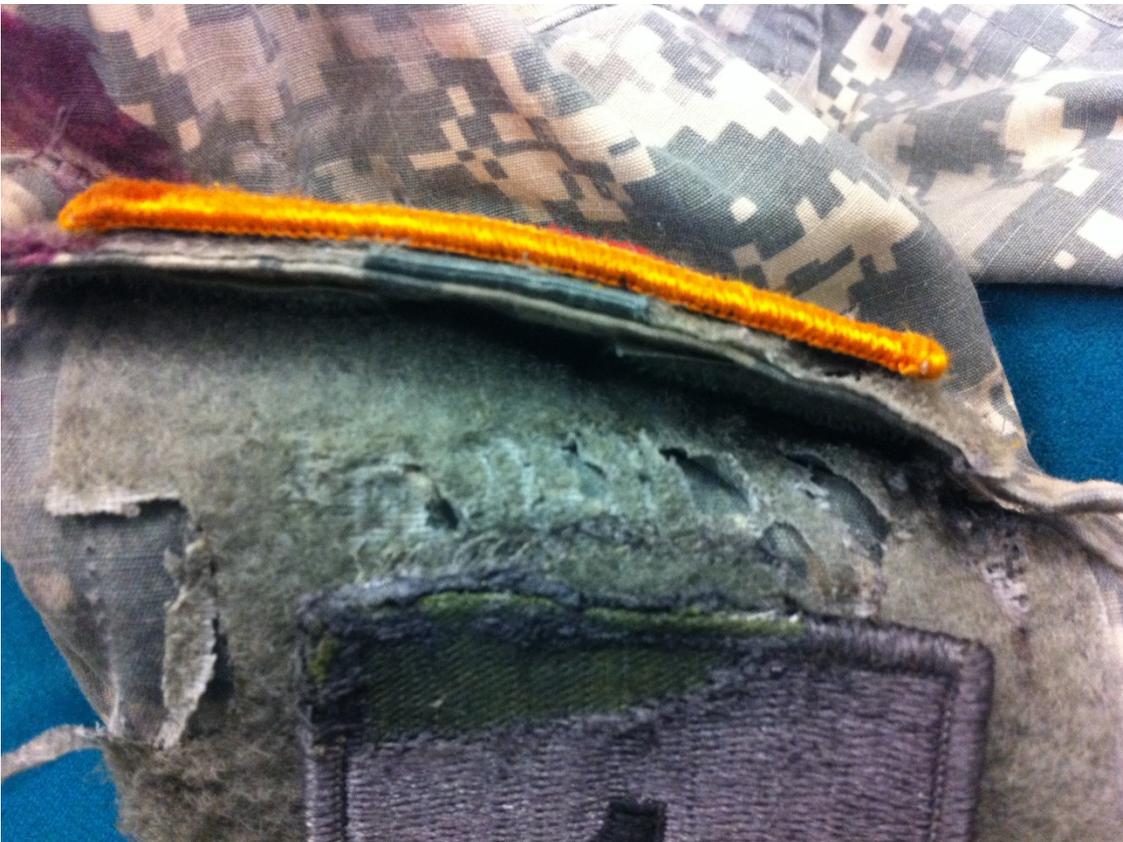
Suspected Cause of Malfunction - Incident: Static line wrapped around jumpers right arm and cause his arm to pull / break upon exiting the aircraft.

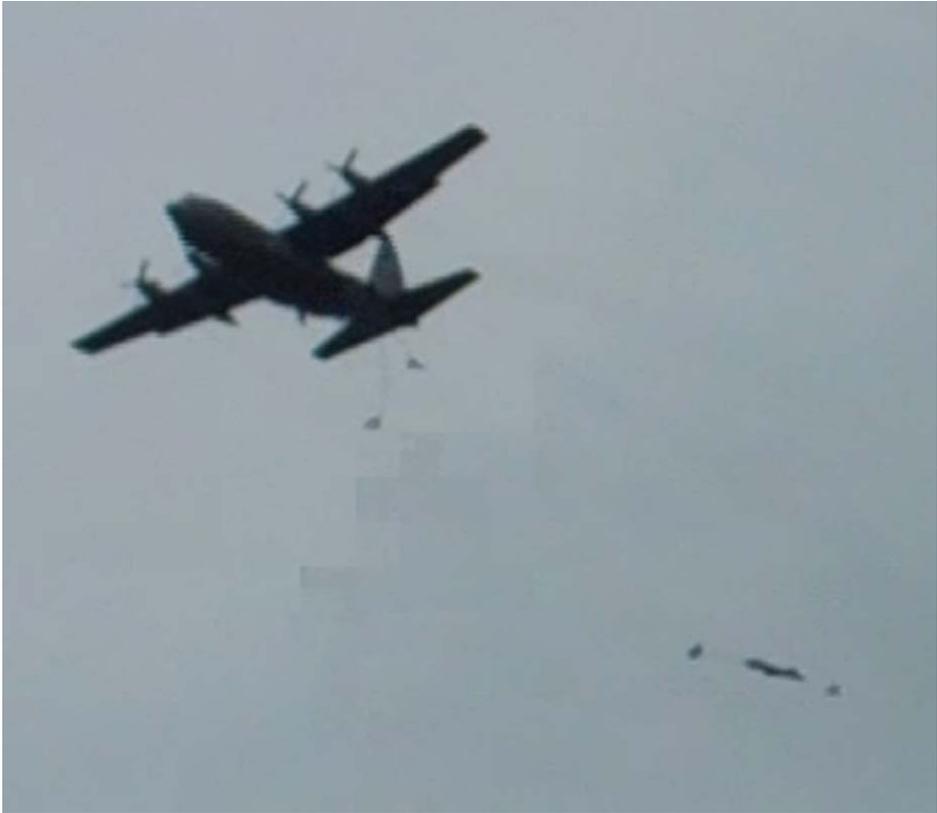
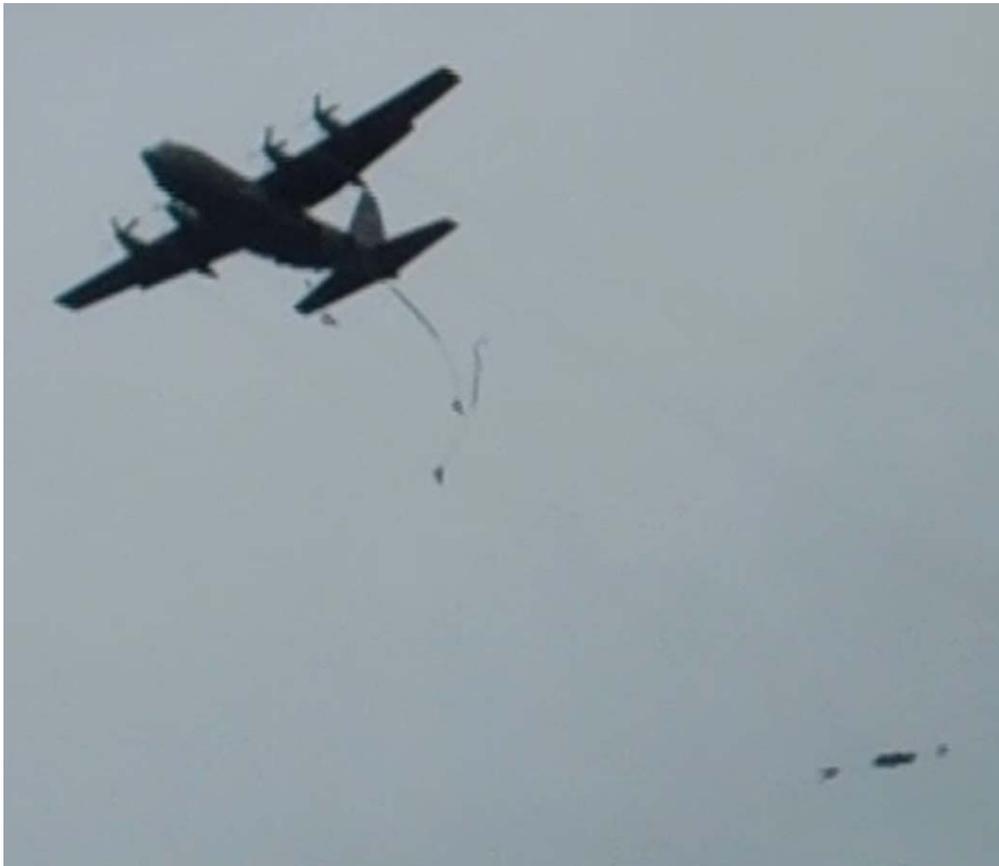
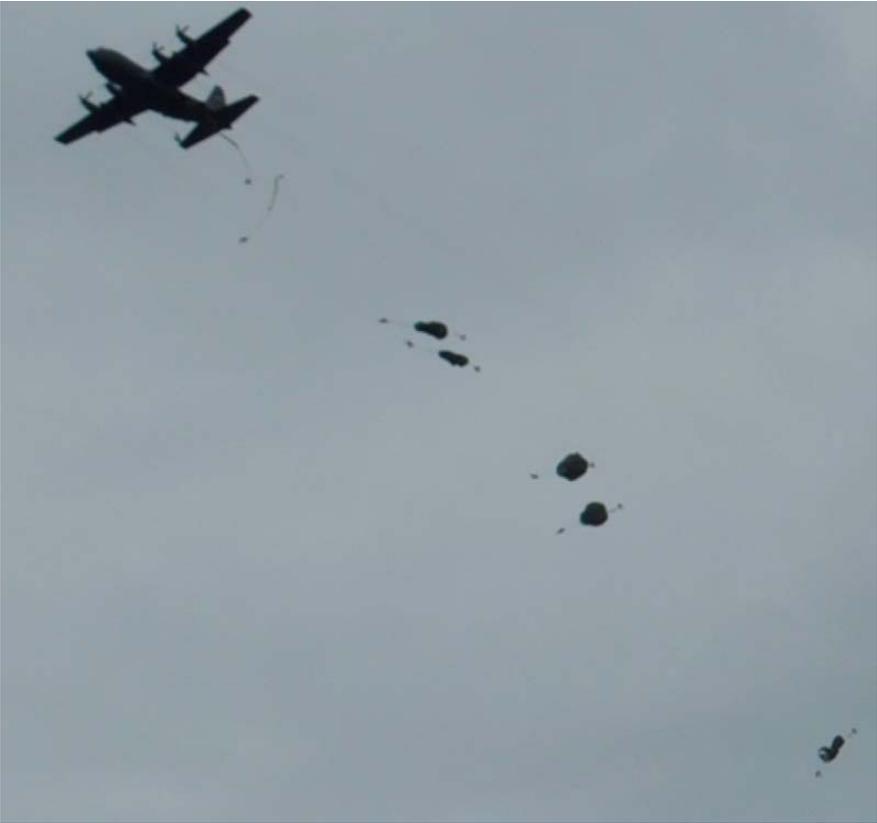
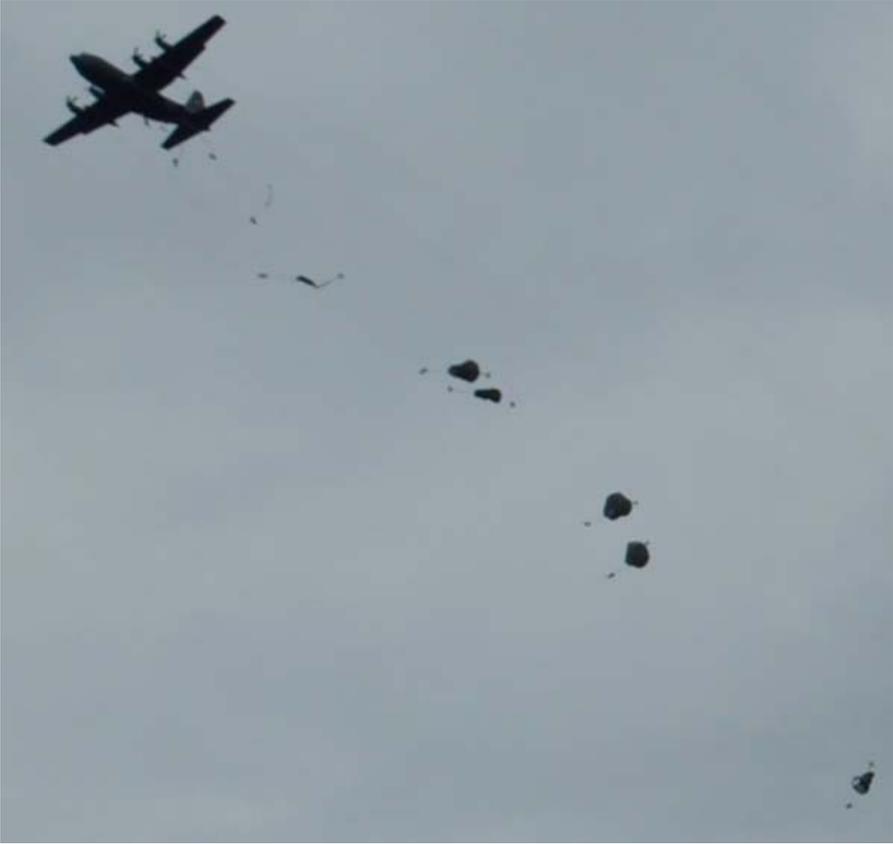
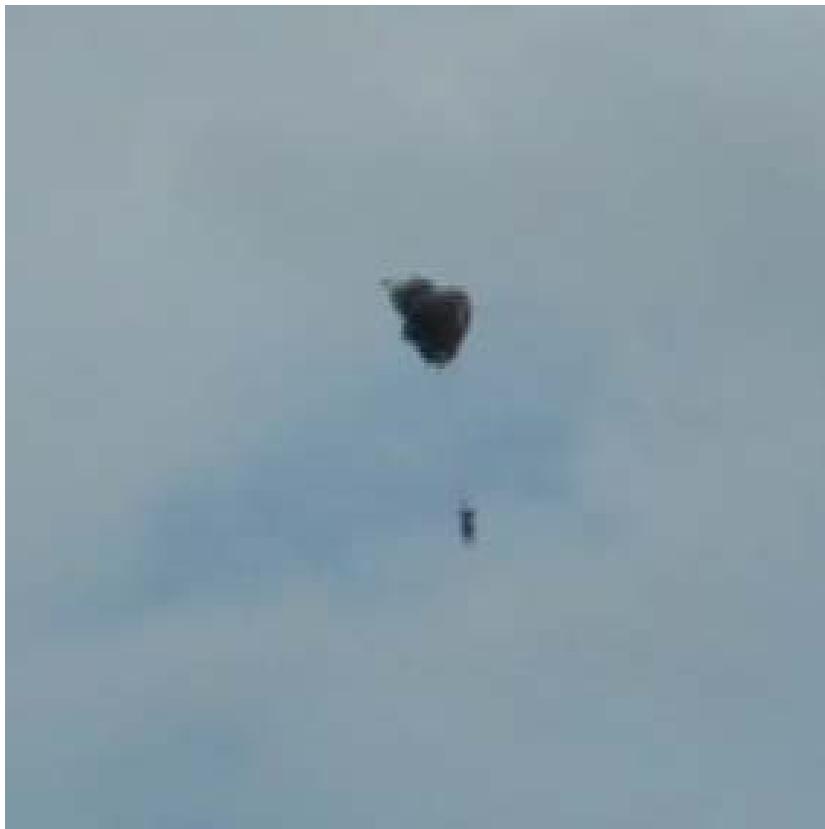
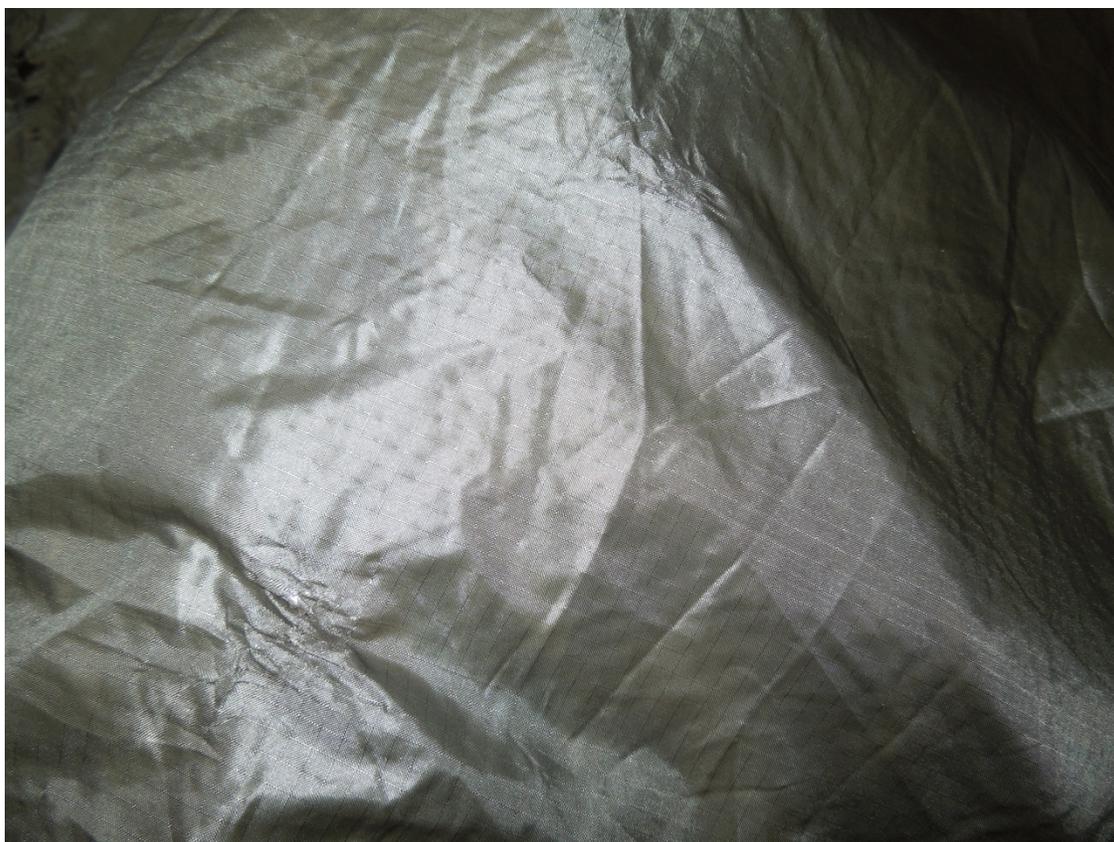
Suspected Cause of Malfunction - Incident: Possible poor body position resulting in severe twists upon exiting the AC, due to the twists the slider remained hung causing a mushroom affect. After analysis of the canopy the damage area was located on panel 6, 7, 8, 10. The slider was hung by the left group causing the left side of the parachute to become distorted to the point of loss of lift capability. We suspect that the grouping of the of slider grommets at lines 6, 7, 8 causing friction burns resulting in holes in the canopy. It is also possible some tension knots may have been present.

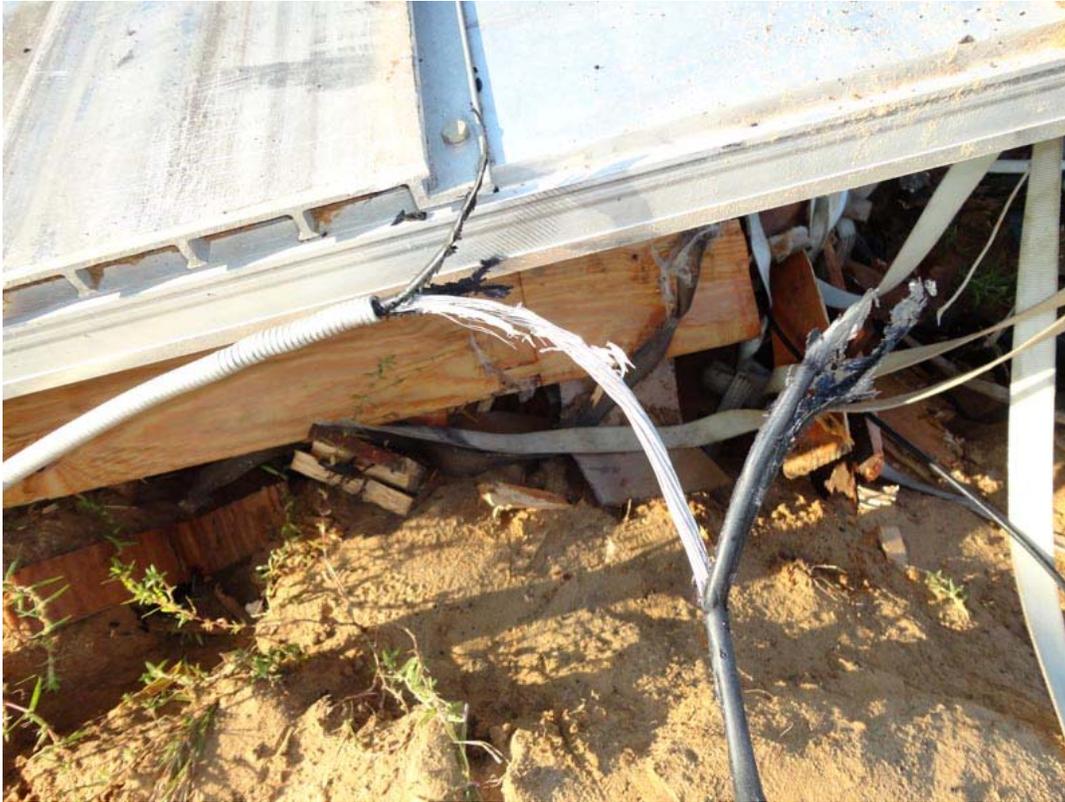
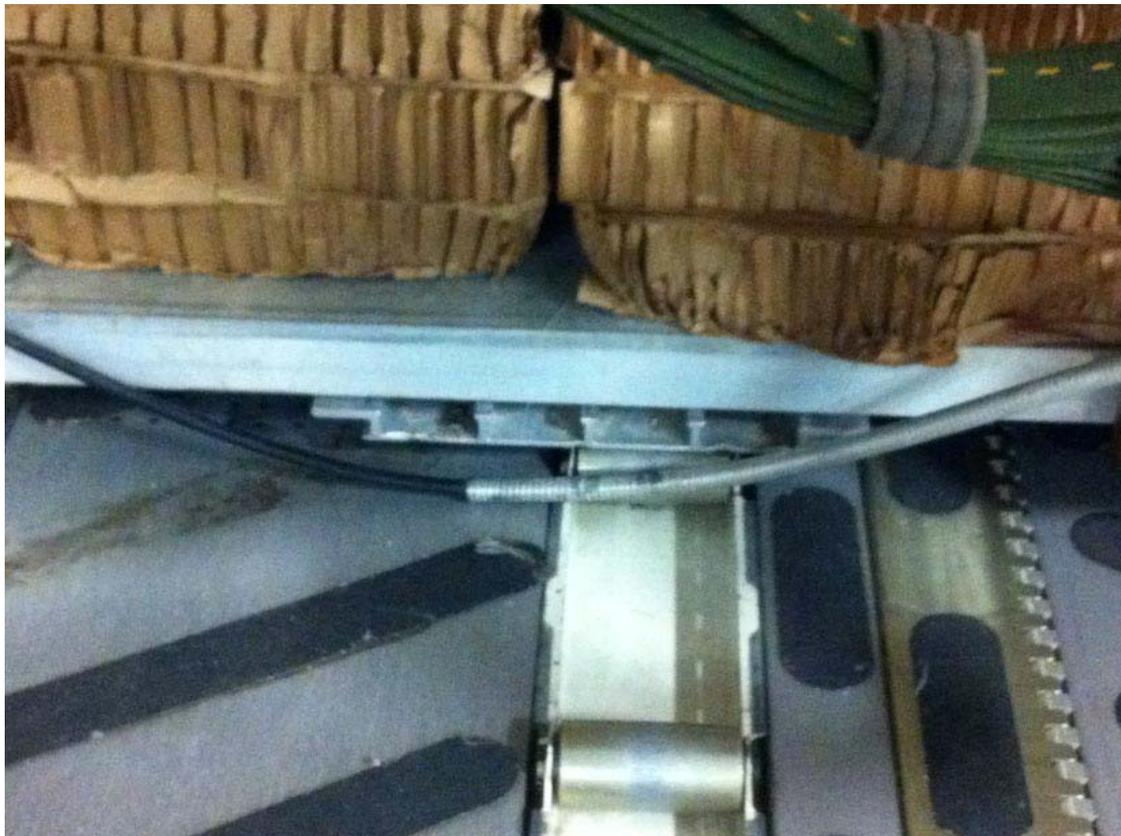
HE10_20120907_11QM_G11_EFTC_Failure_C17

“Reenactment” of EFTC cable below platform shown above

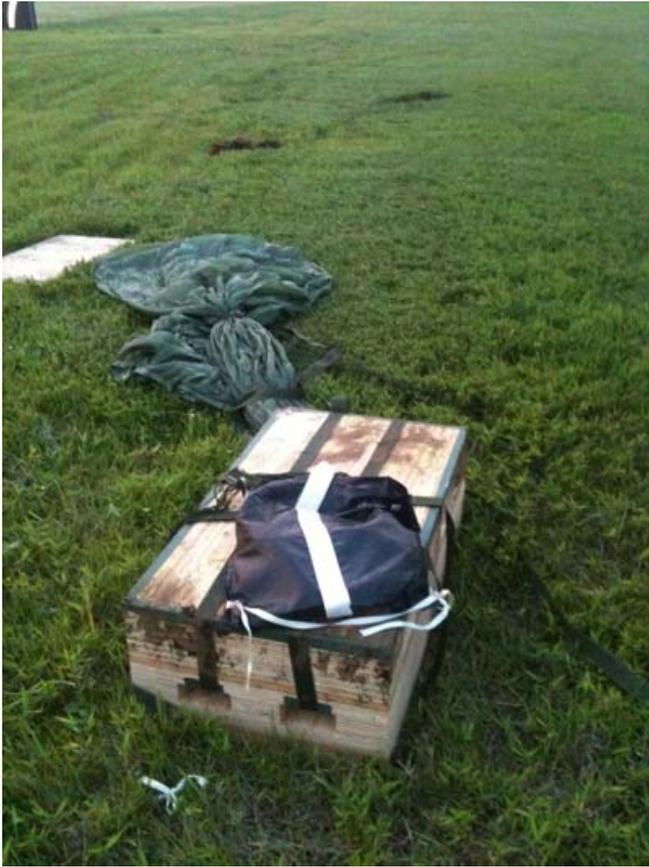
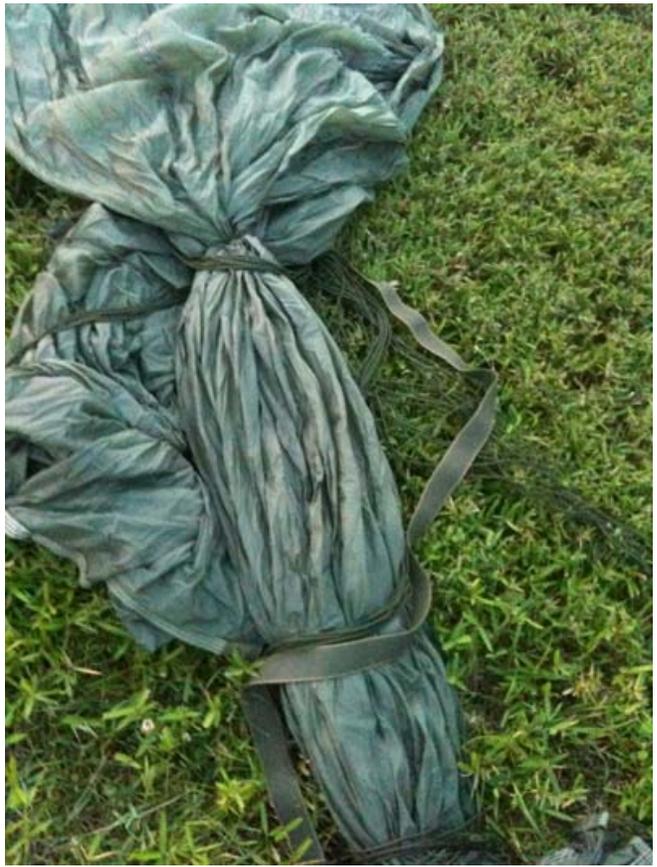
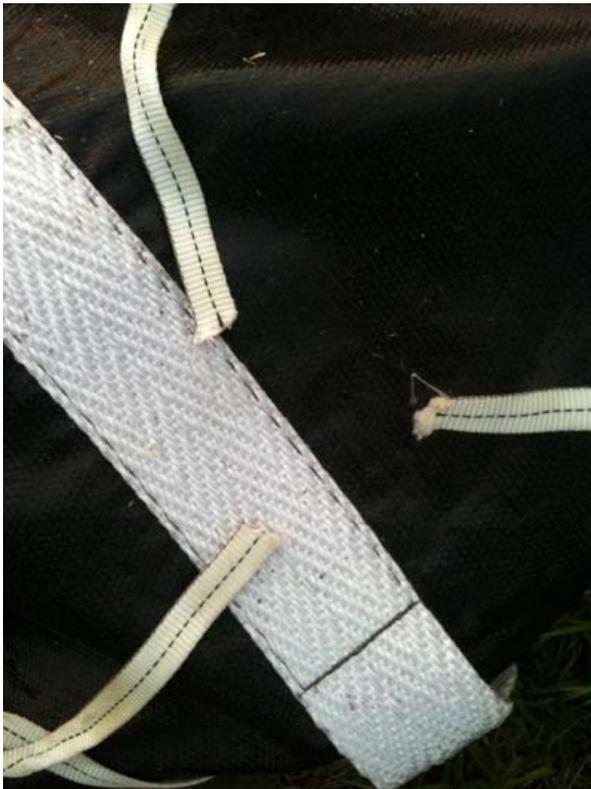
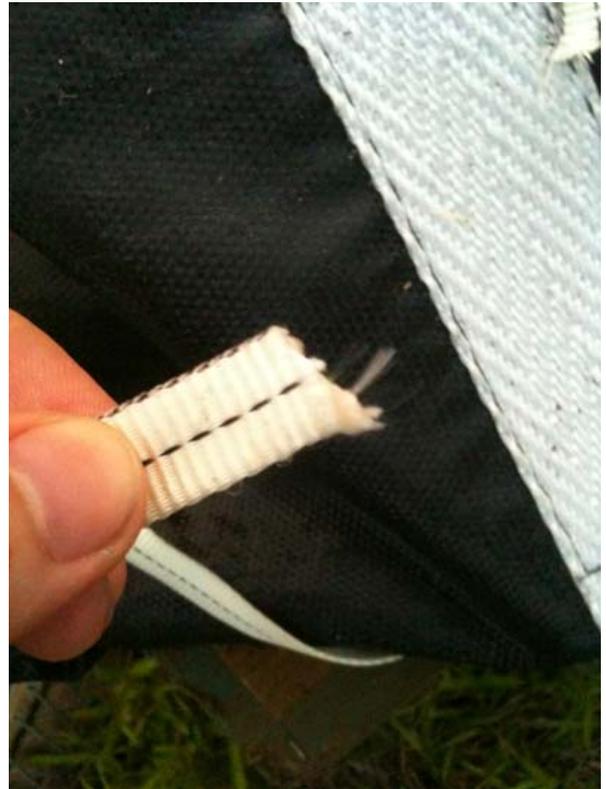
Suspected Cause of Malfunction - Incident: The was classed as an incident because the finding was that the error was with the Loadmaster and not the equipment. After cutting the gate, when the loadmaster stood and pushed the load aft the static line inadvertently came in contact with the J-Knife in the LM right hand. This severed the static line preventing the T-10R parachute from ever opening.

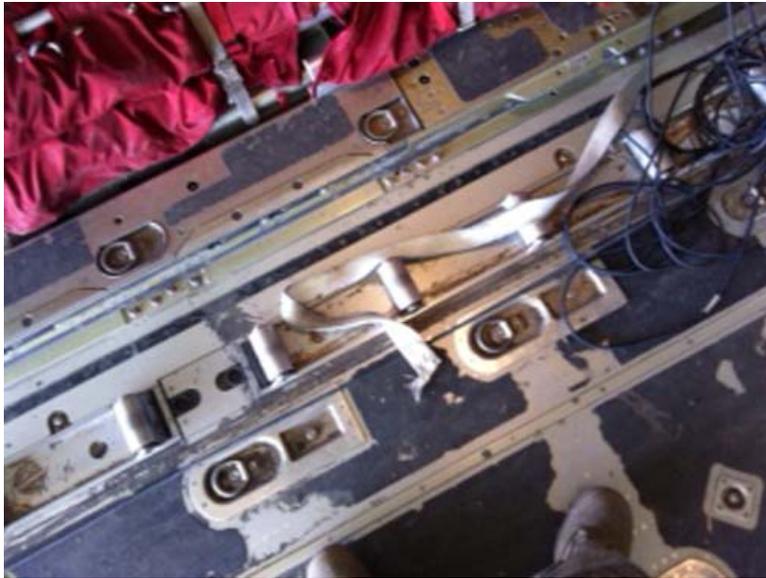
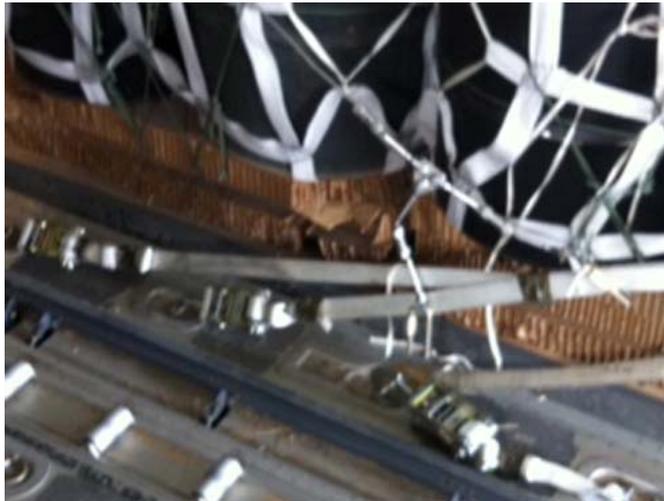
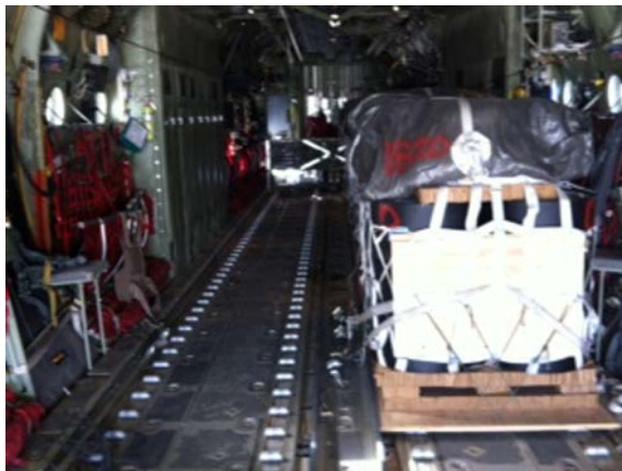
Suspected Cause of Malfunction - Incident: Both LCAD bundles had different strength release gates restraining them causing different amount of stretching of the type XXVI release gates. After takeoff the loadmasters did not ratchet the van zelms to tighten the release gate. They climbed to 16,500 feet MSL for a minute then descended down to 7700 feet MSL leveling off and calling flaps 50 percent while passing through 180 knots. In both of these instances caused both sticks of bundles to shift forward against the BSA. Before the initiation of the release point, the primary loadmaster noticed approximately 12 inches of slack in the static line retriever cable and took out an estimated 6 inches of the slack out of the cable. The target airspeed was 140 knots but slowed down to about 135 knots so the pilot pushed up the throttles to increase the airspeed and also changing the deck angle pushing both sticks of bundles aft. Once the bundles went aft the quarter inch tie broke cutting the release gate on the aircraft left side releasing nine bundles.

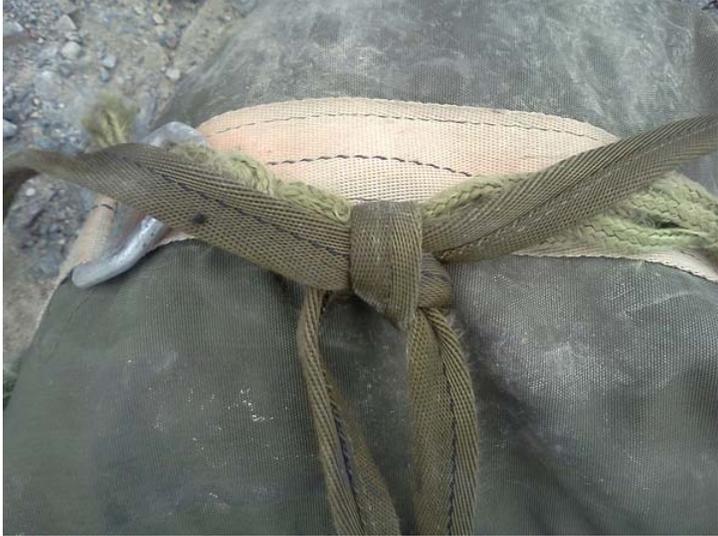
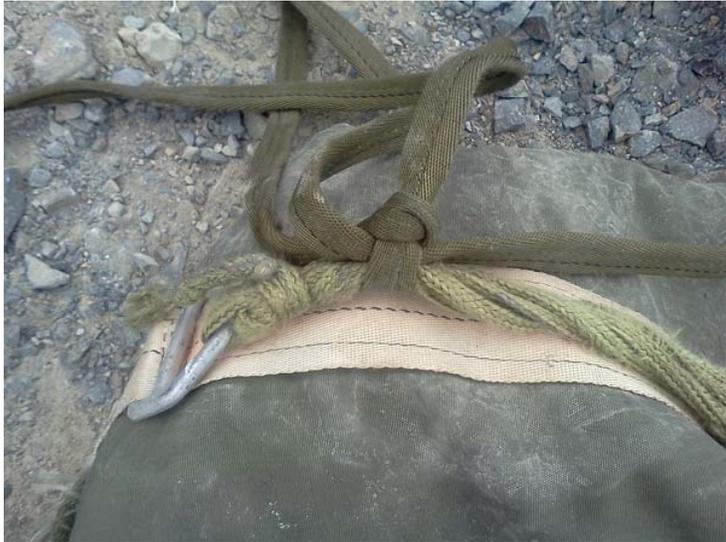
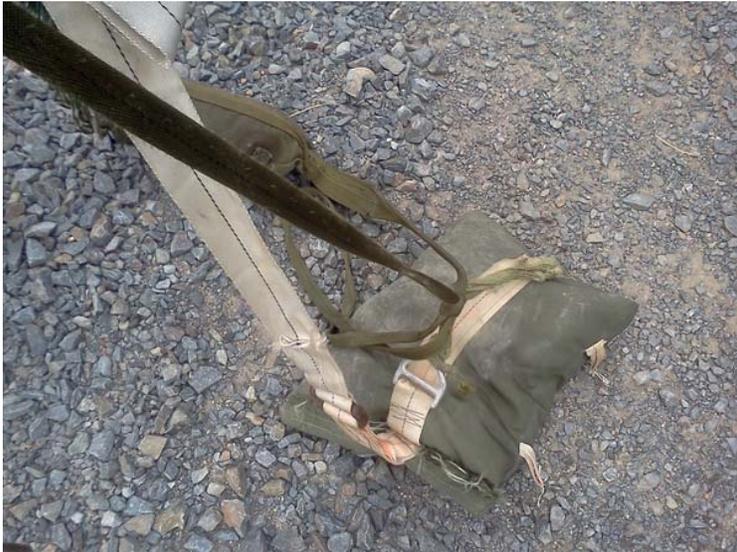
Suspected Cause of Malfunction - Incident: The pendulum line was tied thru the "V" ring several times on the SATB on the side opposite of the pilot chute for storage and transportation to the airplane. The static line was in a trucker's hitch knot wrapped around the pendulum line approximately twelve inches from the end of the pilot chute. This prevented the pilot chute bag from separating from the chute resulting in a towed SATB. After examining the facts the Malfunction Officer determined that the truckers hitch was present on the SATB prior to flight and the resulting towed SATB was due to the aircraft loadmasters improper pre-flight of the bundle.
