# 140<sup>th</sup> TRIANNUAL AIRDROP REVIEW and MALFUNCTION SAFETY ANALYSIS BOARD

Feb 26- 28, 2013

## MALFUNCTIONS / INCIDENTS REPORTED

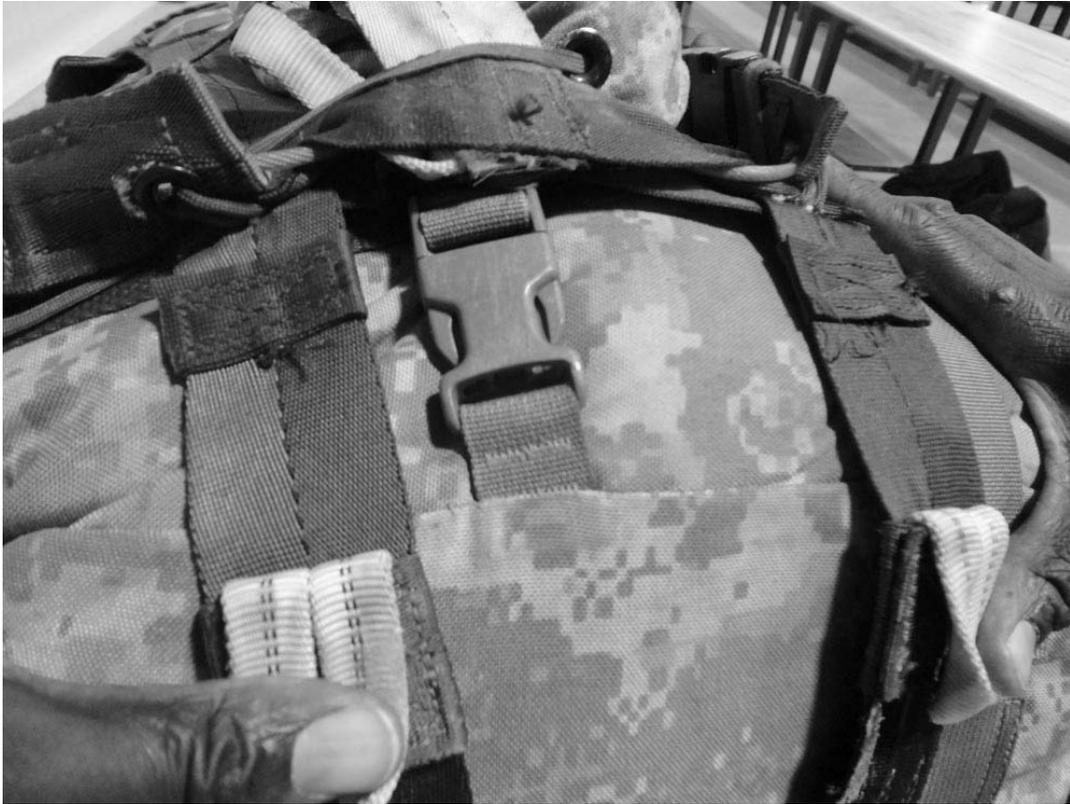
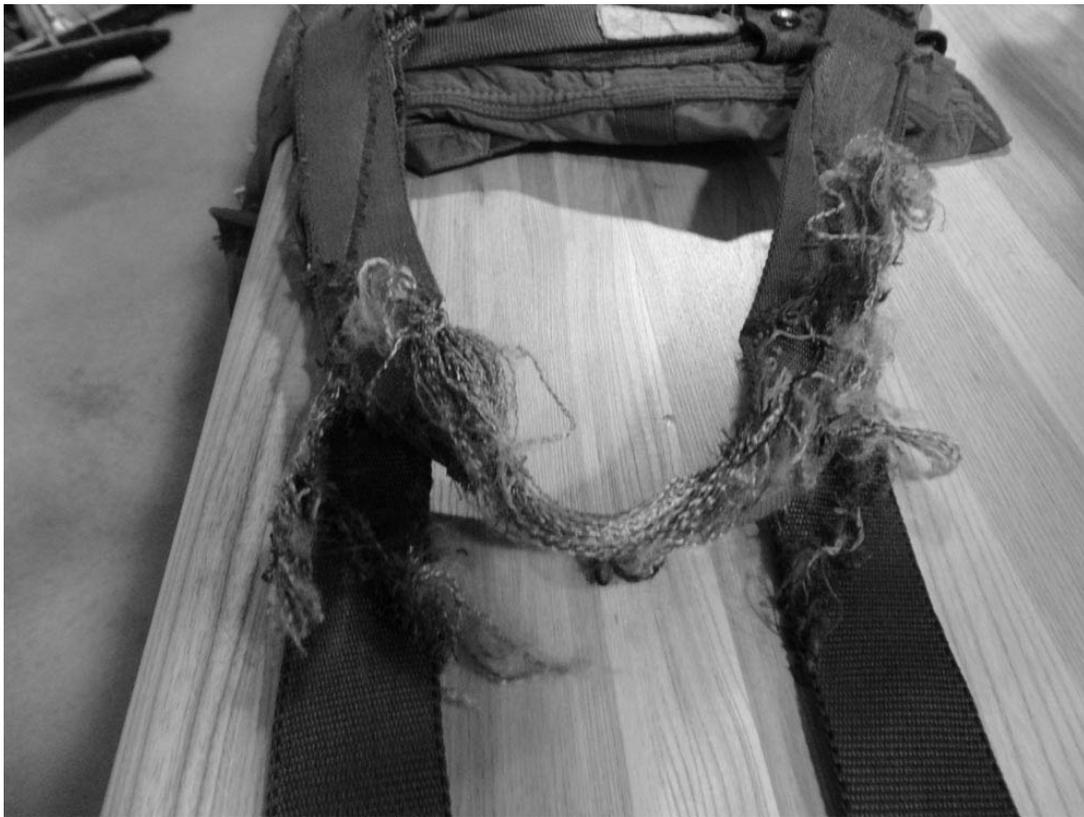
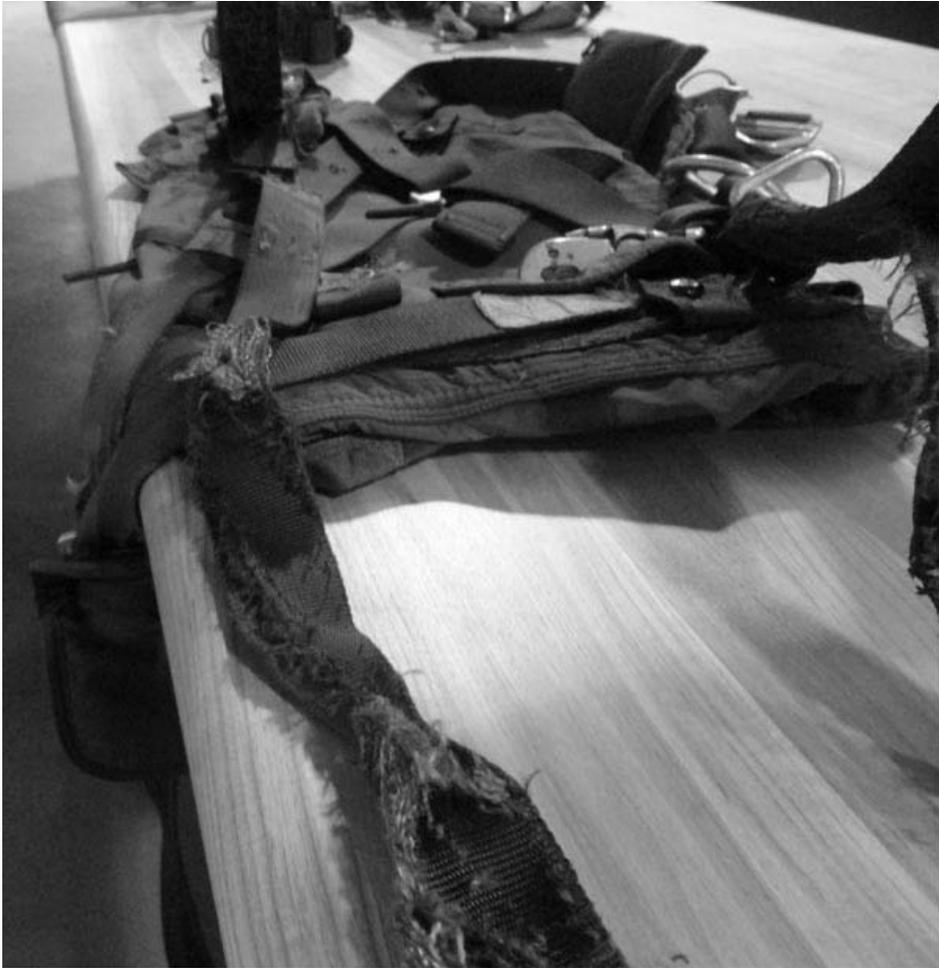
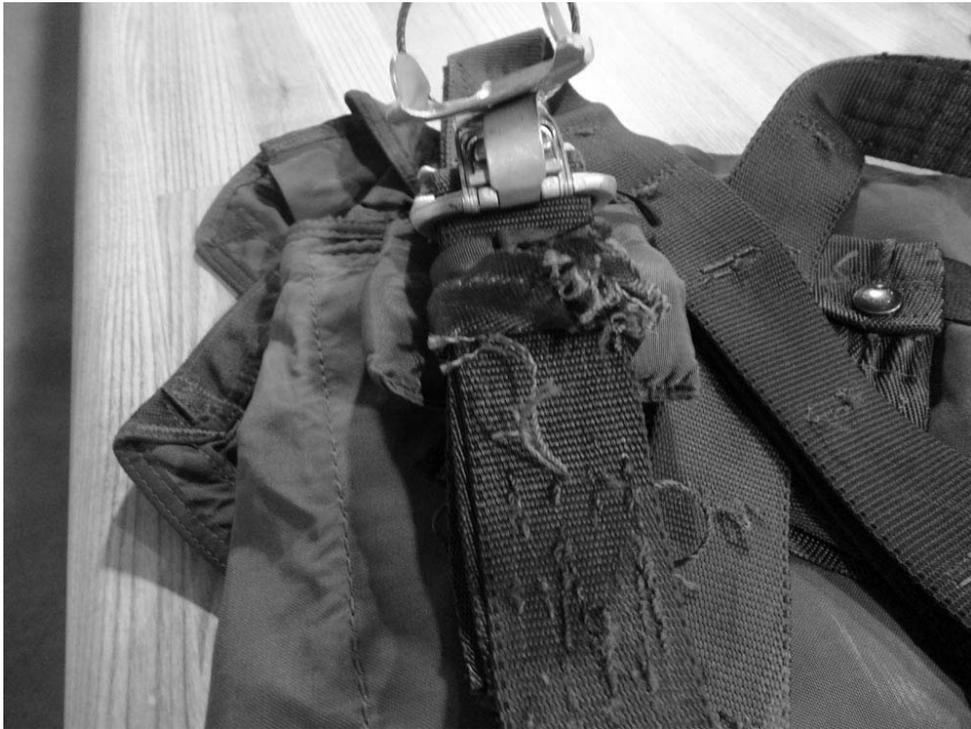
**SL23\_20120913\_1509INF\_T10D\_Static\_Line\_Injury\_C130H**

Suspected Cause of Malfunction - Incident: The suspected cause of the incident is a combination of the 90lbs MOLLE and the jumper's weak exit from the aircraft. Once the green attaching loops separated from the HSPR the MOLLE was lowered by the lowering line which traveled in an upward motion making contact with the suspension lines and the D-bag. There were no deficiencies noted in the aircraft. The following damage was noted from the jumper's equipment. The green attaching loops on the HPT lowering line were missing. The lowering line was burned and ripped approximately 12 inches from the ejector snap. All suspension lines had burns and were seared approximately 5-6 feet from the parachute connector link. There was a hole in the deployment bag that appears to be caused by the MOLLE getting stuck between the suspension lines. The diagonal back strap keepers were ripped from the pack tray.

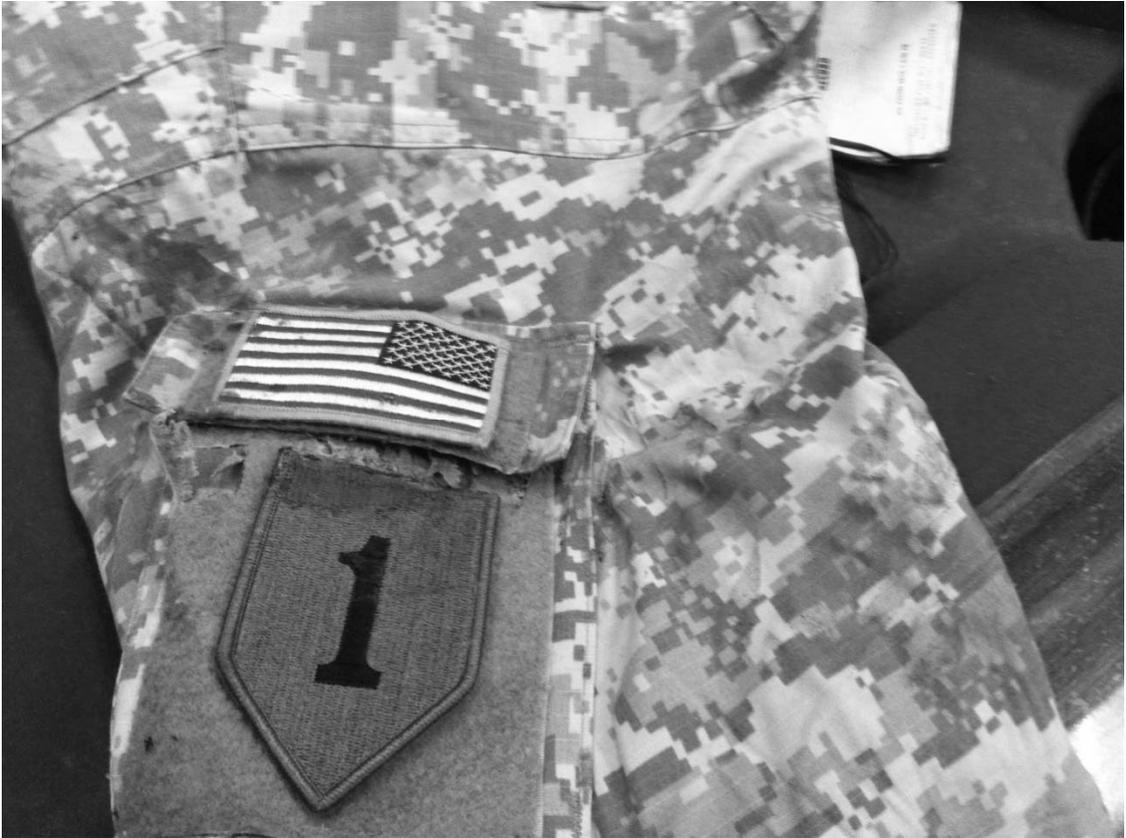
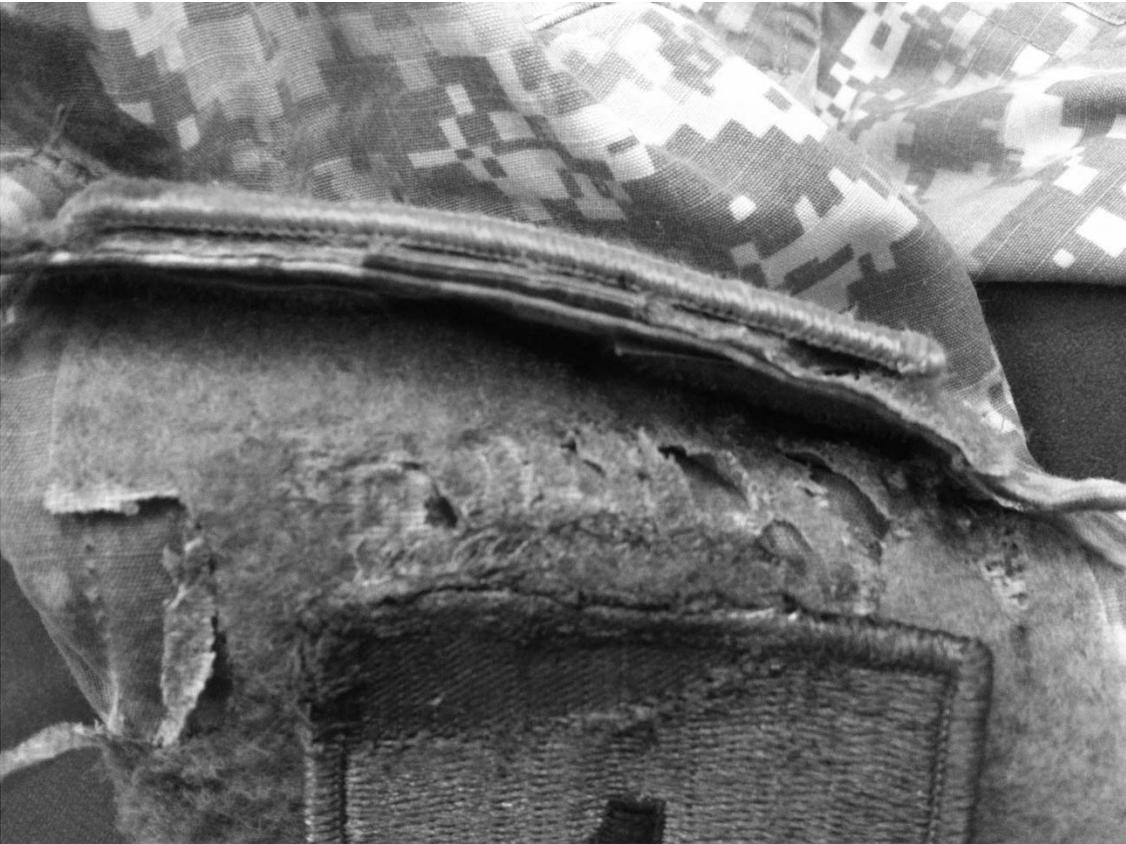
Suspected Cause of Malfunction - Incident: Static line wrapped around jumpers right arm and cause his arm to pull / break upon exiting the aircraft.

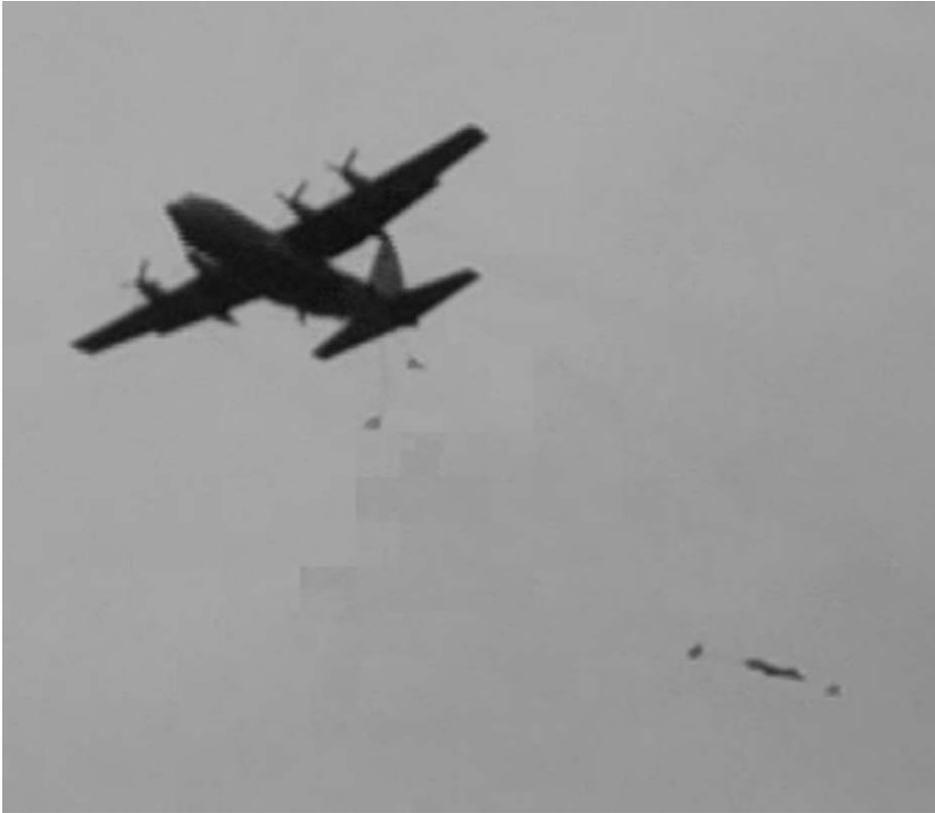
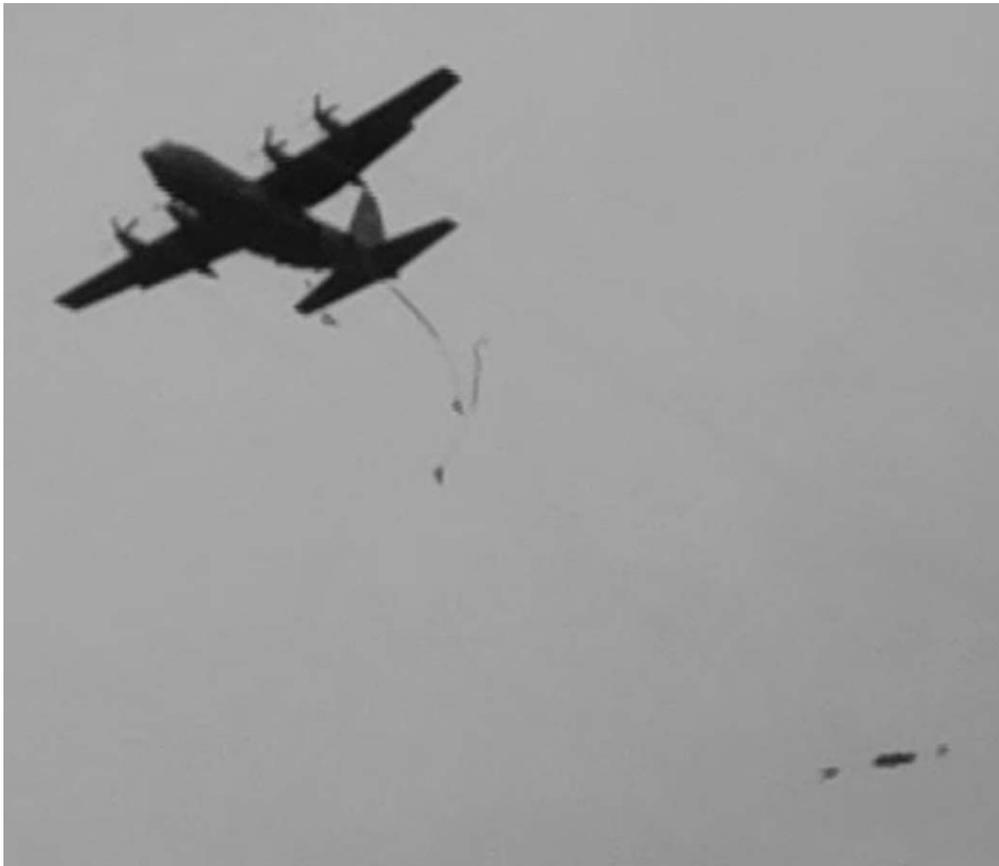
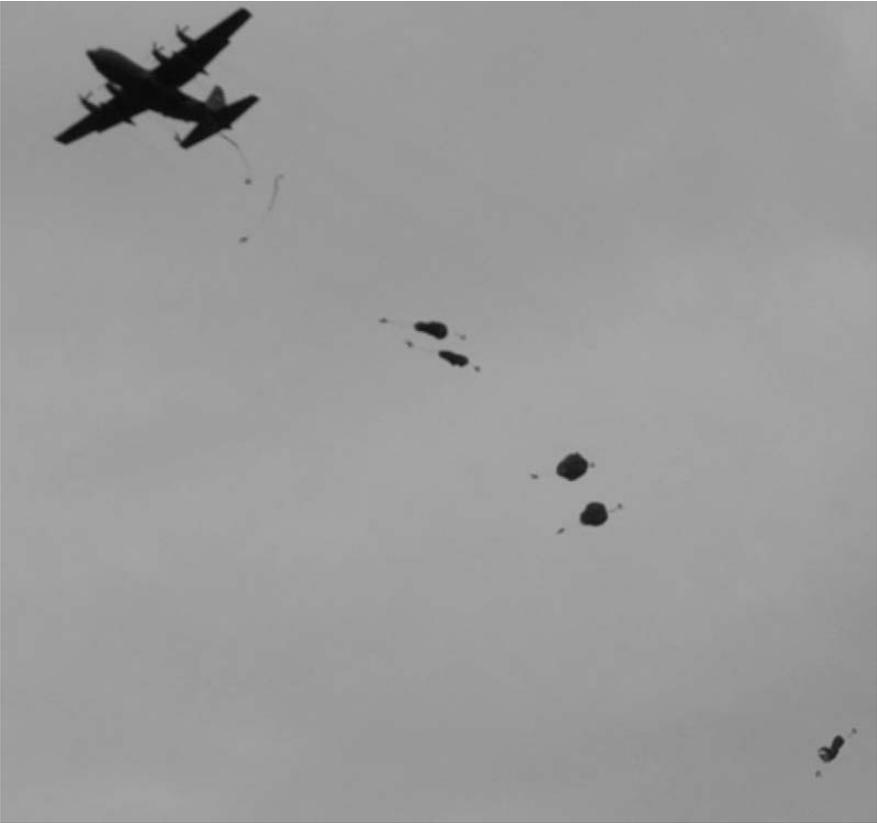
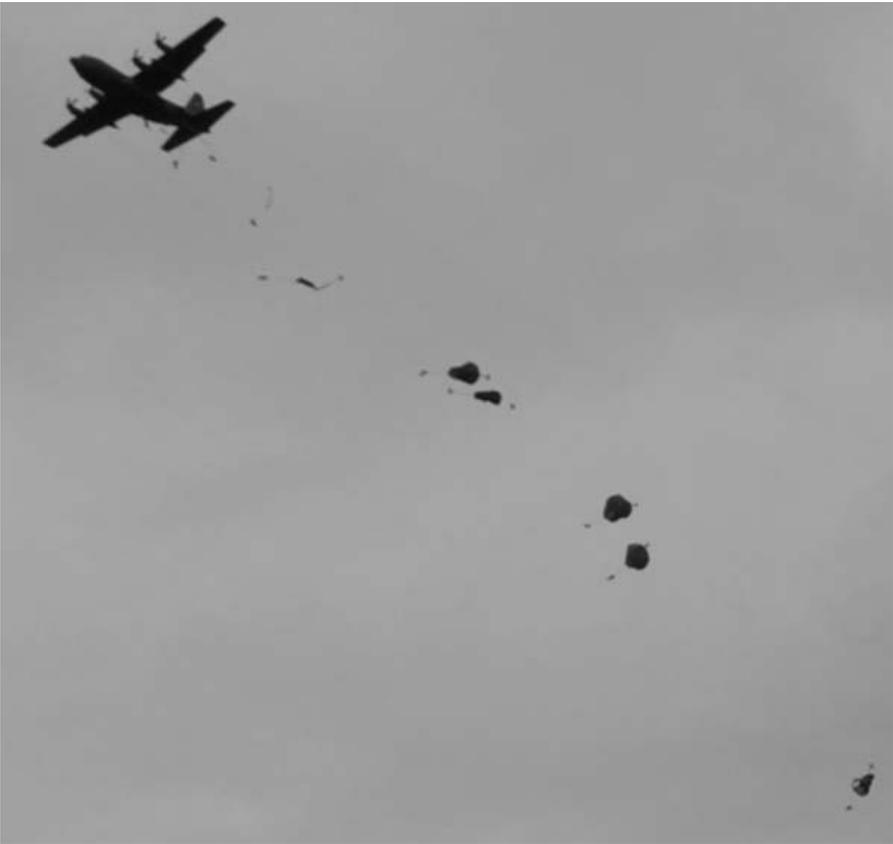
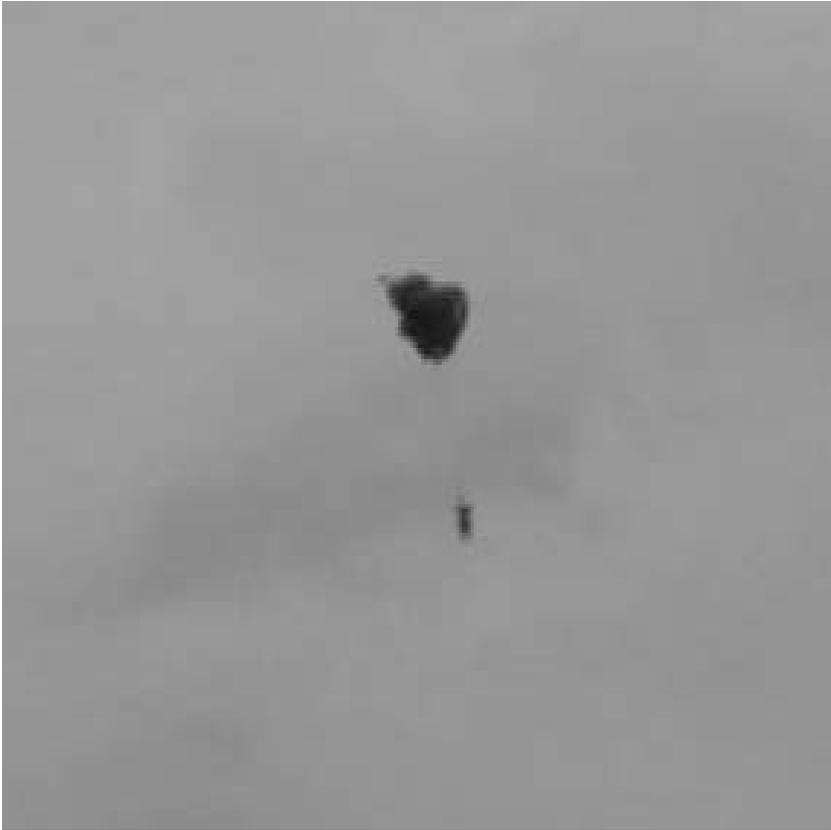
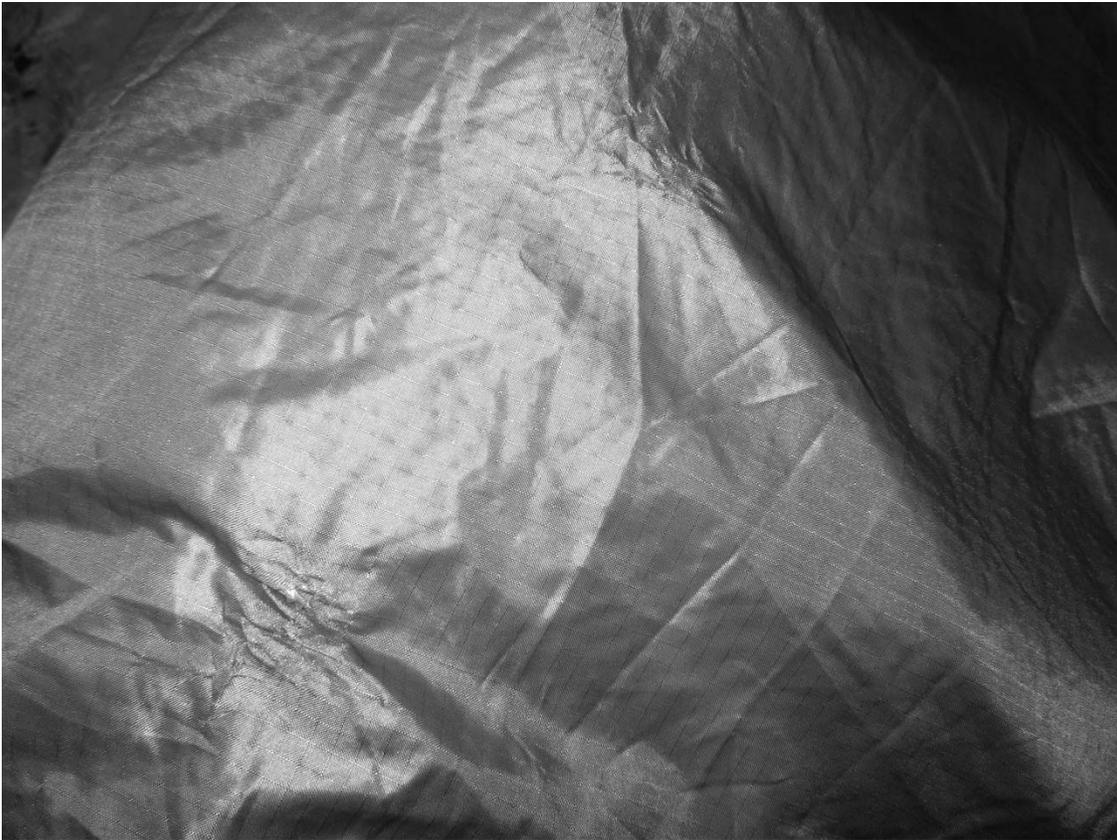
Suspected Cause of Malfunction - Incident: Possible poor body position resulting in severe twists upon exiting the AC, due to the twists the slider remained hung causing a mushroom affect. After analysis of the canopy the damage area was located on panel 6, 7, 8, 10. The slider was hung by the left group causing the left side of the parachute to become distorted to the point of loss of lift capability. We suspect that the grouping of the of slider grommets at lines 6, 7, 8 causing friction burns resulting in holes in the canopy. It is also possible some tension knots may have been present.

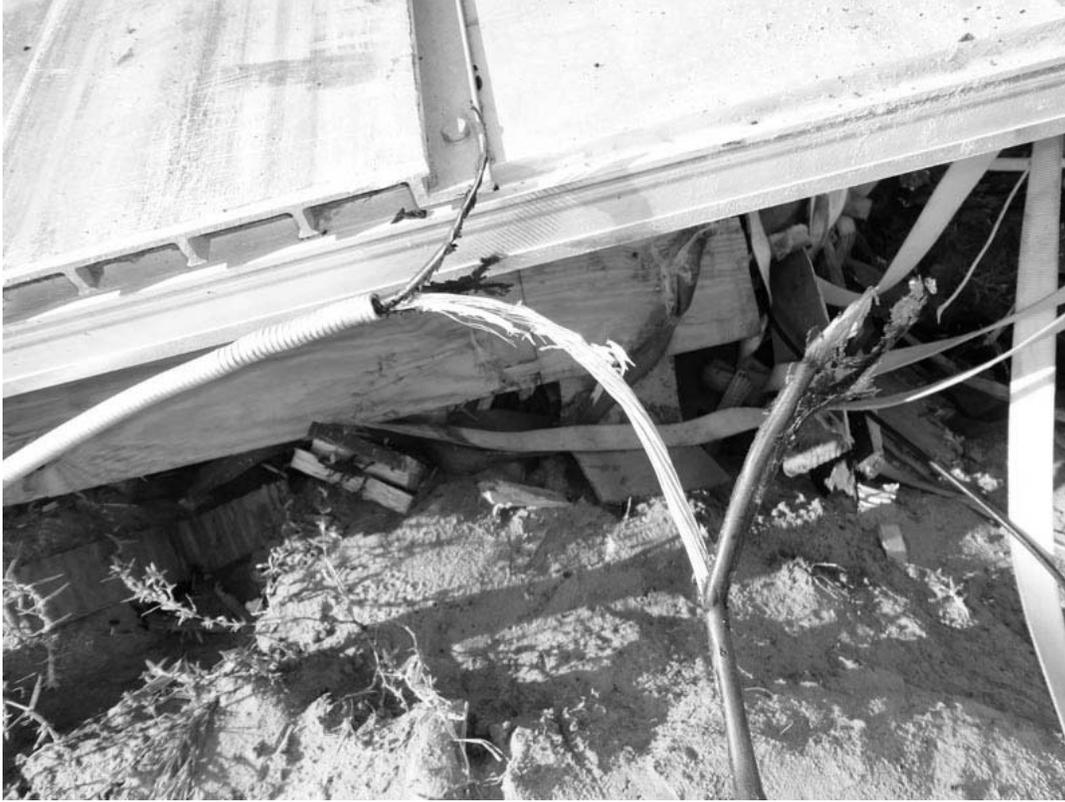
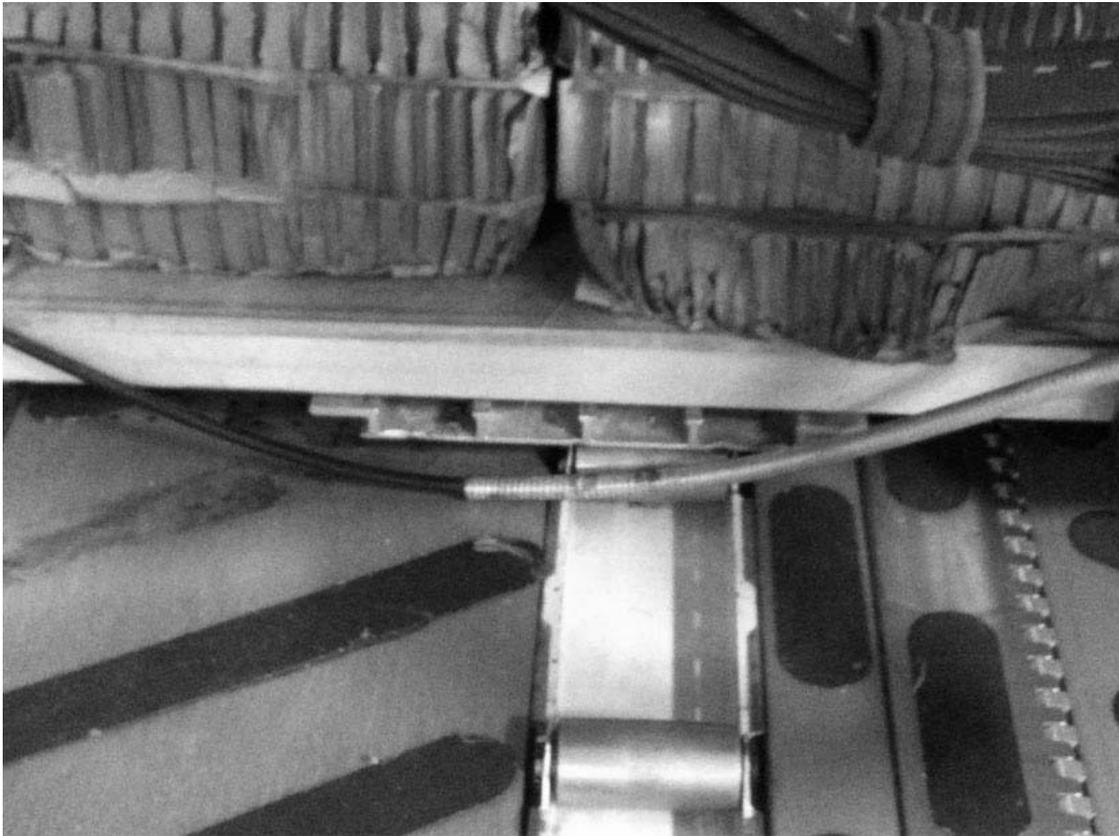
HE10\_20120907\_11QM\_G11\_EFTC\_Failure\_C17

“Reenactment” of EFTC cable below platform shown above

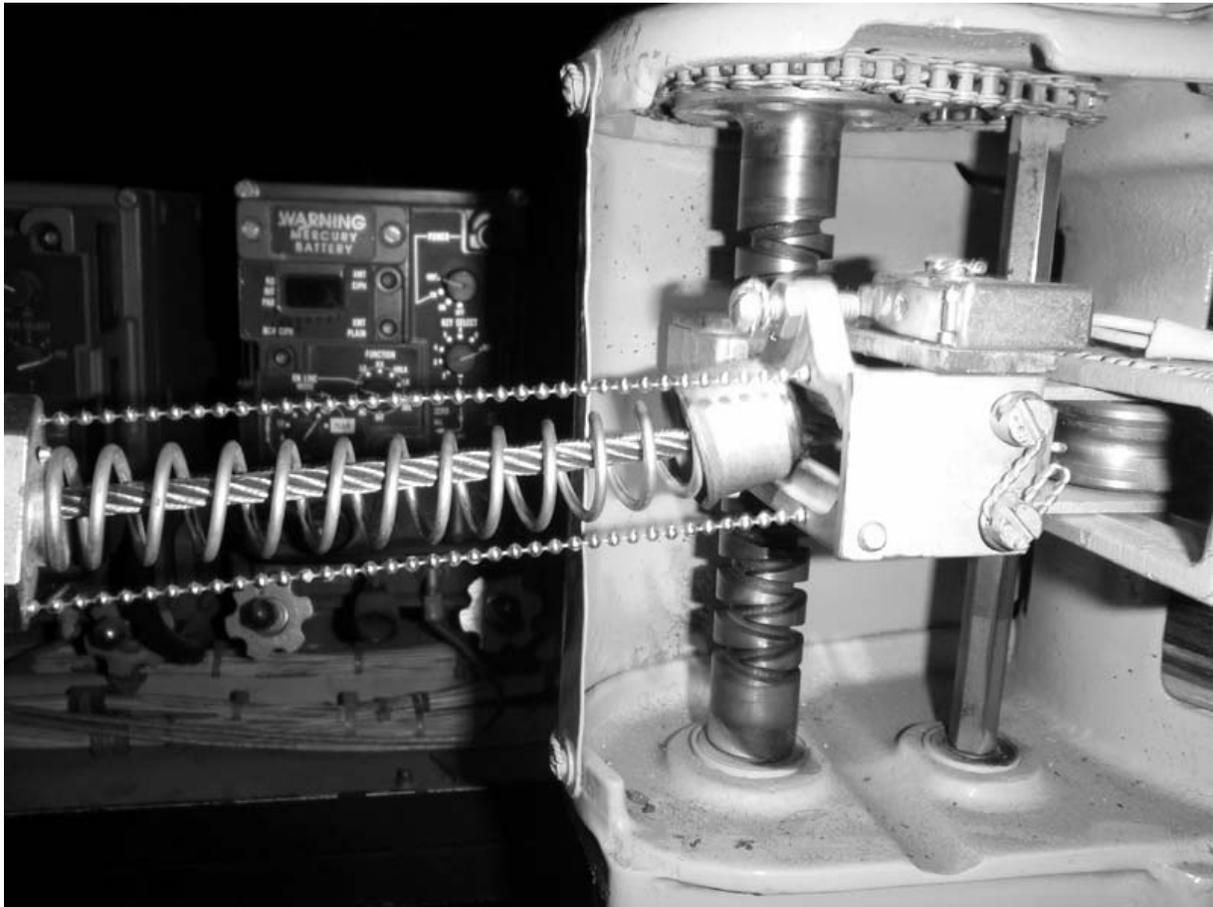
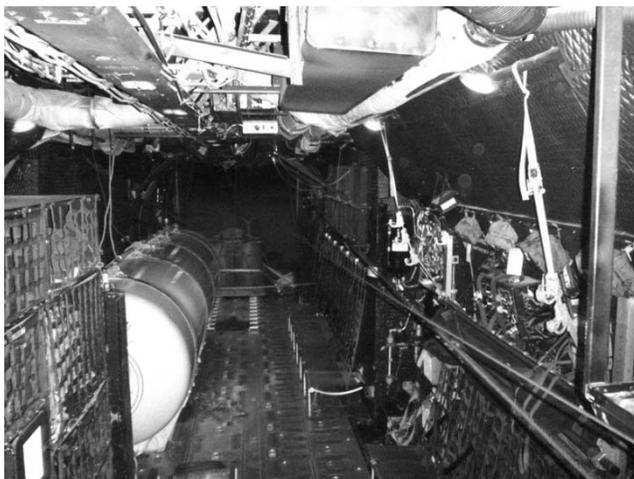
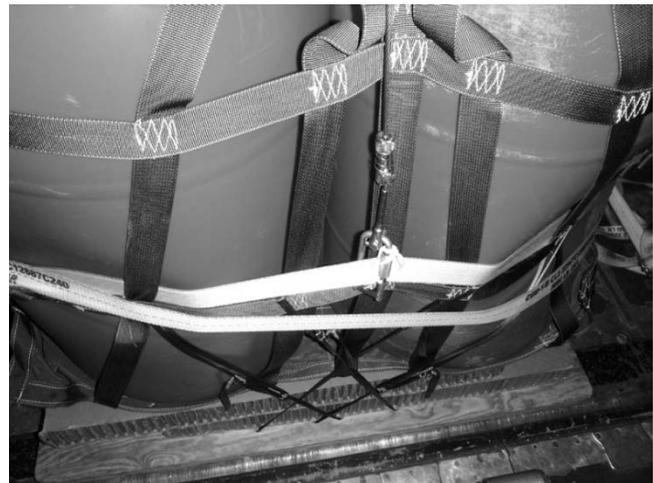
Suspected Cause of Malfunction - Incident: After going to the aircraft we noticed that that spring was not fully seated. We measured the beaded chains and found that one was 3/16 inch longer than the other and determined that the beaded chains being different lengths caused the spring to come out when the slack was taken up and pressure was applied to the static line retriever cable.

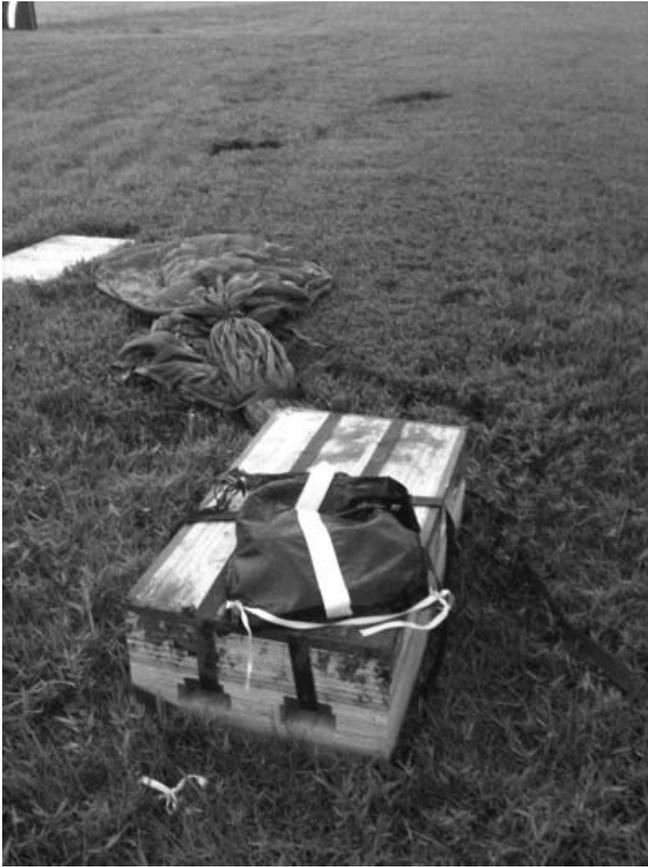
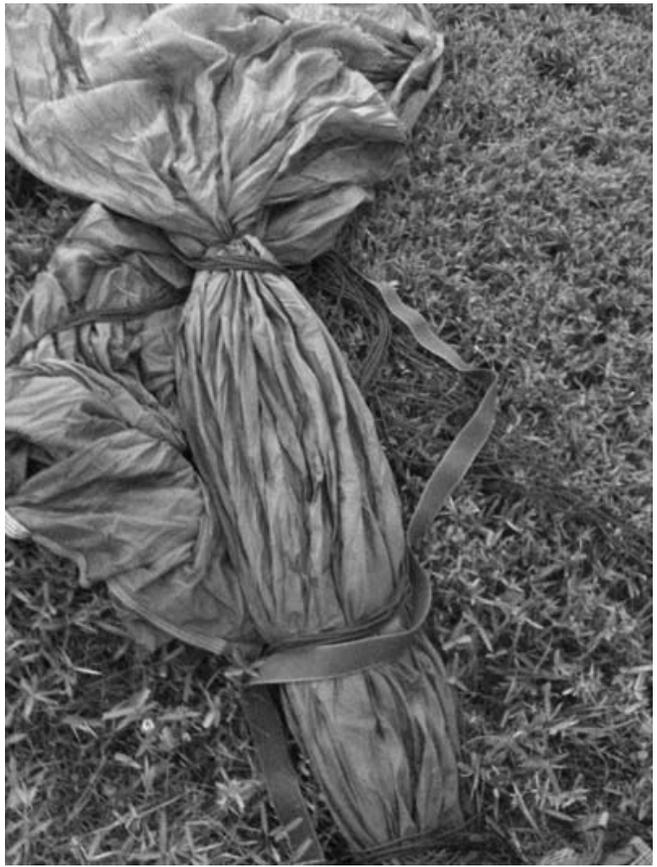
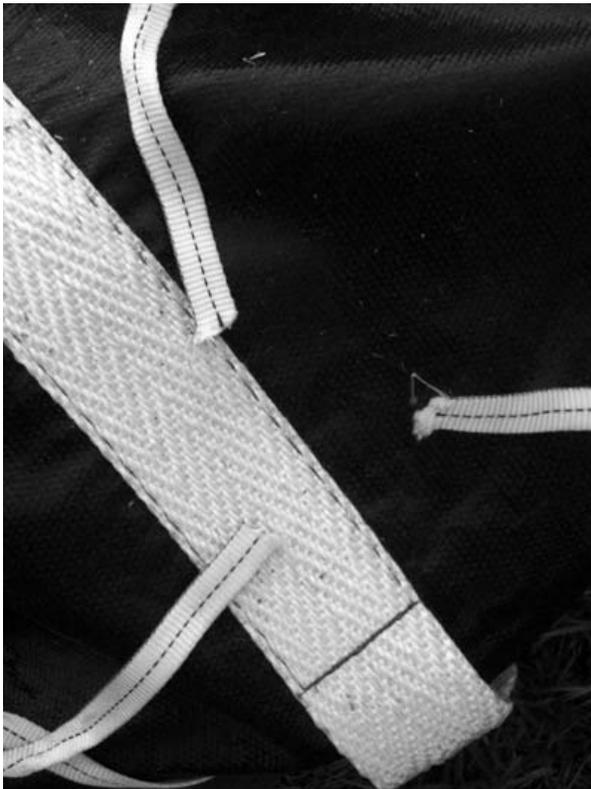
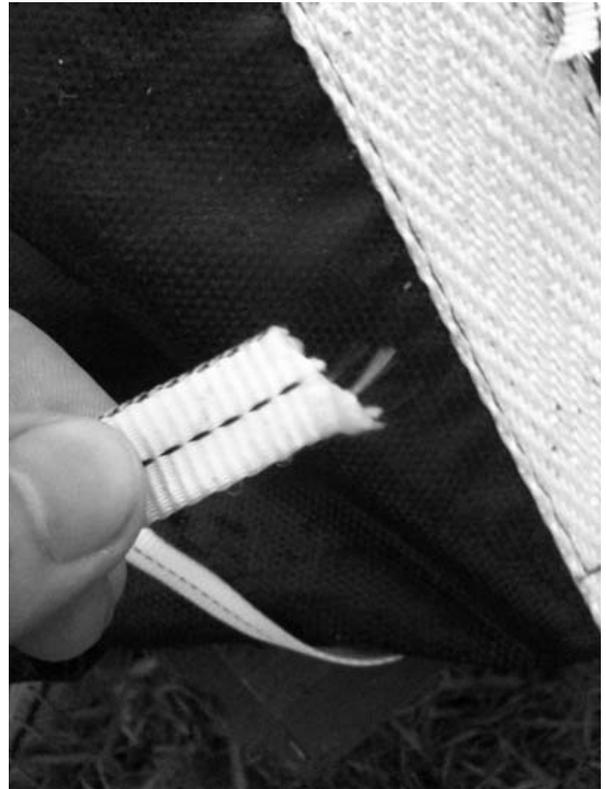
**CDS8\_20120613\_374LRS\_LCLA\_24'\_Free\_Fall\_C130E/H**

Suspected Cause of Malfunction - Incident: The was classed as an incident because the finding was that the error was with the Loadmaster and not the equipment. After cutting the gate, when the loadmaster stood and pushed the load aft the static line inadvertently came in contact with the J-Knife in the LM right hand. This severed the static line preventing the T-10R parachute from ever opening.

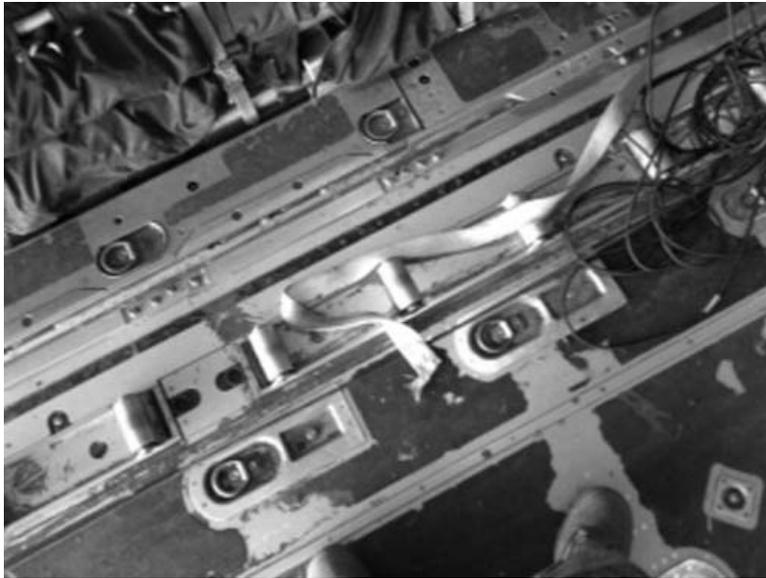
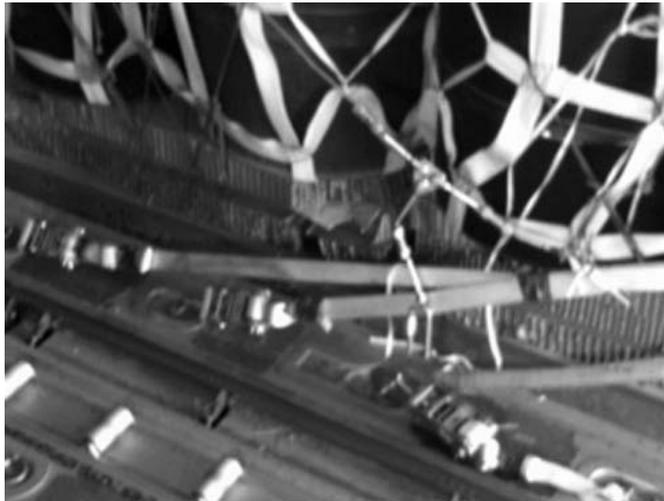
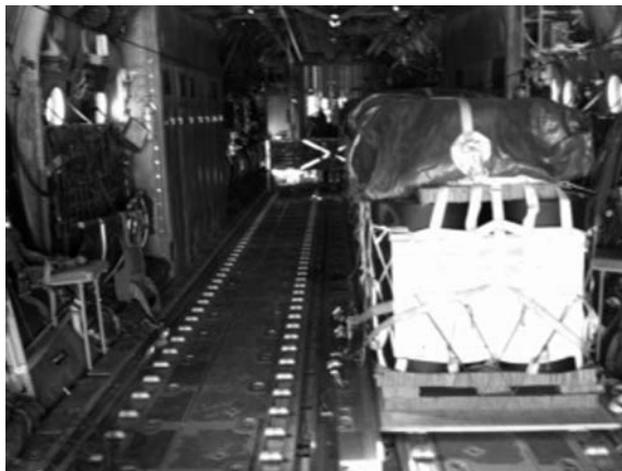
**CDS9\_20120623\_CJSOTF-72\_LCADS\_LV\_Early\_Release\_C130J**

Suspected Cause of Malfunction - Incident: Both LCAD bundles had different strength release gates restraining them causing different amount of stretching of the type XXVI release gates. After takeoff the loadmasters did not ratchet the van zelms to tighten the release gate. They climbed to 16,500 feet MSL for a minute then descended down to 7700 feet MSL leveling off and calling flaps 50 percent while passing through 180 knots. In both of these instances caused both sticks of bundles to shift forward against the BSA. Before the initiation of the release point, the primary loadmaster noticed approximately 12 inches of slack in the static line retriever cable and took out an estimated 6 inches of the slack out of the cable. The target airspeed was 140 knots but slowed down to about 135 knots so the pilot pushed up the throttles to increase the airspeed and also changing the deck angle pushing both sticks of bundles aft. Once the bundles went aft the quarter inch tie broke cutting the release gate on the aircraft left side releasing nine bundles.

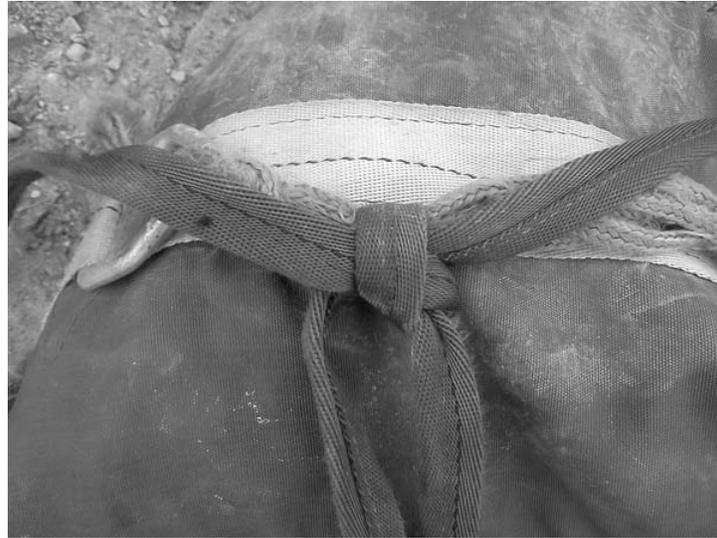
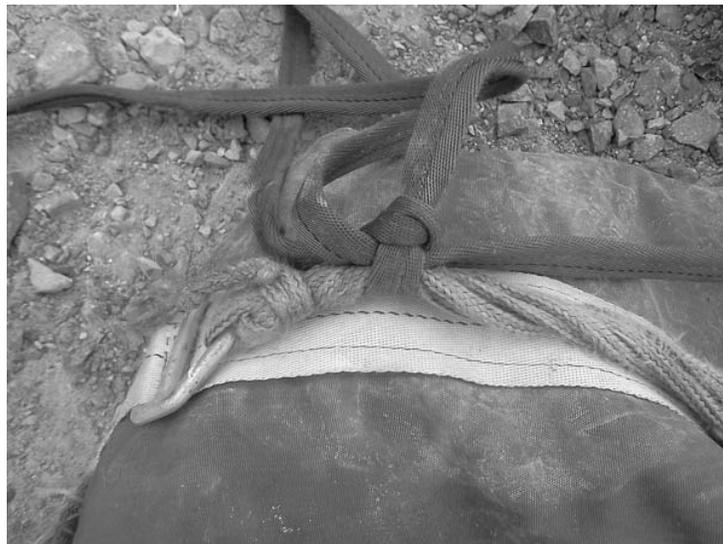
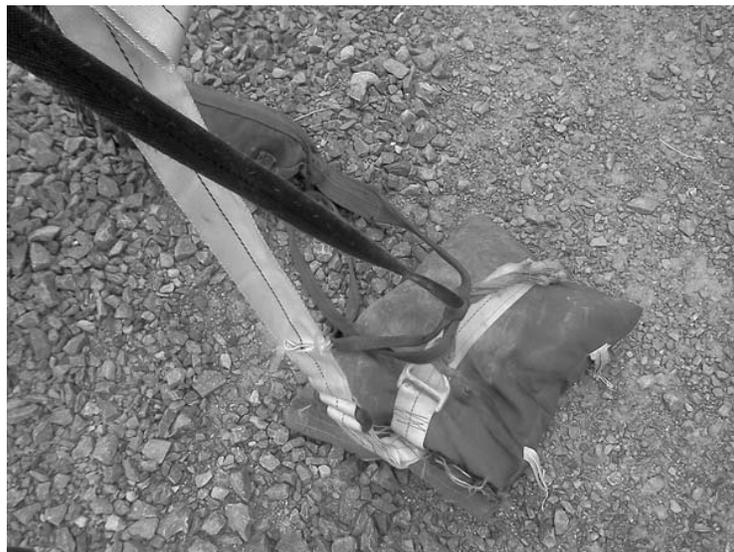
Suspected Cause of Malfunction - Incident: The pendulum line was tied thru the "V" ring several times on the SATB on the side opposite of the pilot chute for storage and transportation to the airplane. The static line was in a trucker's hitch knot wrapped around the pendulum line approximately twelve inches from the end of the pilot chute. This prevented the pilot chute bag from separating from the chute resulting in a towed SATB. After examining the facts the Malfunction Officer determined that the truckers hitch was present on the SATB prior to flight and the resulting towed SATB was due to the aircraft loadmasters improper pre-flight of the bundle.
