**127th
TRIENNIAL
AIRDROP REVIEW AND
MALFUNCTION SAFETY
ANALYSIS BOARD
9-11 SEP 08**

AIRDROP MALFUNCTION REPORT
CATEGORICAL LISTING

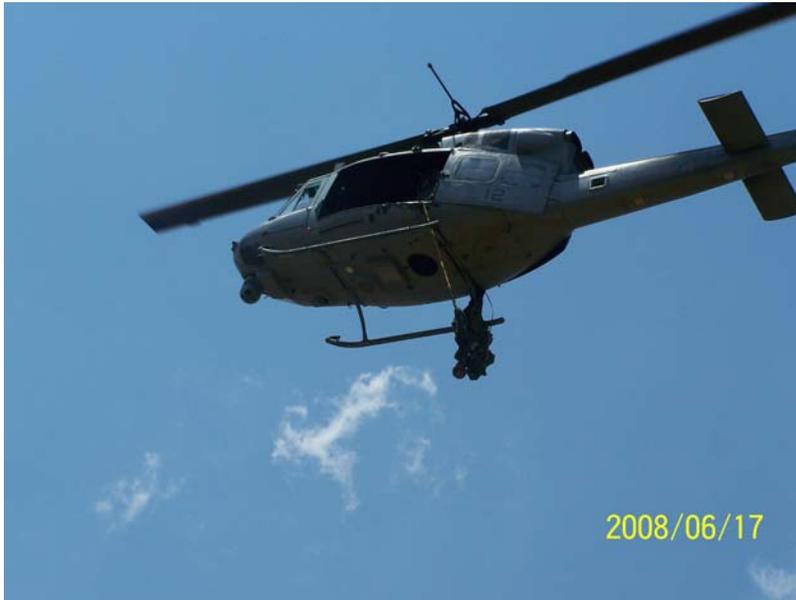
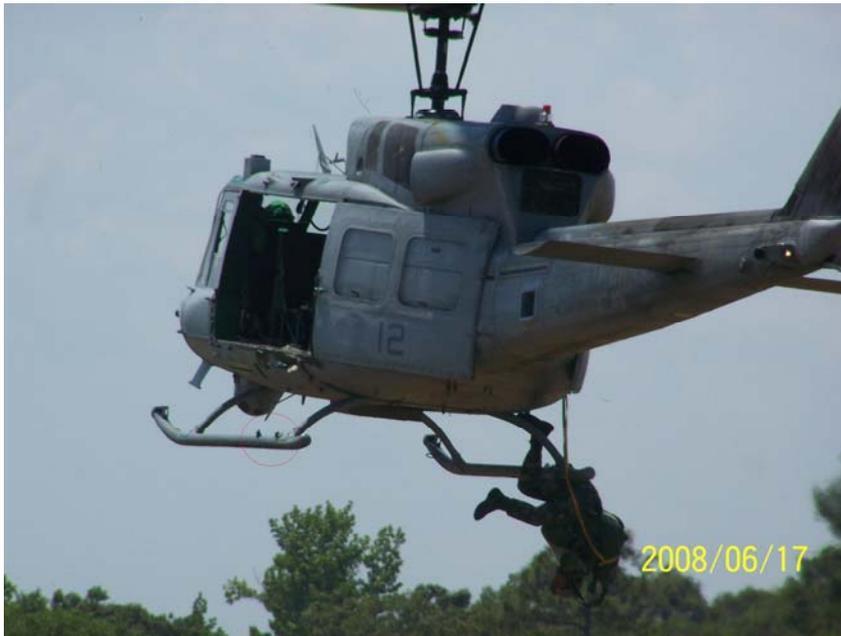
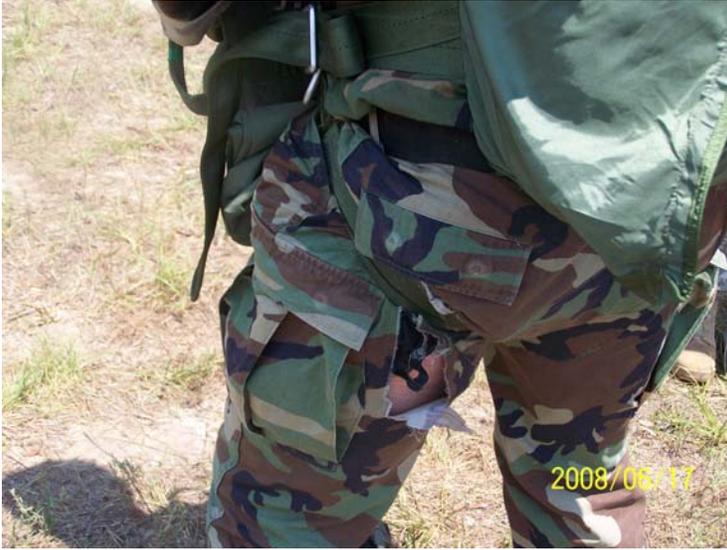
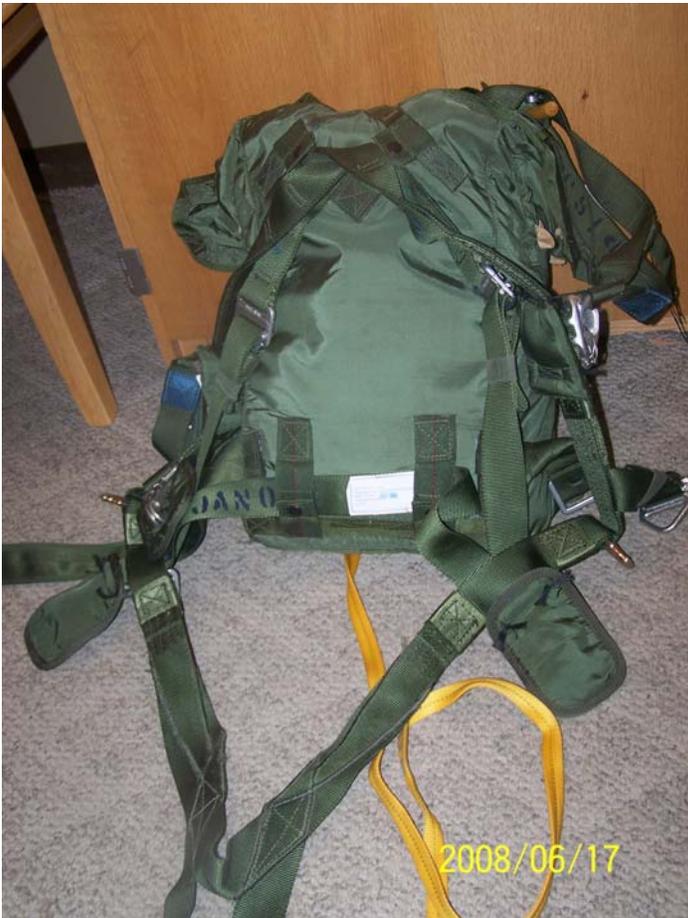
SUSPECTED CAUSE OF MALFUNCTION OR INCIDENT: Due to the weak exit that the jumper stated he executed and the un-padded/un-taped wheel mounting brackets of the skid on the aircraft, the jumper became hung on the wheel bracket of the right skid by his parachute harness saddle. The jumpmaster was the last jumper out and stated that after he exited the aircraft and his parachute opened, that he then looked back at the aircraft and saw a hung jumper. The using unit had utilized a static safety and a JM, the static safety executed hooking up the jumpers and the initial commands and the jumping JM found the release point and gave the command "GO" to the jumpers and then exited himself as the last jumper. FM 3-21.220 clearly states that "The JM is a static JM" on the UH-1H/1N, that, "In the event of a towed jumper on a rotary-wing aircraft, the jumpmaster will prevent any other jumpers from exiting and will notify the pilot." "The jumpmaster will ensure the jumper is securely attached to the aircraft and will not break free during descent." "If the jumper is not securely attached, the jumpmaster will attempt to shake or cut him free." "If the jumper is attached, the aircraft will slowly descend to the DZ and come to a hover, and the jumper will be freed from the aircraft." Therefore concluding that, the JM wasn't in the aircraft to stop the additional jumpers from exiting or able to provide assistance to the towed jumper, and the "static safety" was located in the rear portion of the aircraft where he was possibly unable to see if there was a towed jumper or not. The towed jumper was not secured to the aircraft and was not

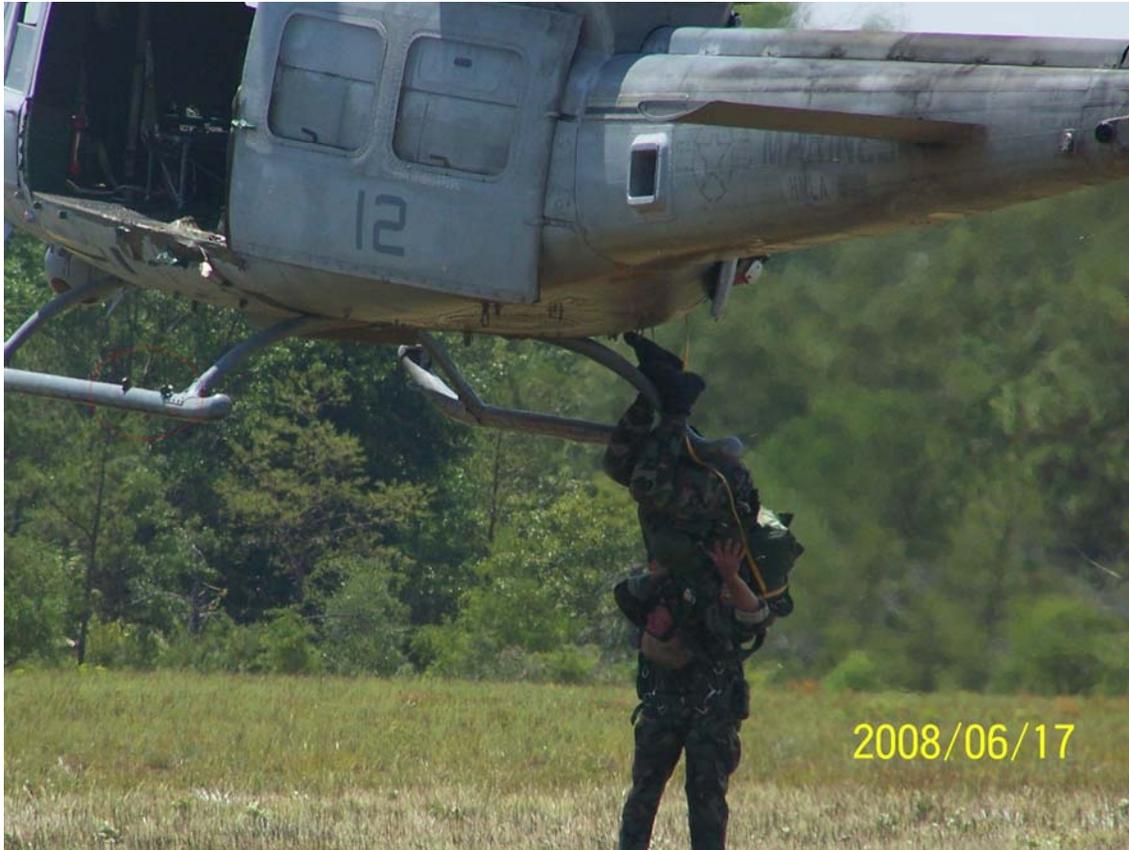
Photo 3 of 5: note the unpadded wheel mounts on near side circled in red

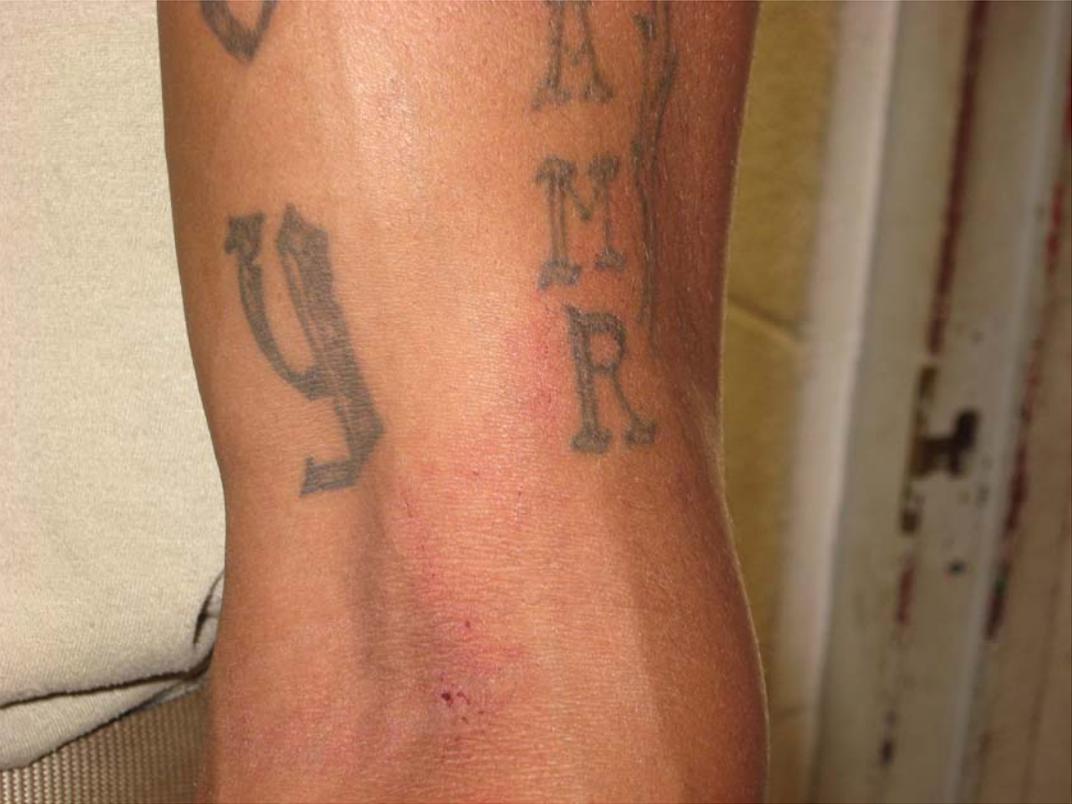
1 of 1 photos

DESCRIPTION OF SUSPECTED MALFUNCTION OR INCIDENT: On 10 JUN 08 at approximately 1800 hrs there was a static line injury during an ABN Operation conducted by the 507th CSG. SPC Jumper stated that he had too much slack in his static line. He handed his static line to the safety, jumped out of the left paratroop door and he felt his left arm getting caught up in the static line outside the aircraft. He also felt the static line tighten up on his left bicep and burning it. SPC XX was the number 21 jumper in the left door. According with SPC XX's statement he saw SPC Jumper's left arm getting caught by the static line. SSG Safety was the safety on the left door. According to his statement, SPC Jumper was moved from being the #1 jumper on the second pass to being the #20 because he expressed that he was scared to be the first jumper. SSG Safety observed each jumper making eye to eye contact and handing the static line to him. He stated that he felt a difference in one of the static lines. He said there was a snag feeling, but he didn't remember whether it was in the beginning, the middle, or the end of the chalk. SPC Jumper reported his injury after he had turned in his parachute to the parachute turn in point. It was impossible to identify his equipment at that time. After meeting with the SSG Safety, and SPC Jumper, they stated the same thing they wrote in their statements. There was excess slack in the jumper's static line and SPC Jumper's left arm was caught up as he was exiting the left paratroop door.

SUSPECTED CAUSE OF MALFUNCTION OR INCIDENT: Improper static line control.

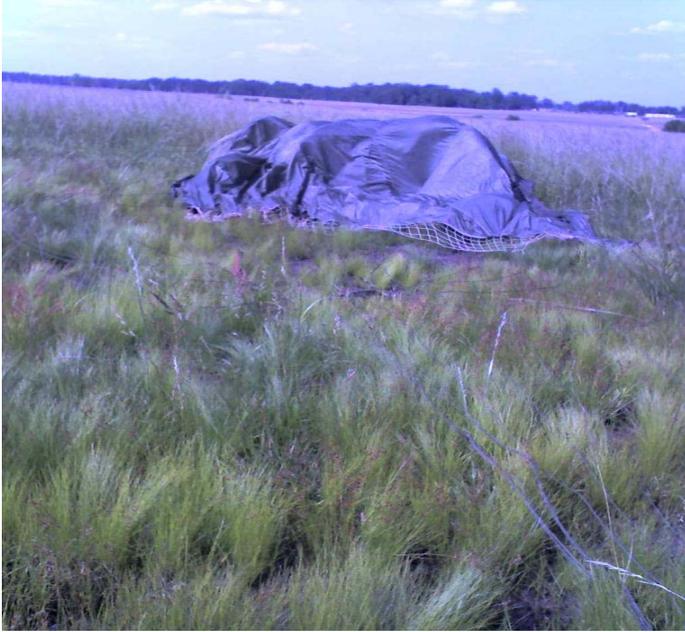
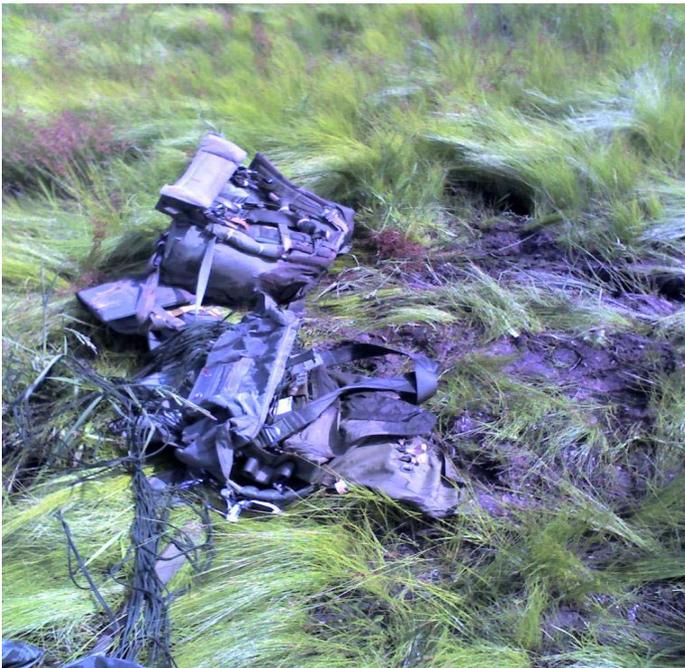
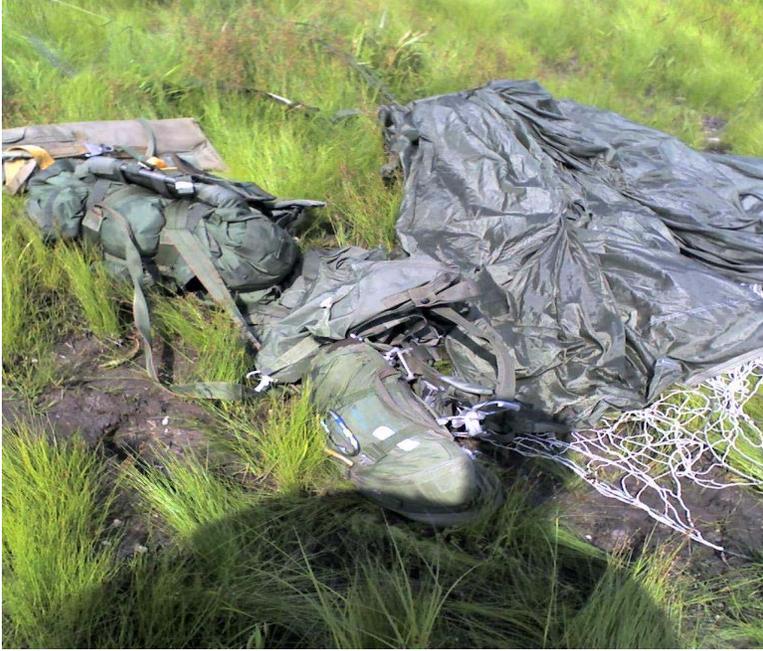
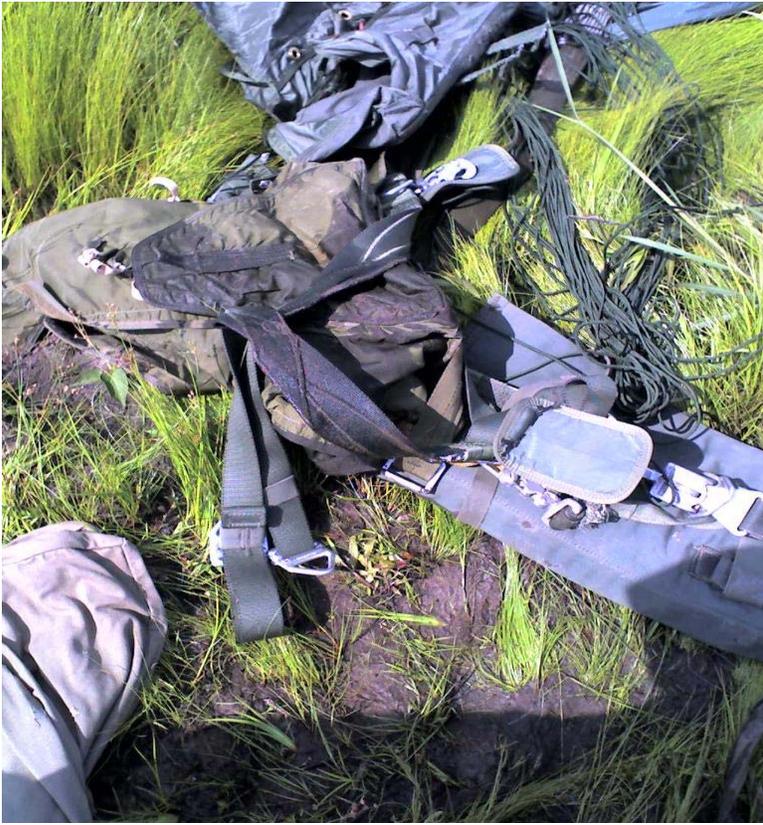
SUSPECTED CAUSE OF MALFUNCTION OR INCIDENT: ., Upon mass exit from the left and right doors of a C130, two Basic Airborne Students experienced a high altitude entanglement. This resulted in the higher jumper becoming entangled with the lower jumpers main canopy and suspension lines. As a result of this event, the higher jumper tries to free himself from the lower jumper's main canopy and suspension lines. While doing so, the higher jumper unintentionally activates the left canopy release assembly and experiences a left riser separation which becomes entangled with the lower jumper's suspension lines. Lower jumper activates SLCP reserve approximately 150' above the ground with limited inflation of the reserve canopy. Both main canopies provided enough lift for both jumpers to land safely. Higher jumper states he does not activate SLCP reserve because of commands heard from a Black Hat to "Hold what you got". During inspection of the harness, no damage or mechanical deficiencies were found in regards to either canopy release assemblies. Only minor suspension

line friction burns were noted on investigation of the higher jumper's main canopy and suspension lines. Upon inspection of the lower jumper's equipment, only minor suspension line friction burns were noted.

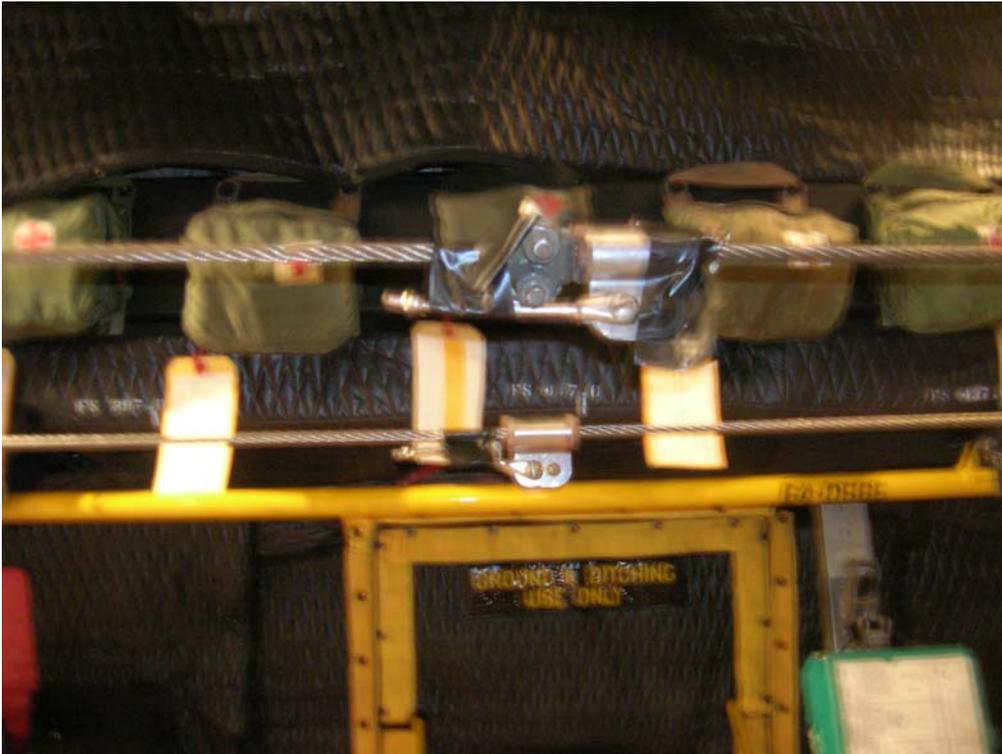
SUSPECTED CAUSE OF MALFUNCTION OR INCIDENT: Upon investigation and talking to SM the cause of the malfunction was failure to hook-up. SM was second to last jumper (15 of 16) and was hooked forward of the bolts anchoring the anchor line cable. At the command of go he realized the dilemma, unhooked and as he walked to the door re-hooked. When he re-hooked he did not fully connect the snap hook to the anchor line cable. Either prior to exit or upon exit the static line disconnected from the anchor line cable. Sworn statements were received from the jumper and last jumper, who also disconnected his snap hook and reconnected prior to exit. A sworn statement from the Safety indicated that both jumpers were connected to the anchor line cable upon his inspection. However, he did not notice them hooked up in front of the anchoring point of the anchor line cable. Pictures to follow and the unit is conducting an in depth investigation of the malfunction. Unit investigation report will follow as well.

Photo 1 of 3 - Right door Pitford bracket assembly located approx. 10 feet from Electronic Warfare Console

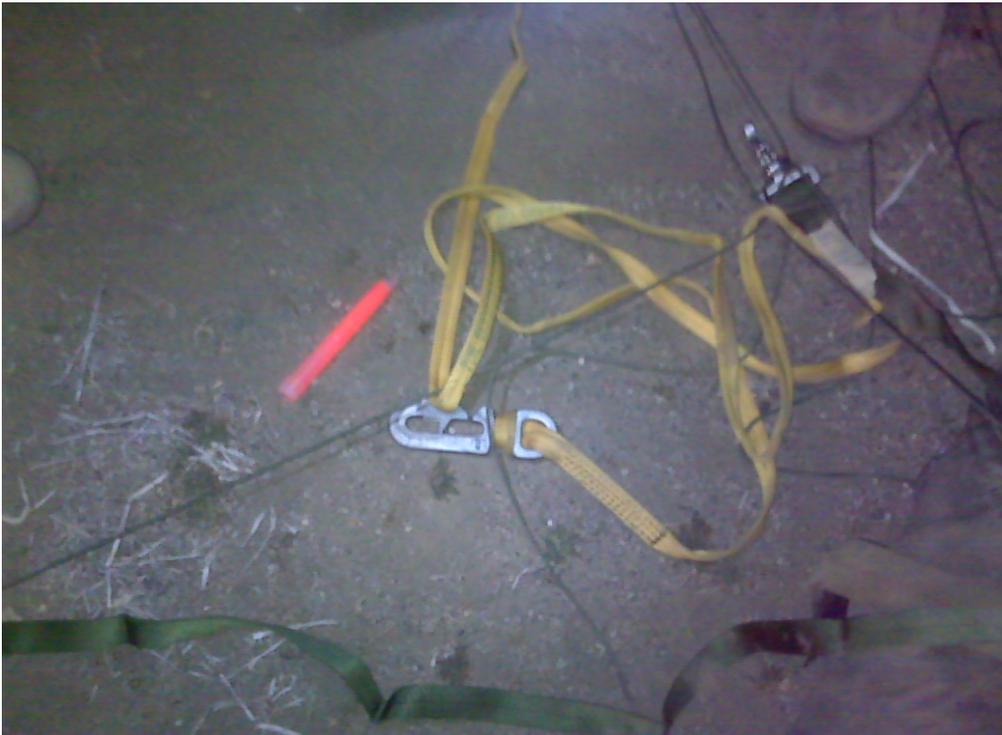
Photo 2 of 3 - No Sign of damage on either the Static Line Snap Hook or Static Line

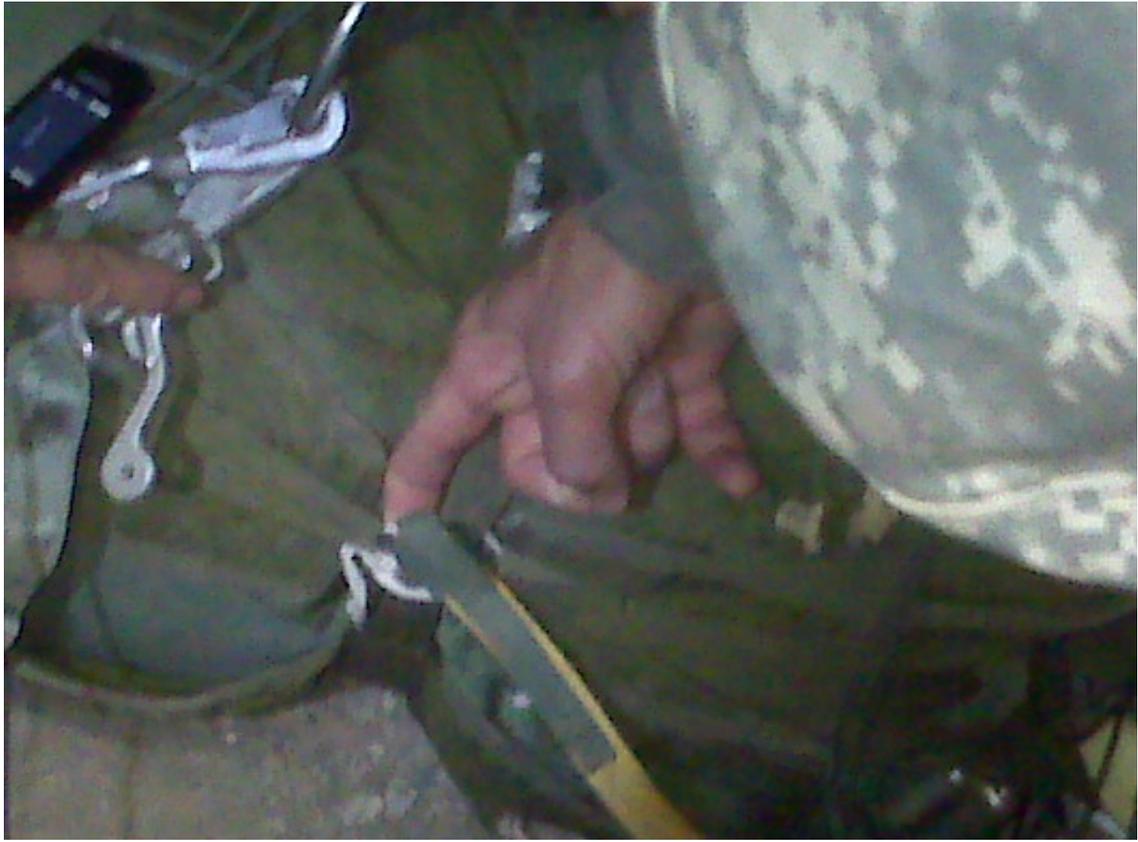
Photo 3 of 3 - ¼" Cotton Webbing intact. All Retaining Bands Broken.

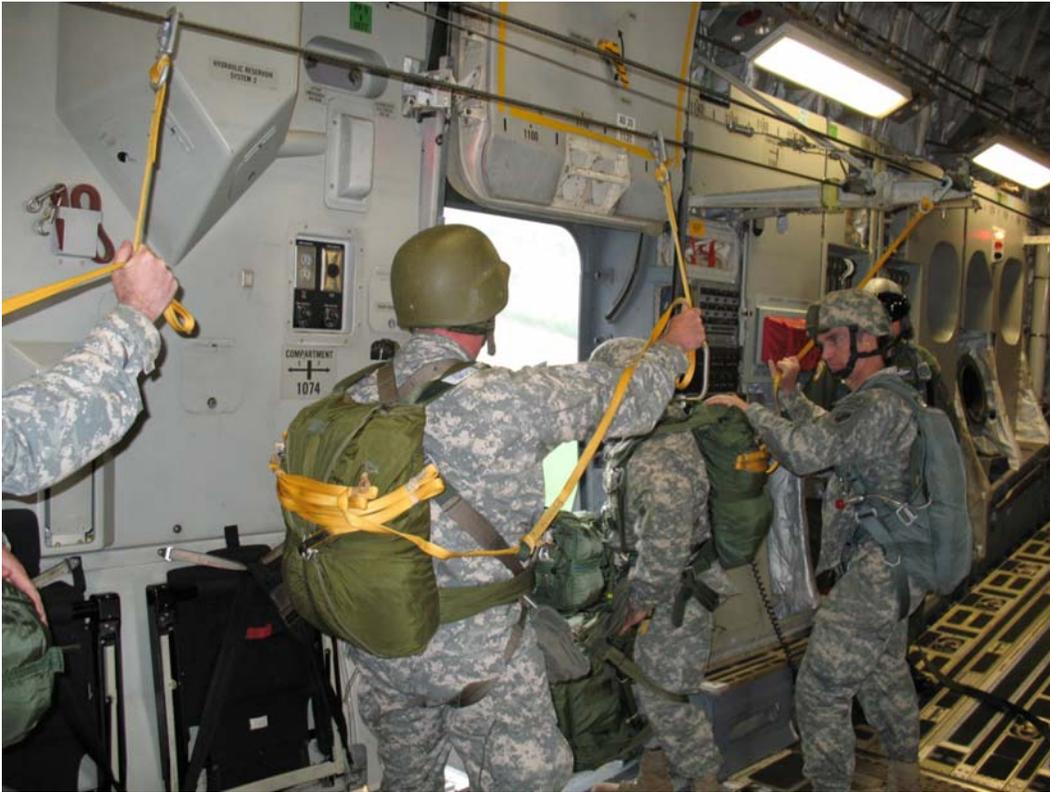
Photo 1 of 6 - LTC XX with static line over arm (not underneath)

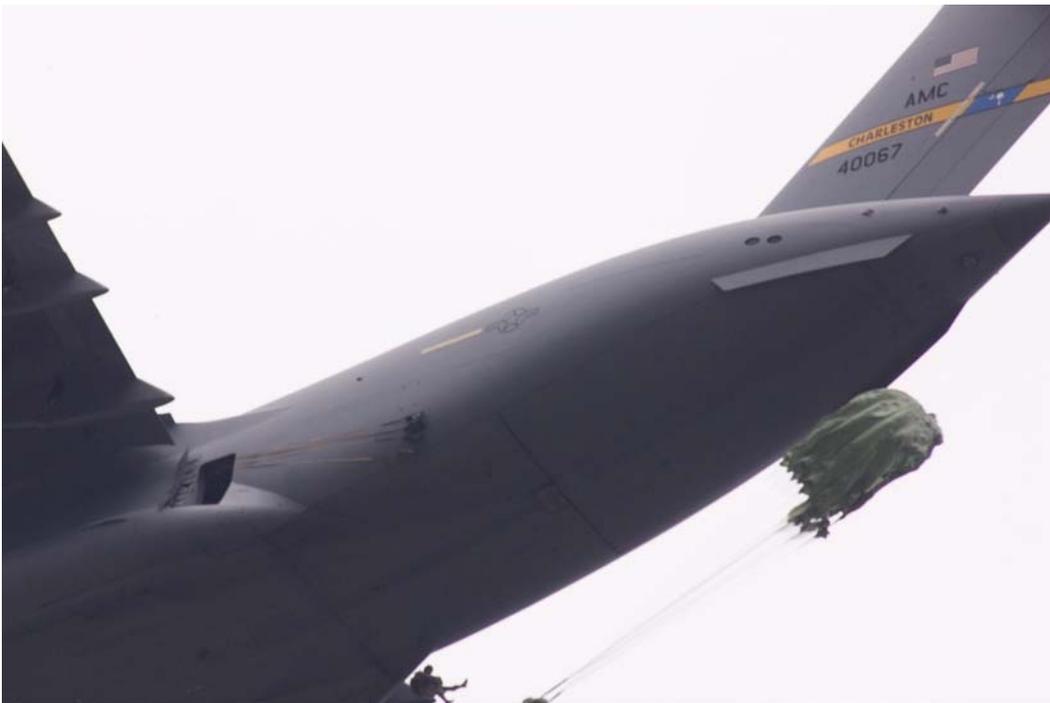
SUSPECTED CAUSE OF MALFUNCTION OR INCIDENT: The number one jumper, LTC XX, at some point between handing his static line to the safety (SFC Maddox) and exiting the door had the static line routed under his arm based on Photo 2 (onboard photo file). Examining the marks on the soldiers arm and ripped ACU just below the shoulder it appears the static line was routed around his arm.

Photo 2 of 6 - LTC XX on right door falling away from aircraft

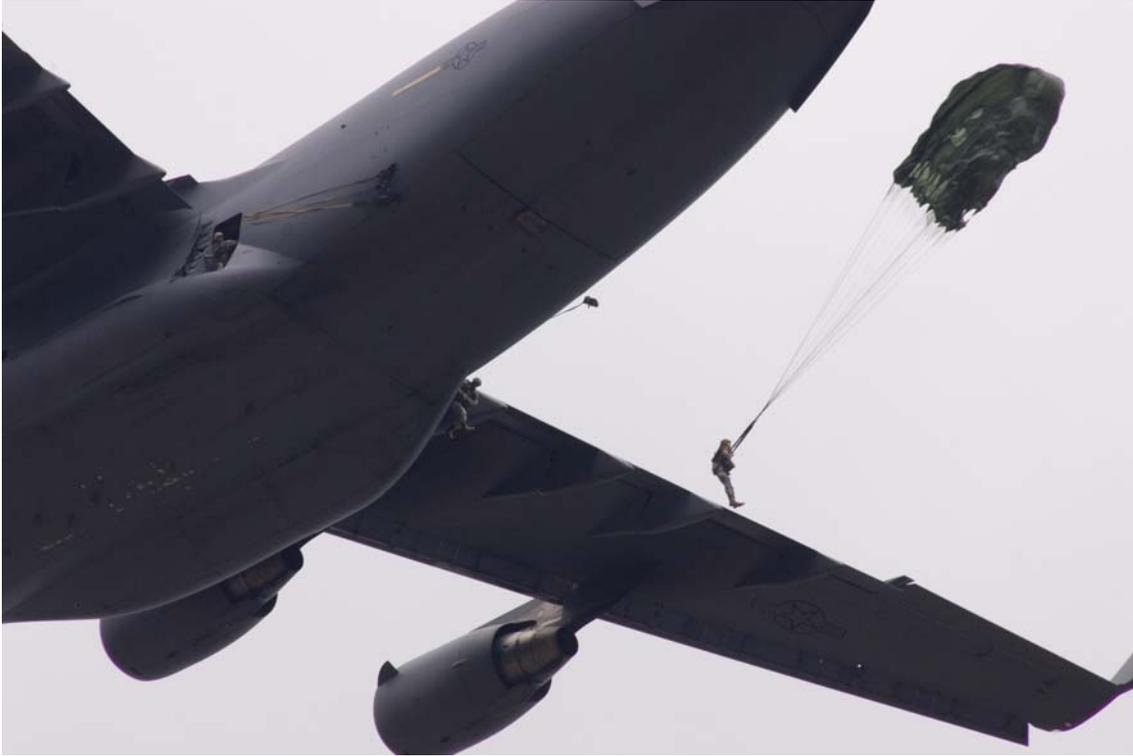
Photo 3 of 6 - LTC XX Chute inflating with twists in risers.

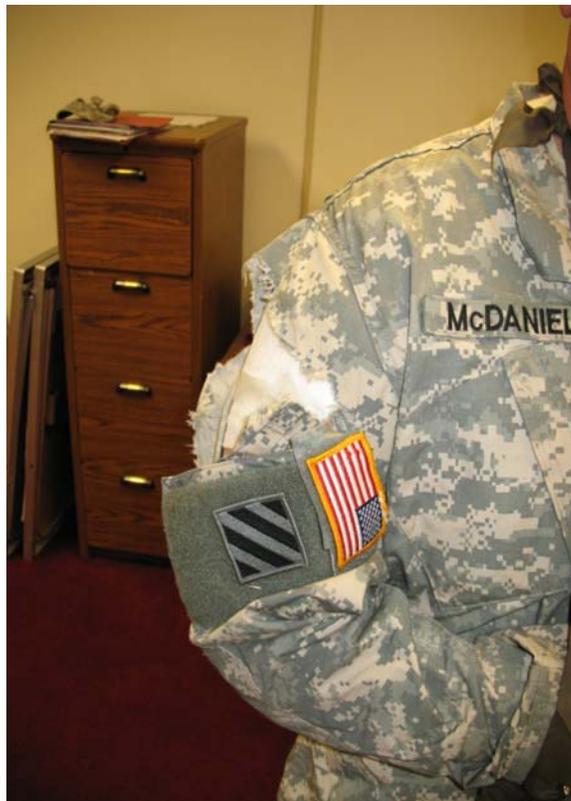
Photo 4 of 6 - Rip in ACU right sleeve

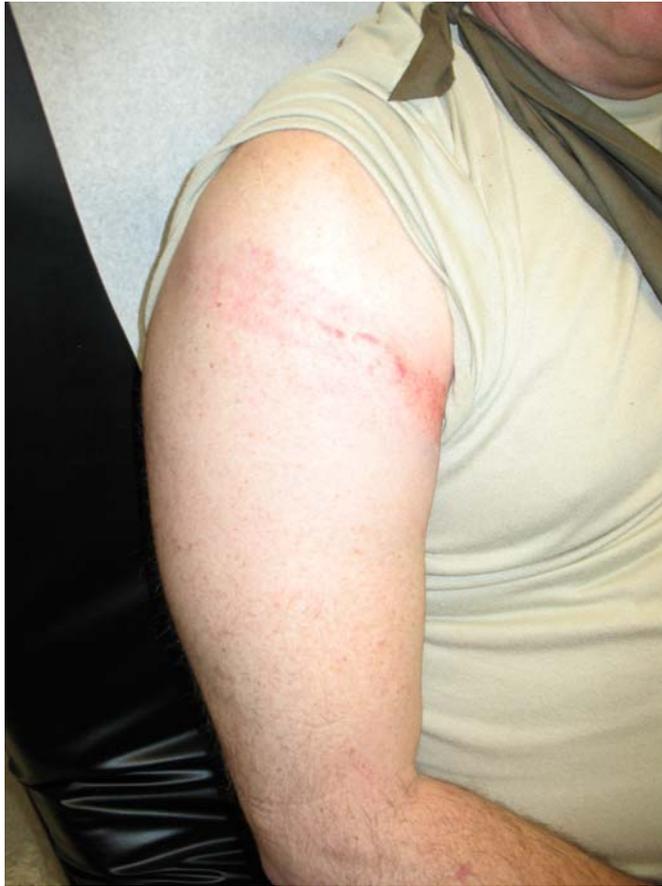
Photo 5 of 6 – Bruising to right arm

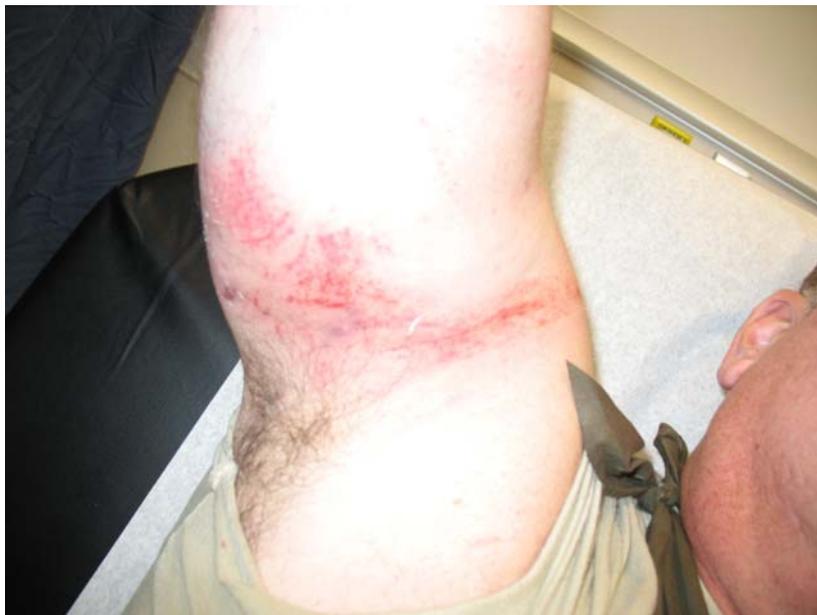
Photo 6 of 6 – Bruising to inside area of right arm

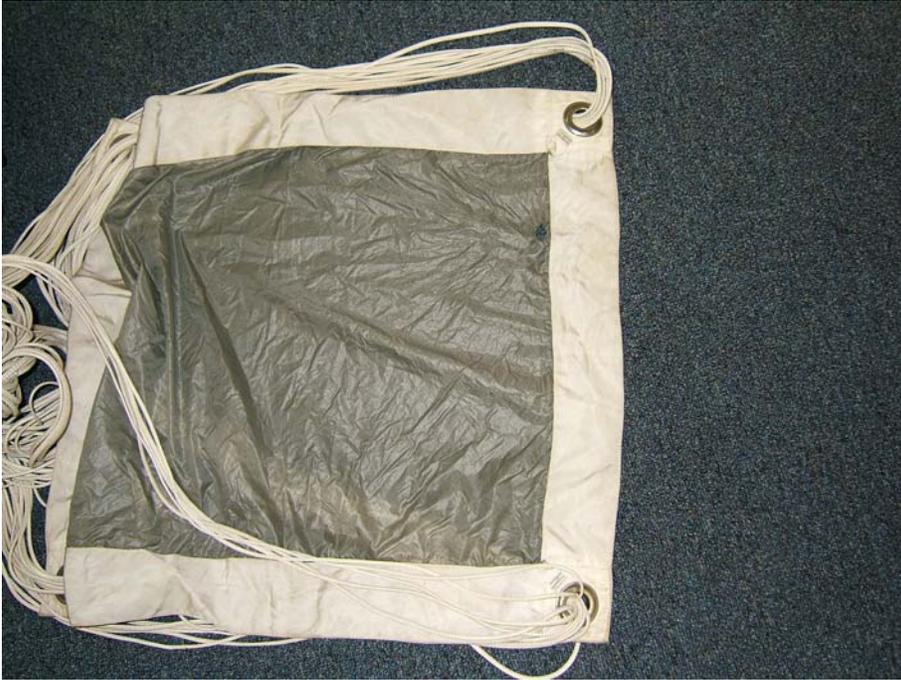
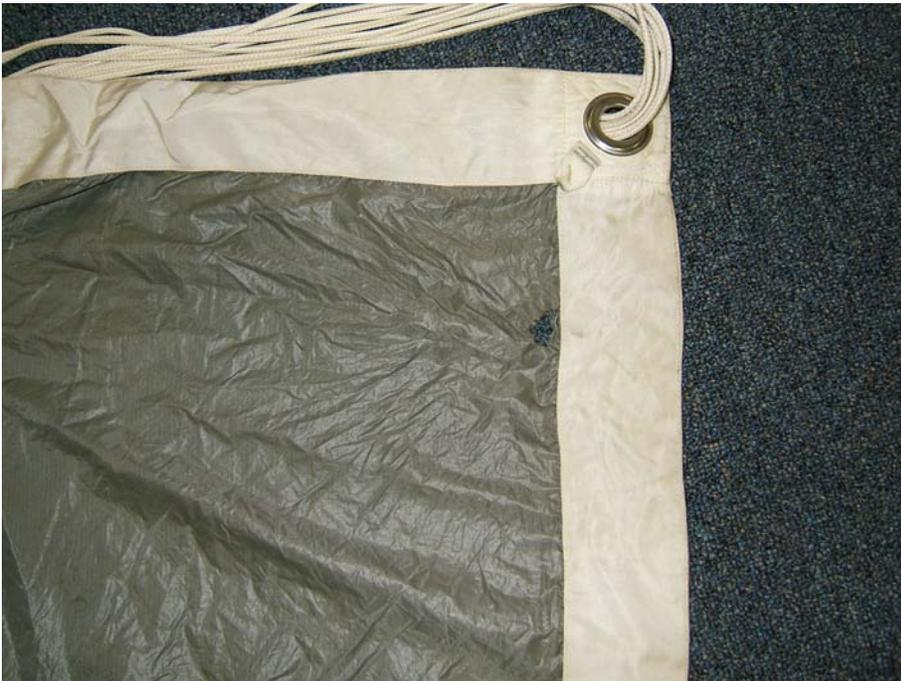
SUSPECTED CAUSE OF MALFUNCTION OR INCIDENT: The main canopy was inspected by military riggers after returning to the drop zone. The top skin of the canopy, suspension lines, slider, and the lift webs were given a through inspection. The only significant findings were a quarter sized burn hole in the corner of the slider, adjacent to the grommet, and slight ware of the line group that runs through the grommet. No other damage was found with the main canopy. Suspected malfunction after canopy inspection is a hung slider. , .

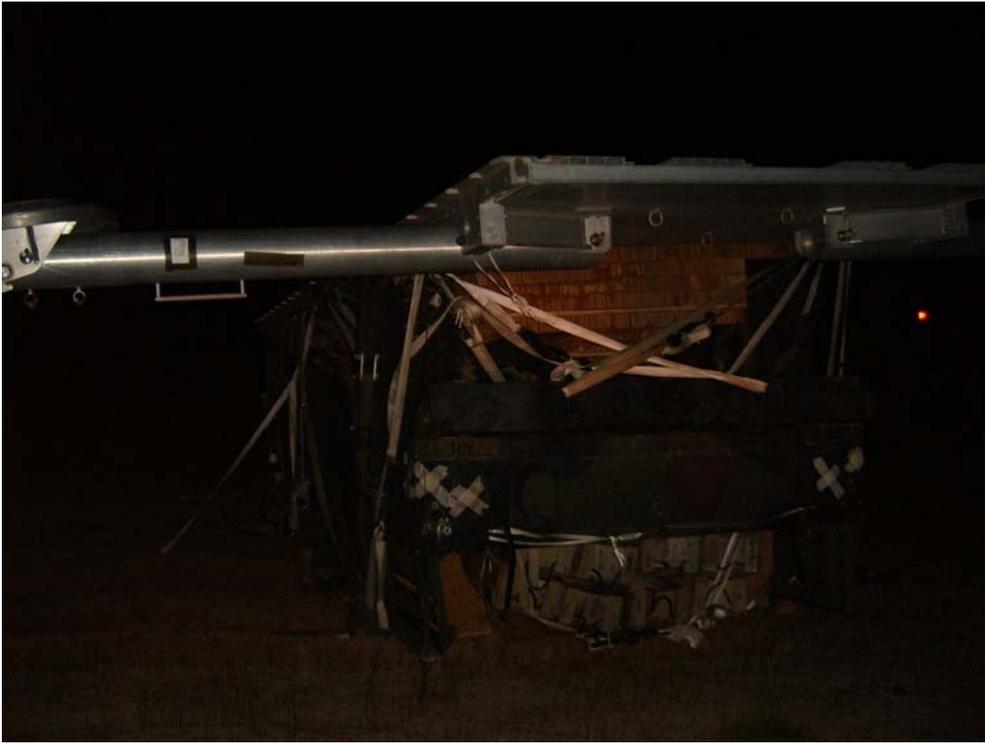
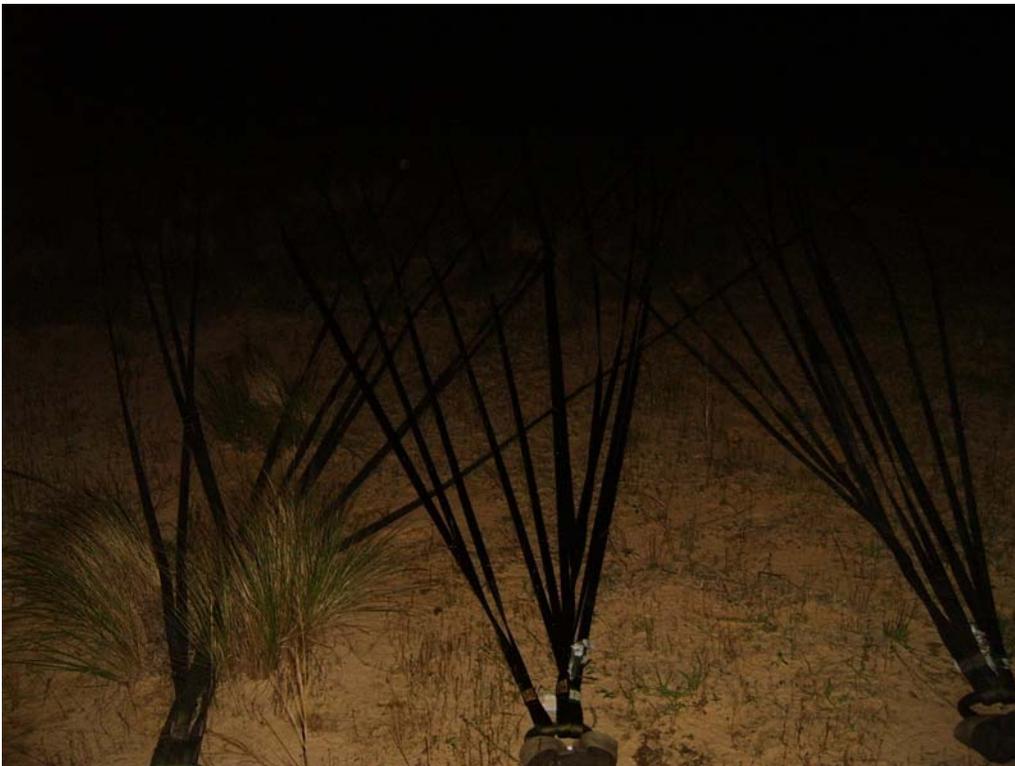
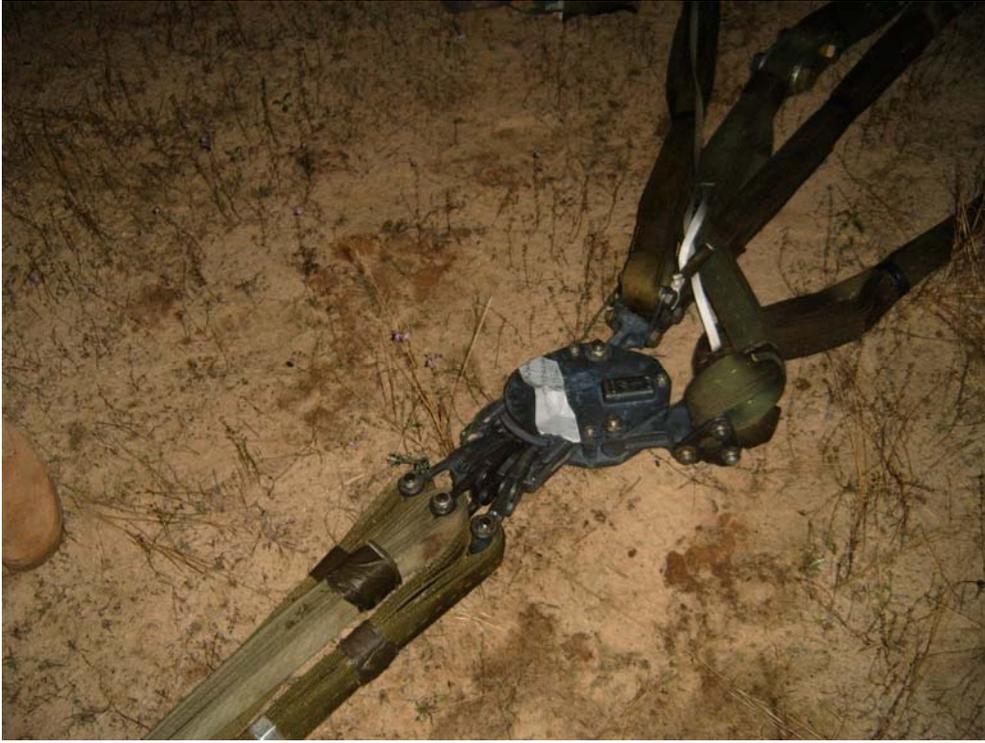
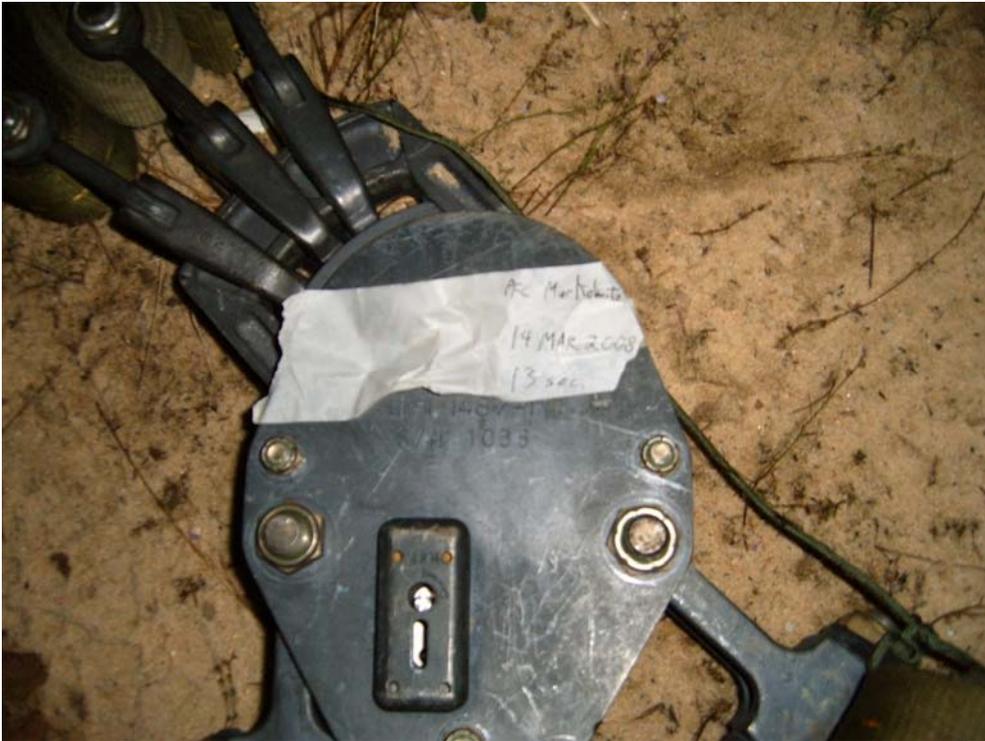
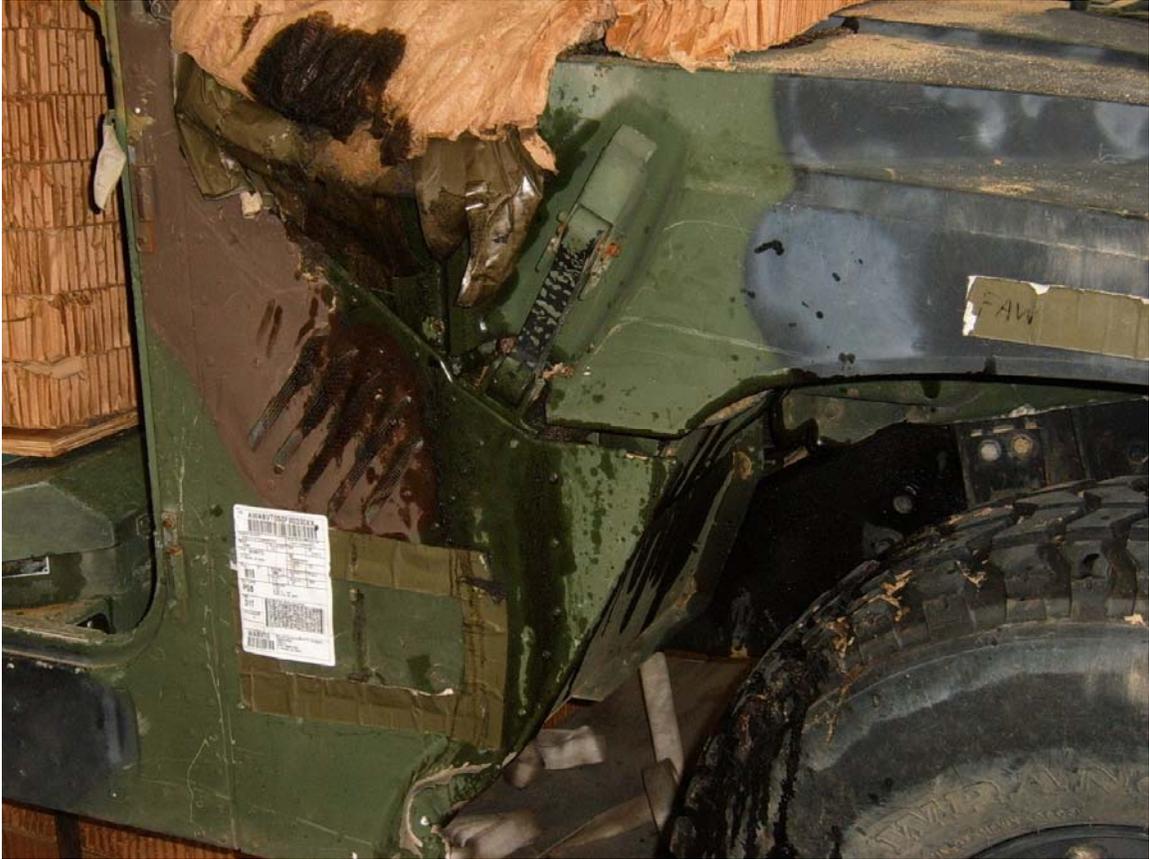
DESCRIPTION OF SUSPECTED MALFUNCTION/INCIDENT/DAMAGED INCURRED: Drop occurred around 1100 hrs on Holland DZ on the 25th of April 2007. The 28 ft type V load which was the SEE extracted properly from the tailgate of the C-130 aircraft. Parachutes were elongated and quickly became fully inflated. The load had five fully functional parachutes all the way through the descendant phase. The M2 Release system never did reach it's critical angle. The canopies continued to hold air after the load landed in the upright position. This caused the load to rotate over to its side and be pulled approximately ten to fifteen feet. Upon making contact with the load it was discovered that the timer block had fallen in the prescribed time of 12-16 seconds. The damage included the roll bar being forced inward, and also the side glass as well as the windshield was broken. The side panel was also disfigured resulting from the load being pulled across the drop zone. After returning the equipment back to the Rigging Facility the release was tested five times and each time the timing block did fall.

SUSPECTED CAUSE OF MALFUNCTION/INCIDENT: Upon inspection of the M-2 Release System at the 82d Heavy Drop Rigging Site, the timer was properly tested a total of five times. each time it activated within the appropriate time. The winds were gusting 6-12 knots. However, the release never did reach it's critical angle so that it would allow the canopy to separate from the load and prevent it from rolling over. A solution to this problem would be to try and design a better release that will properly separate the canopies from the load upon reaching its critical angle.
