**127th
TRIENNIAL
AIRDROP REVIEW AND
MALFUNCTION SAFETY
ANALYSIS BOARD
9-11 SEP 08**

AIRDROP MALFUNCTION REPORT
CATEGORICAL LISTING

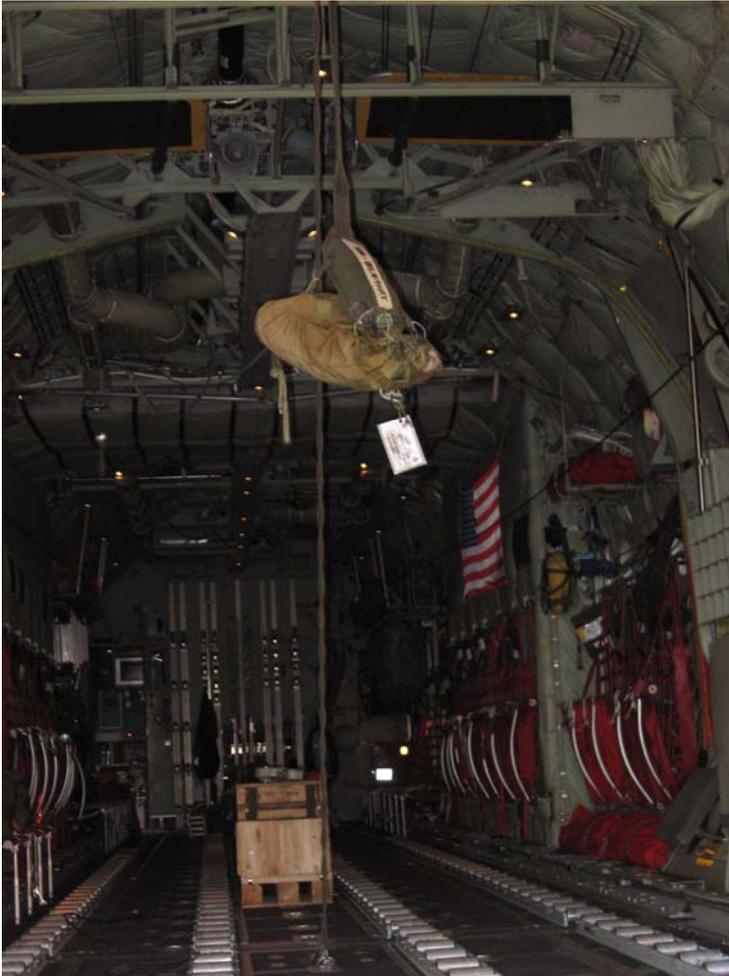
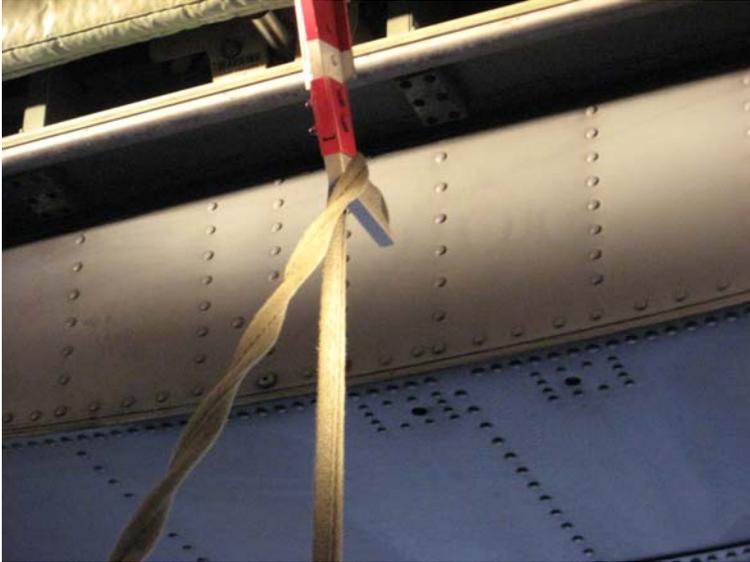
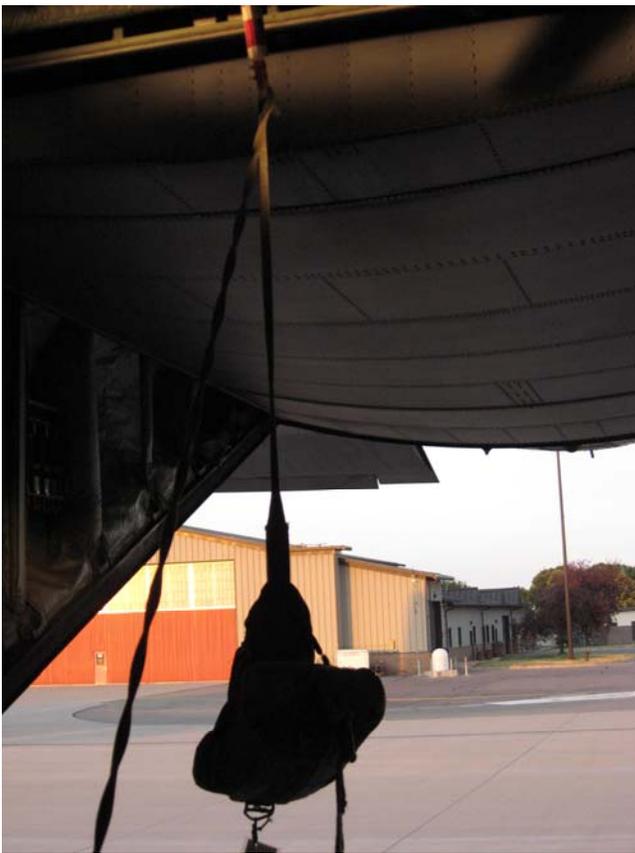
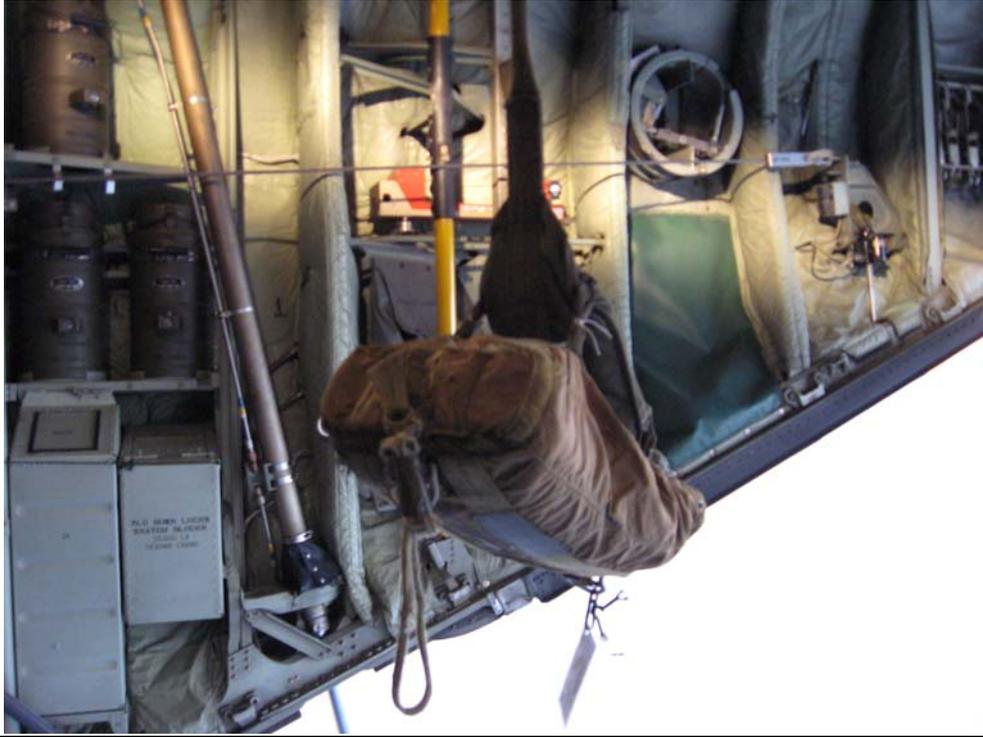
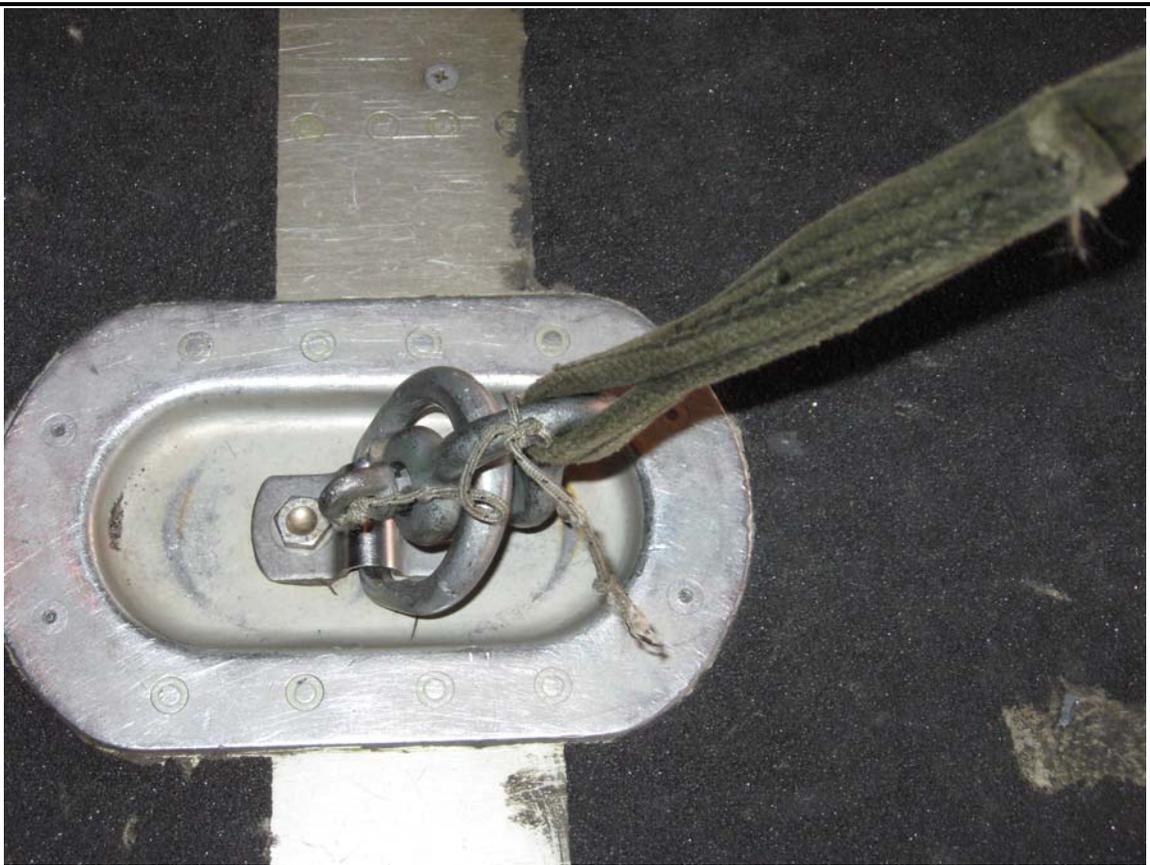
SUSPECTED CAUSE OF MALFUNCTION OR INCIDENT: 910 MXS conducted pressure tests on the lock. The lock passed all pressure tests commencing from
