133nd TRIANNUAL AIRDROP REVIEW and MALFUNCTION SAFETY ANALYSIS

May 11-13, 2010

MALFUNCTIONS / INCIDENTS REPORTED

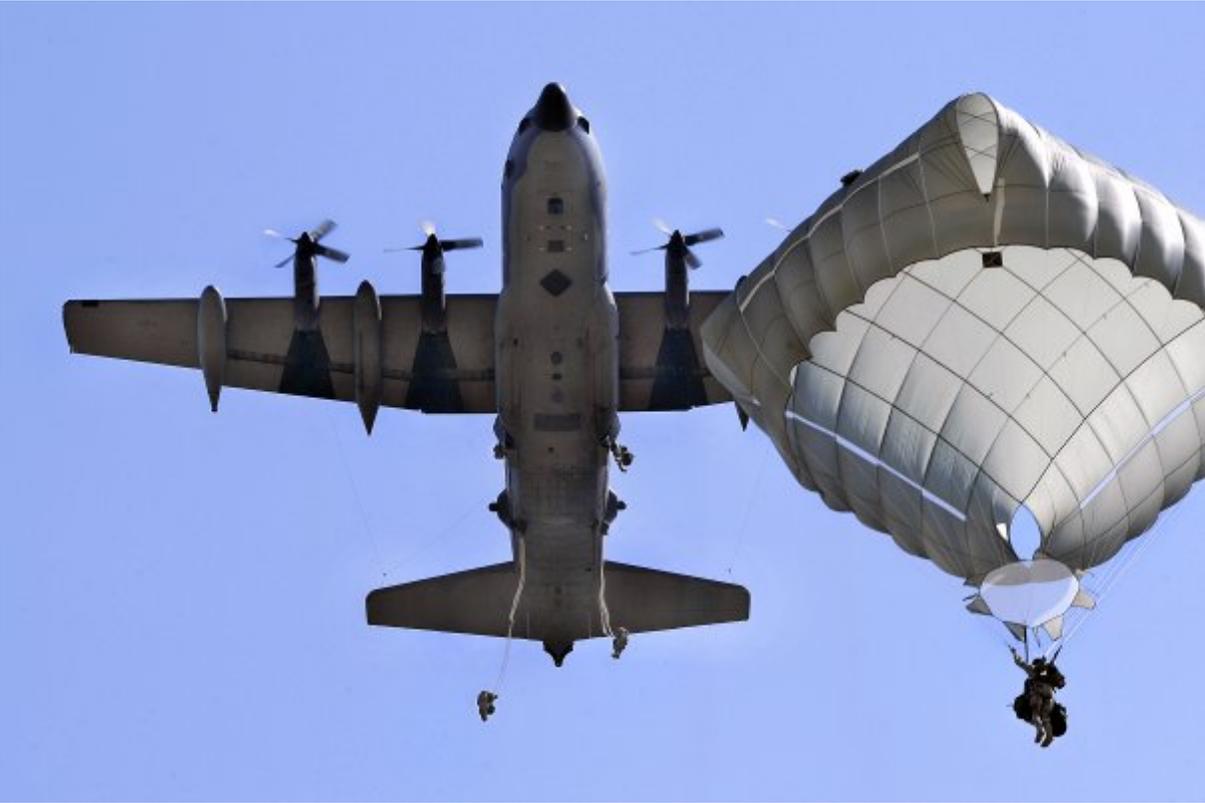
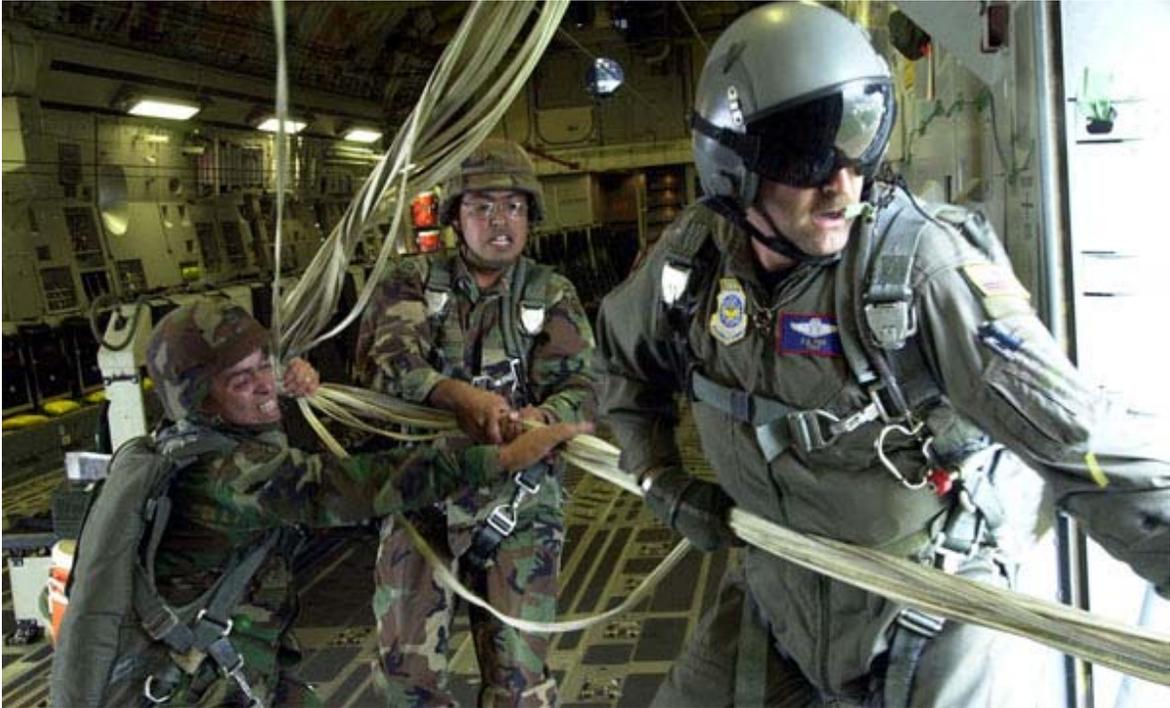
SL1_20091104_22STS_MC6_Broken_Control_Lines_C130

Description of Suspected Malfunction or Incident and Damaged Incurred: Broken Cascade Control line on right side of canopy. The right side cascade control line broke in 2 places 28" from girth hitch. The control lines have been set to 282" under 5 lbs of tension IAW TM 10-1670-327-23&P WP 0007-14.

Suspected Cause of Malfunction or Incident: Cascade control lines are not designed to support jumper weight and equipment.

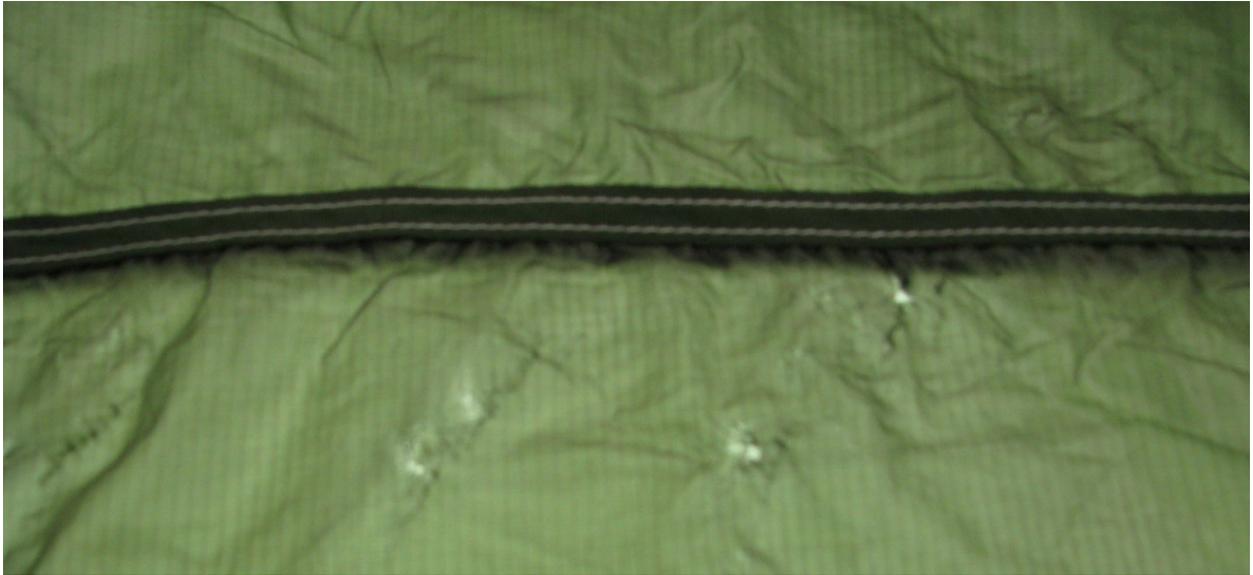
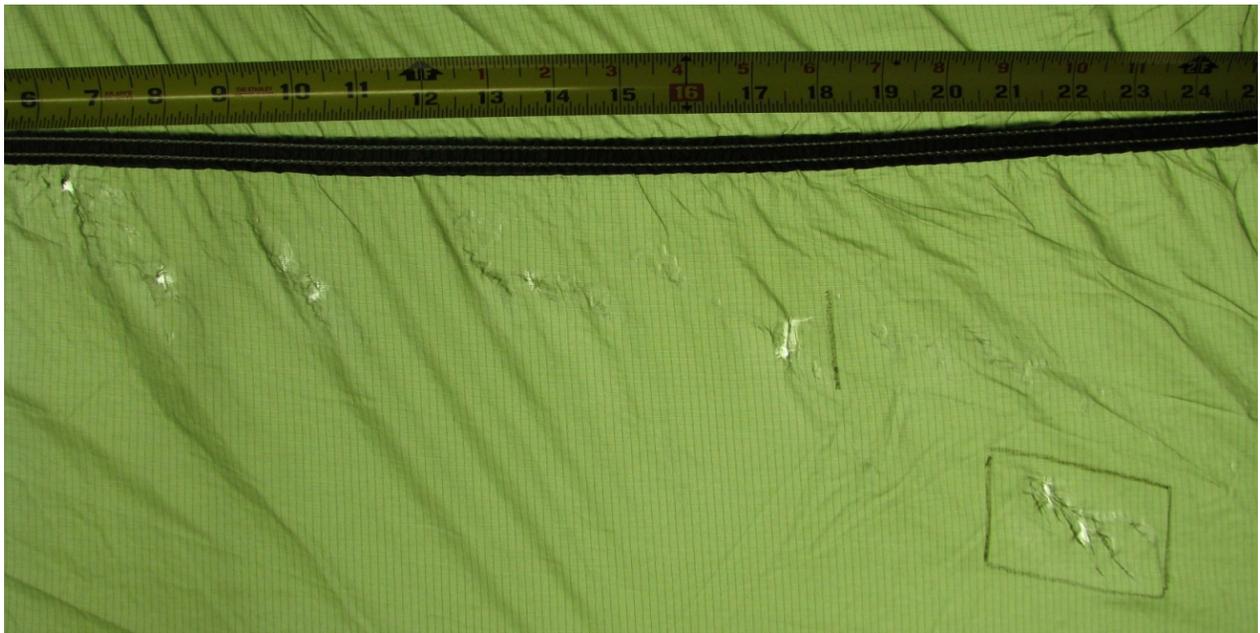
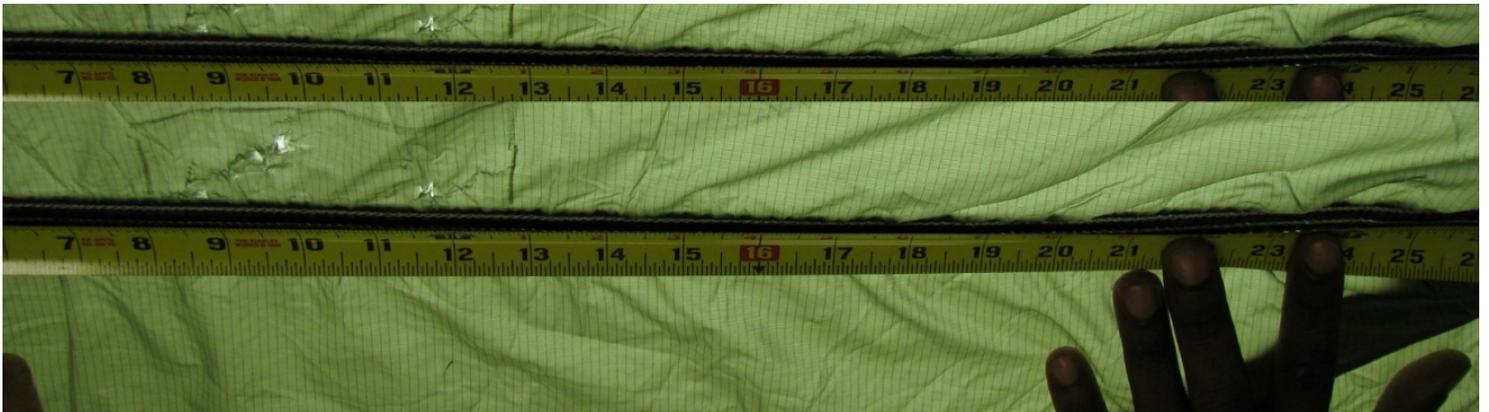
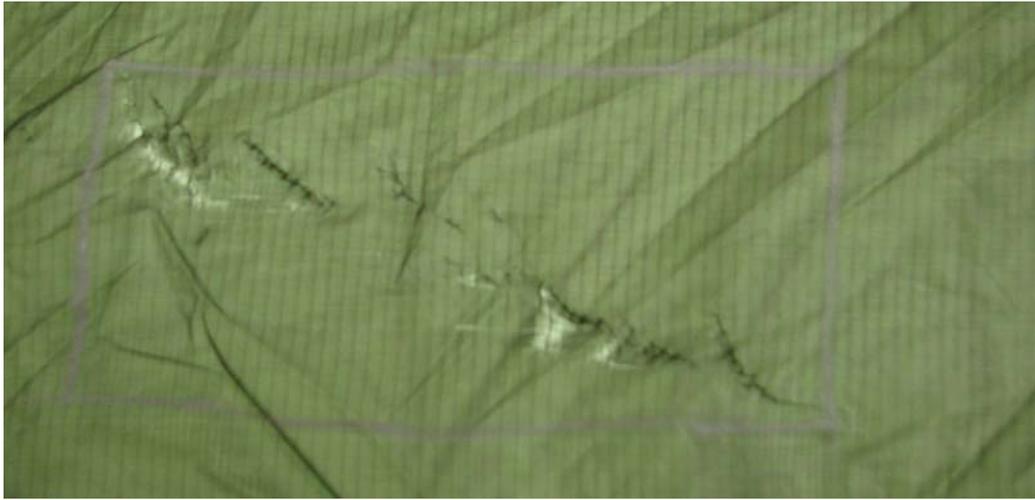
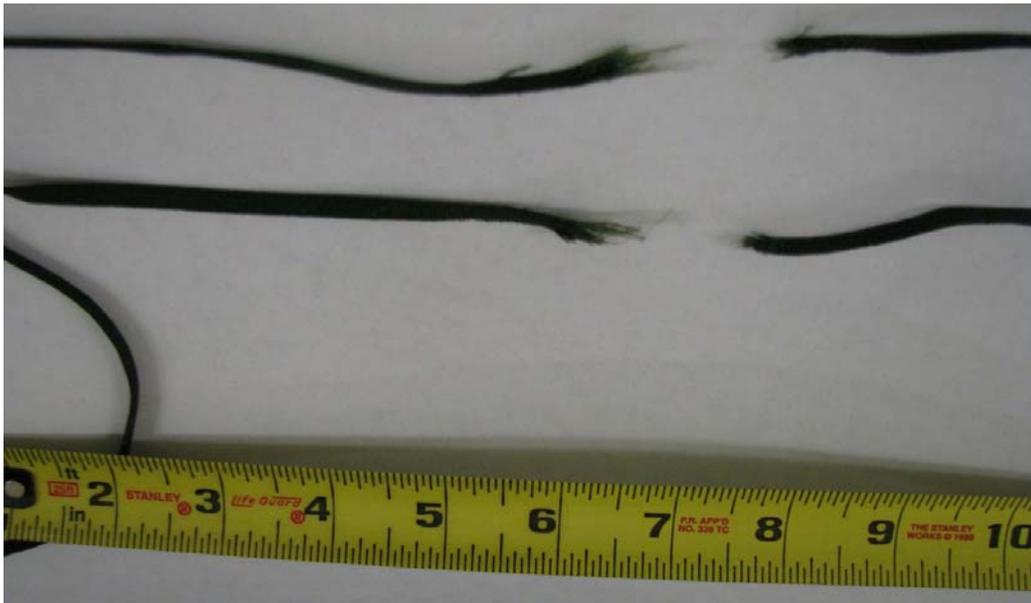
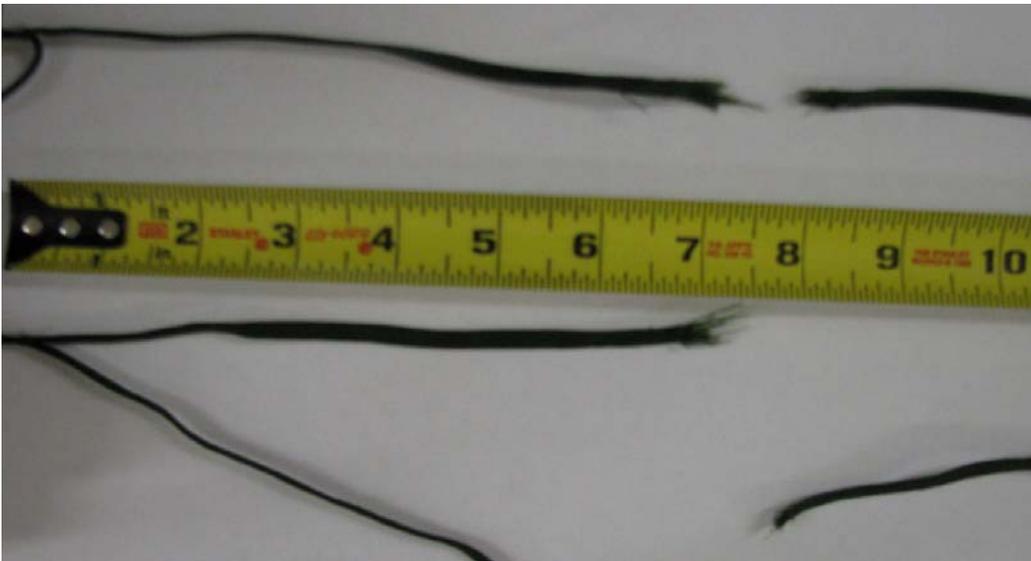
Description of Suspected Malfunction or Incident and Damaged Incurred: On February 3, 2010, at 1300 a malfunction of the left canopy control line occurred. SM stated that the control line snapped upon opening shock. SM used rear risers to control canopy safely to the ground. No injury to jumper occurred.

Suspected Cause of Malfunction or Incident: Upon technical rigger inspection of the SF-10A some damage was found on the parachute system canopy. The damage appears to have been the result of the snapping middle control line. The break occurred 7 inches below the cascade line. The damage to canopy is in Gore 1 and 3. All damage is in a linear pattern above the area where the middle control line snapped. Measurement of the control line was measured at 282 inches with 5lb weighted scale. Light burns were found on the middle control line broken edges. It does not appear that the control line was cut or manipulated. Possible cause is excessive twists in the suspension lines prohibiting free movement of control line during opening sequence or improper pack procedures when stowing excess control line in air channel.

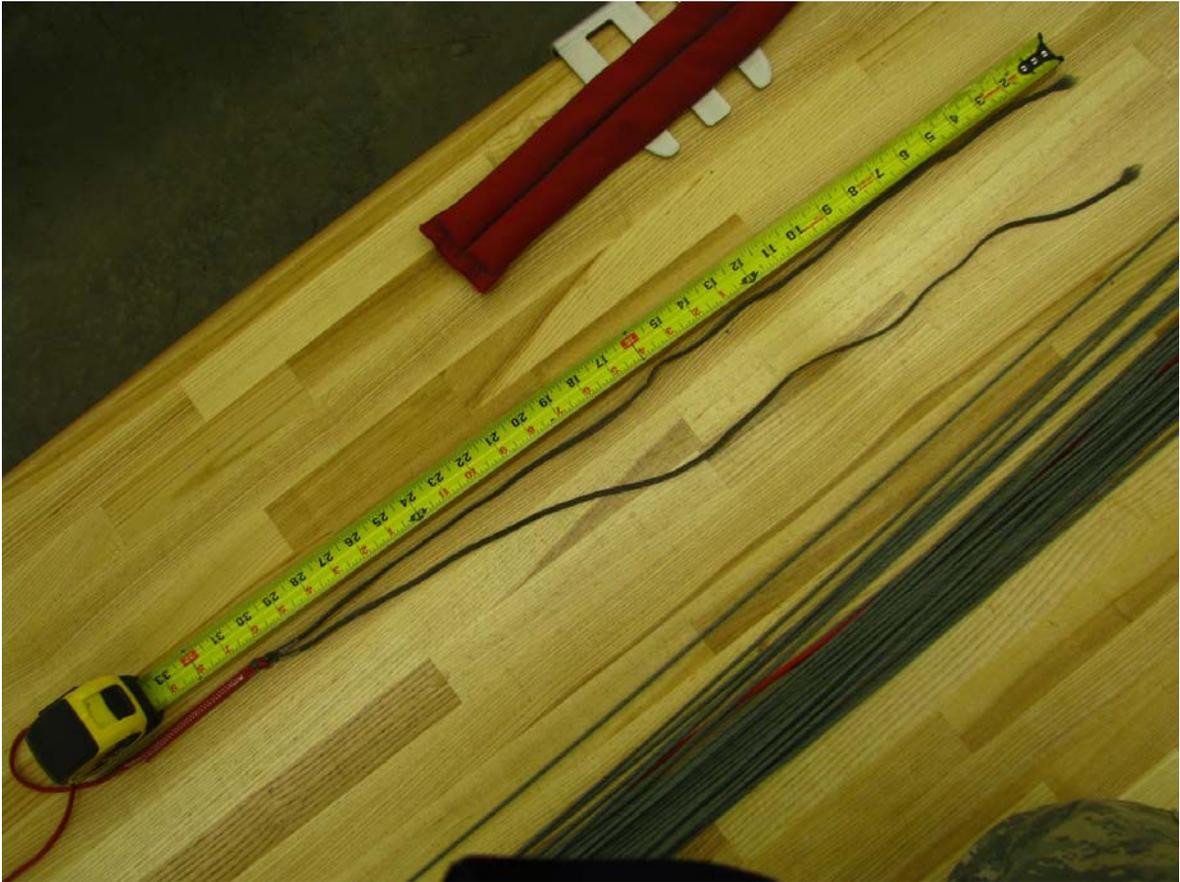
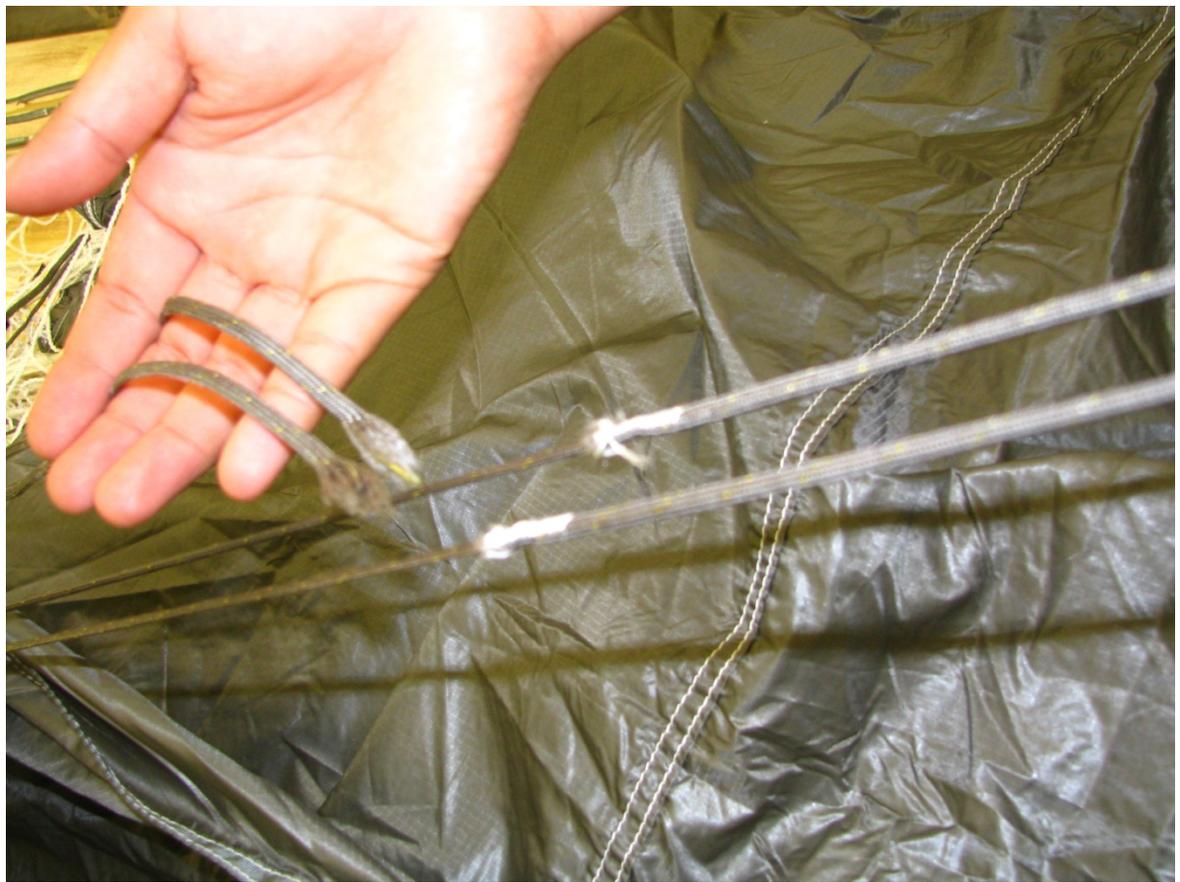
Description of Suspected Malfunction or Incident and Damaged Incurred: Left upper control line broken at the bar tacking. Girth hitch at control line connection point (upper and lower) extremely tight from tension. Possible broken filler cords in control line near toggle. No damage of the canopy or remaining lines was found.

Suspected Cause of Malfunction or Incident: Jumper stated that he had twists in his risers which could have restricted the control line's free range of movement. This resulted in high tension during opening sequence that broke the upper control line at it's weakest point due to control line excess being below the twists. Broken control line measured at 282.5 inches under 5 lbs. Right control line measured at 282 inches. Photos will be sent to attach to report.
