134nd TRIANNUAL AIRDROP REVIEW and MALFUNCTION SAFETY ANALYSIS

Oct 19-21, 2010

MALFUNCTIONS / INCIDENTS REPORTED

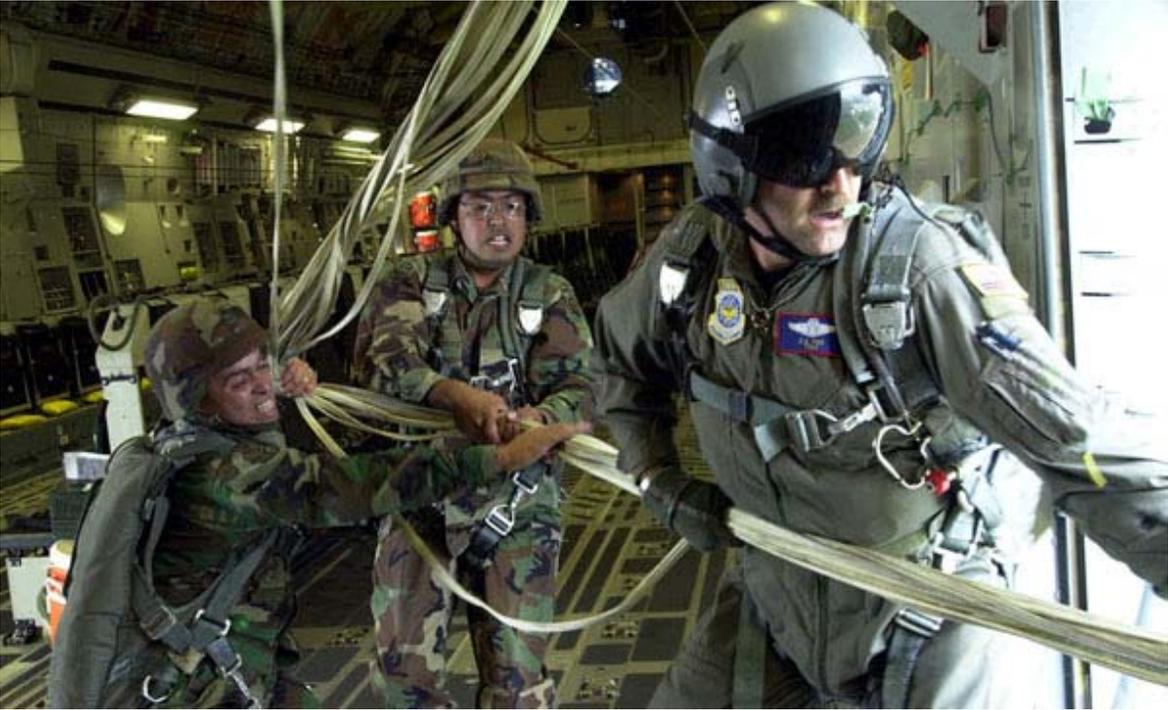
SL1_20100427_1/507_PIR_T11_Twists_C130

Description of Suspected Malfunction or Incident & Damaged Incurred: Very slow opening, deployment sleeve falls through corner vent. The sleeve seems to be caught on the hem of the canopy. Jumper reports reaching six thousand count, but after review was more than likely around the 10 - 11 thousand count.

Suspected Cause of Malfunction or Incident: Jumper had excessive twist which retarded the deployment sequence. Because of the slowing opening, the sleeve and bridle assembly was not able to perform properly. The corner vents were exposed for a prolonged period giving the opportunity for the bridle/sleeve assembly to fall between a corner vent. Once the canopy began to inflate the bridle/sleeve assembly was routed through the vent catching on the hem of the canopy once inflated.

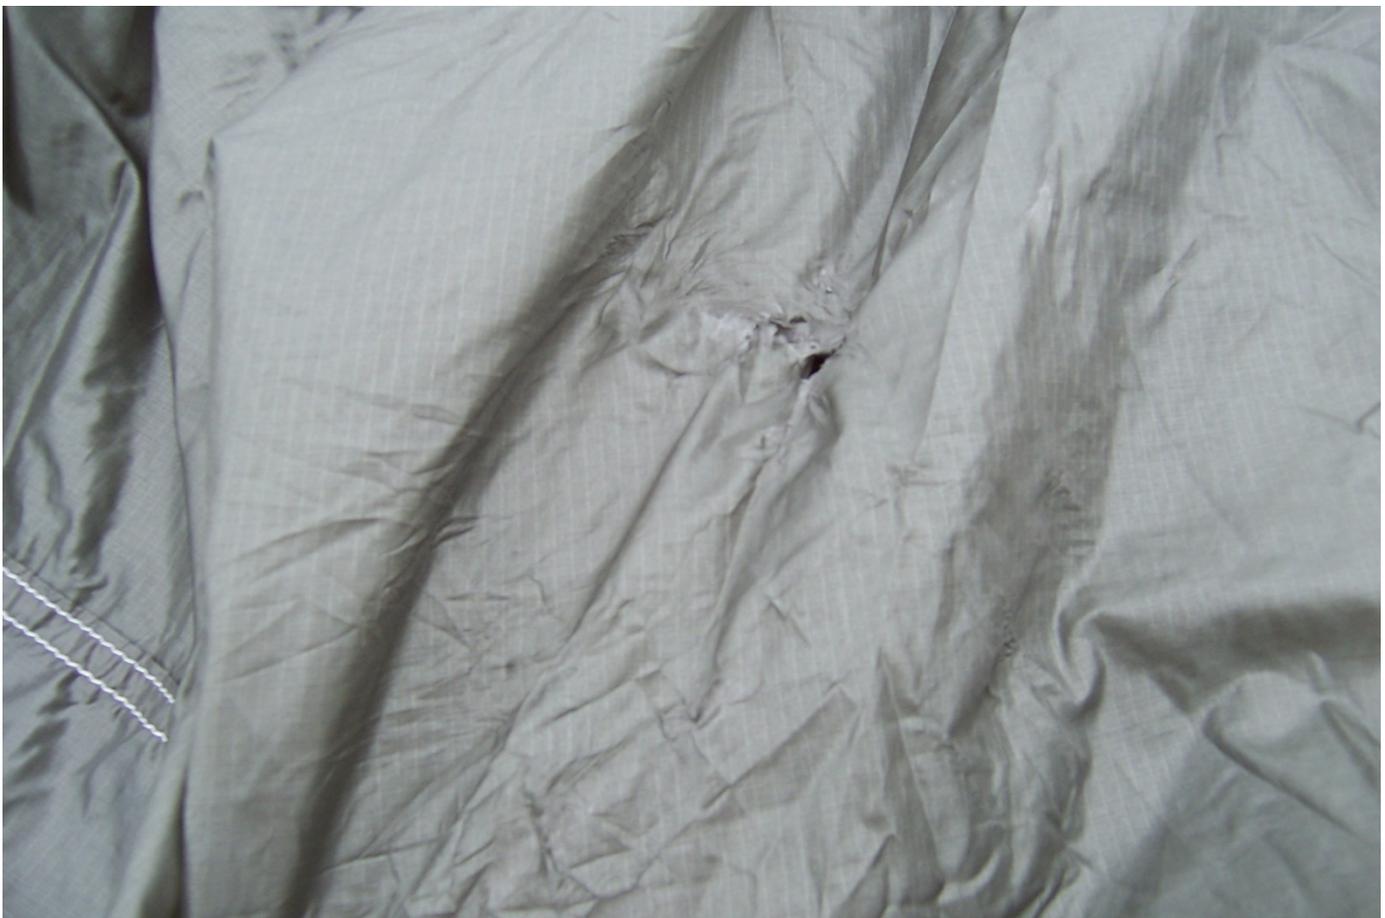
SL3_20100426_1/507_PIR_T11_Bent_#4_Connector_Link_C130

Description of Suspected Malfunction or Incident & Damaged Incurred: Bent #4 link. During deployment the N-4 link used to secure the drogue and sleeve by way of the bridle line, bent while possibly oriented in a horizontal position. The barrel nut used to secure the link in a closed position was forced opened which allowed the looped end of the bridle to come off the N-4 link freeing the sleeve assembly.

Improper link position orientation during packing (barrel nut closing direction)

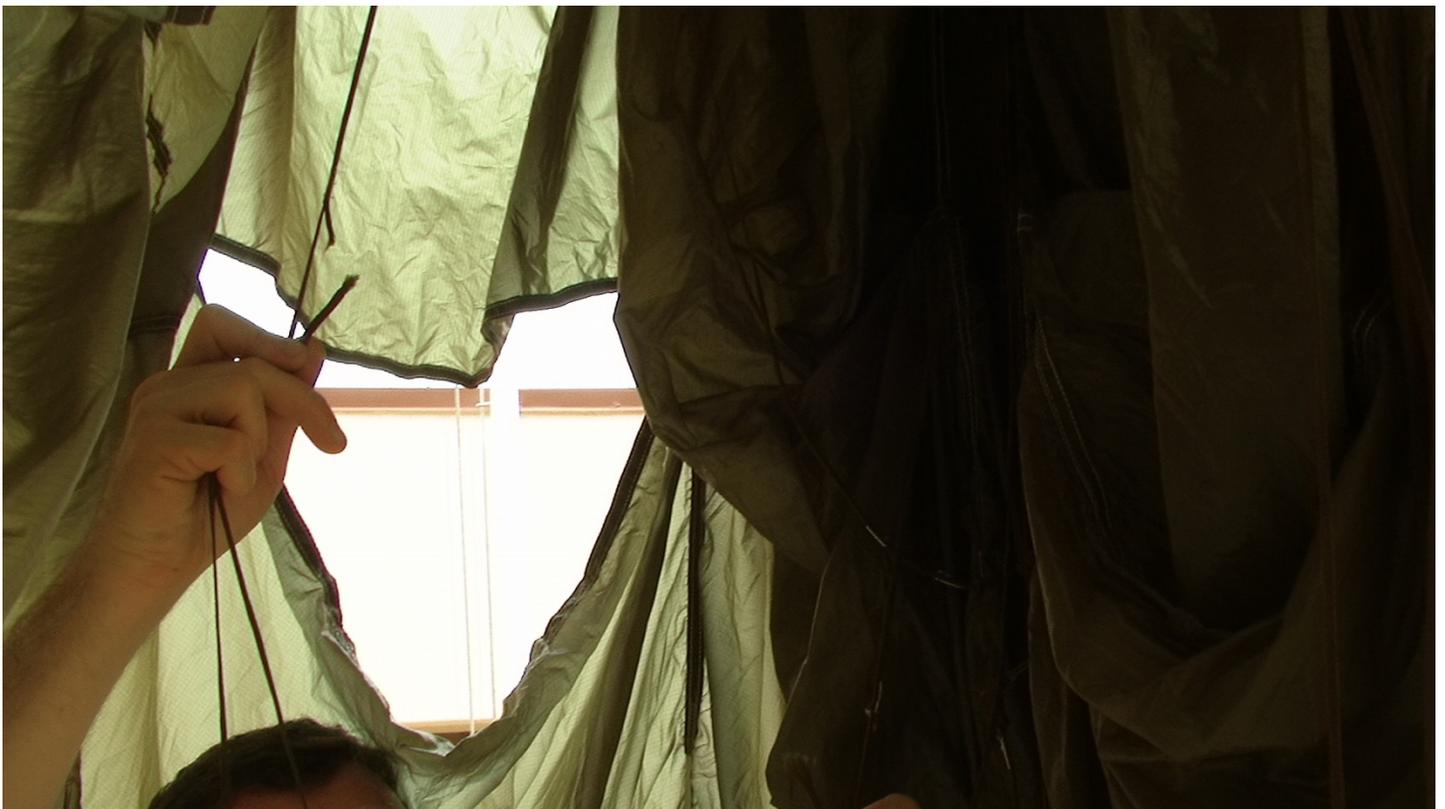
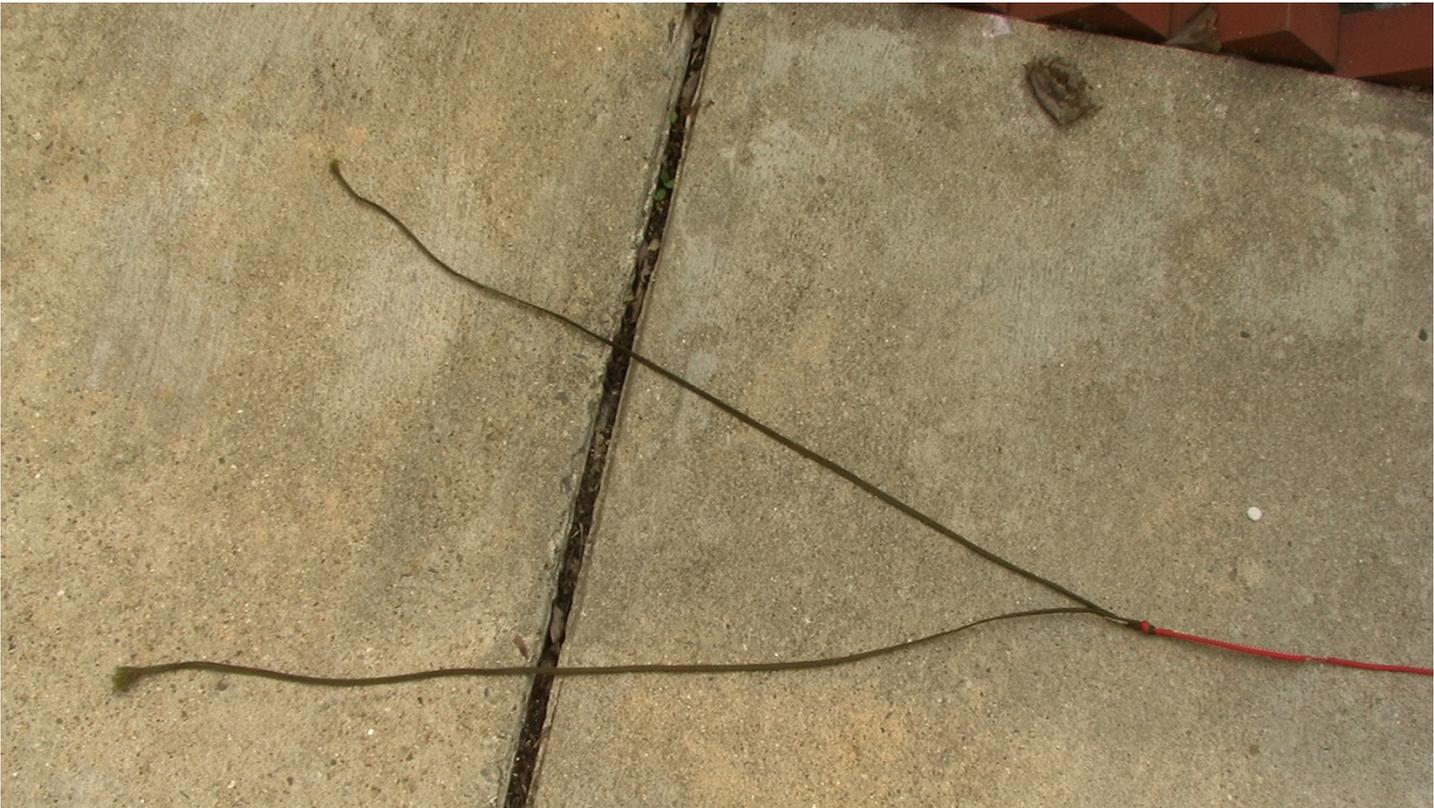
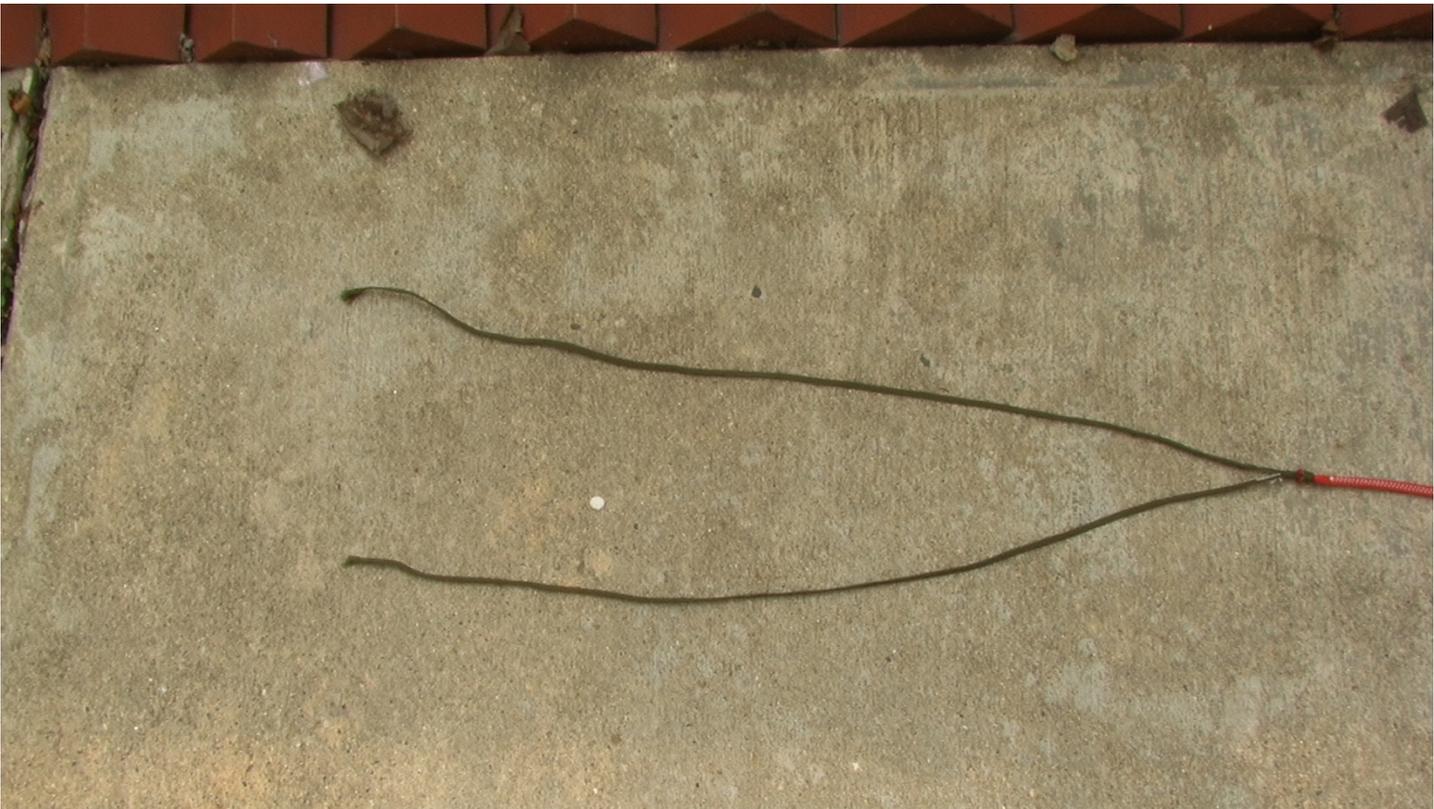
SL7_ 20100618_22STS_MC6_Broken_Control_Line_C130

Description of Suspected Malfunction or Incident & Damaged Incurred: Jumper noticed after opening shock his suspension lines where tangled together. Jumper immediately tried to bicycle kick to free entanglement. After a about six seconds passed jumper was able to free entangled suspension lines, he then noticed his right control line was broken towards the canopy. Jumper compared his rate of descent with his fellow jumpers and determined he would land the main canopy. He controlled his canopy using rear riser slips.

Suspected Cause of Malfunction or Incident: I feel there needs to be some type of change to the current control line system to prevent further control line issues. Jumper did everything he was trained to do.

Attached are pictures to go with the 1748-2 of the broken suspension line on the MC-6. This was the first jump since we completed the retraining on this system. This parachute was rigged while Mr. xxxxxxxx and his team of instructors were here at McChord.

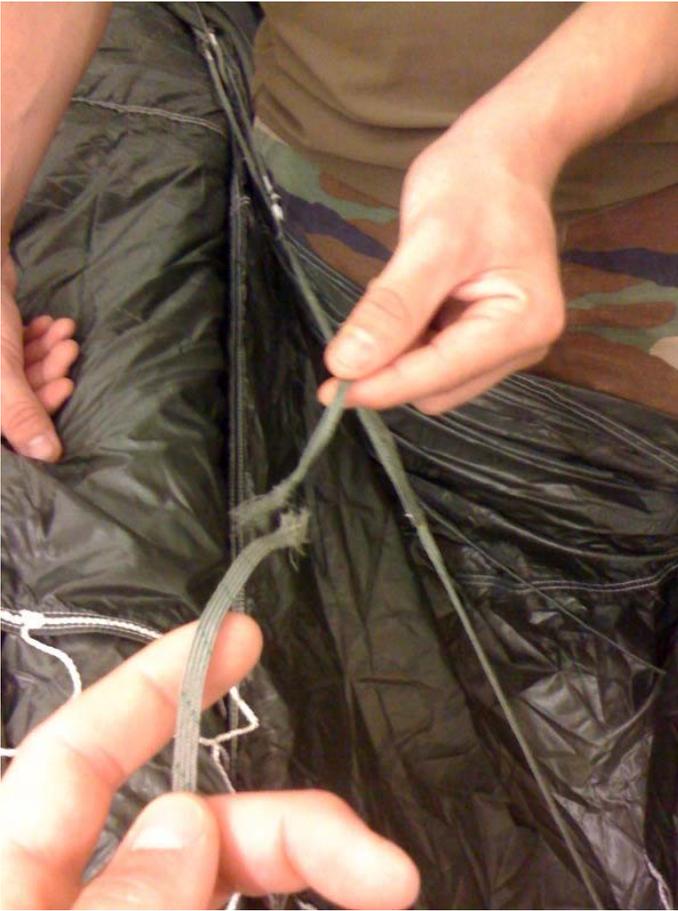
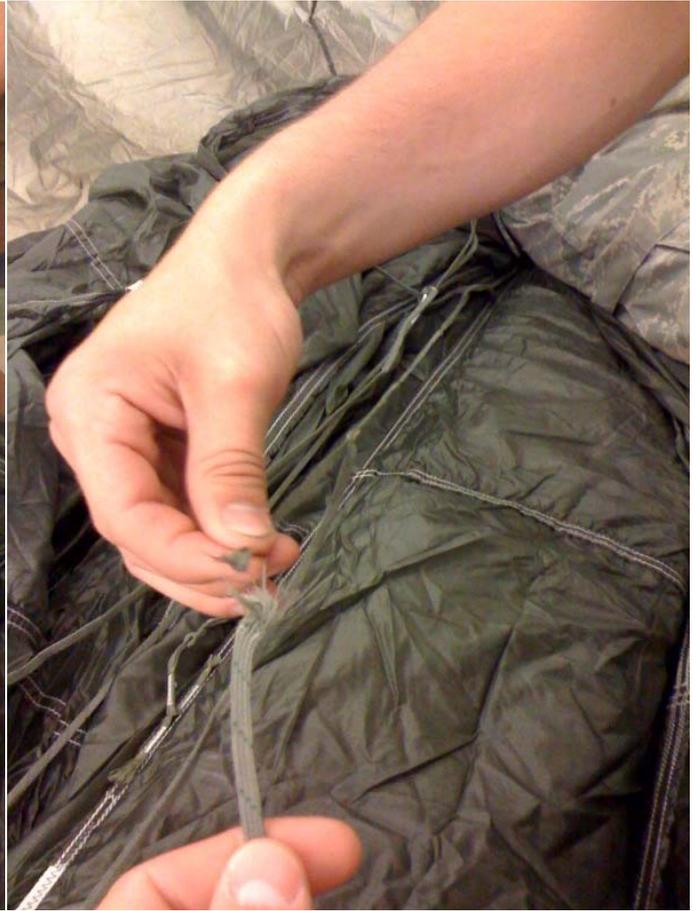
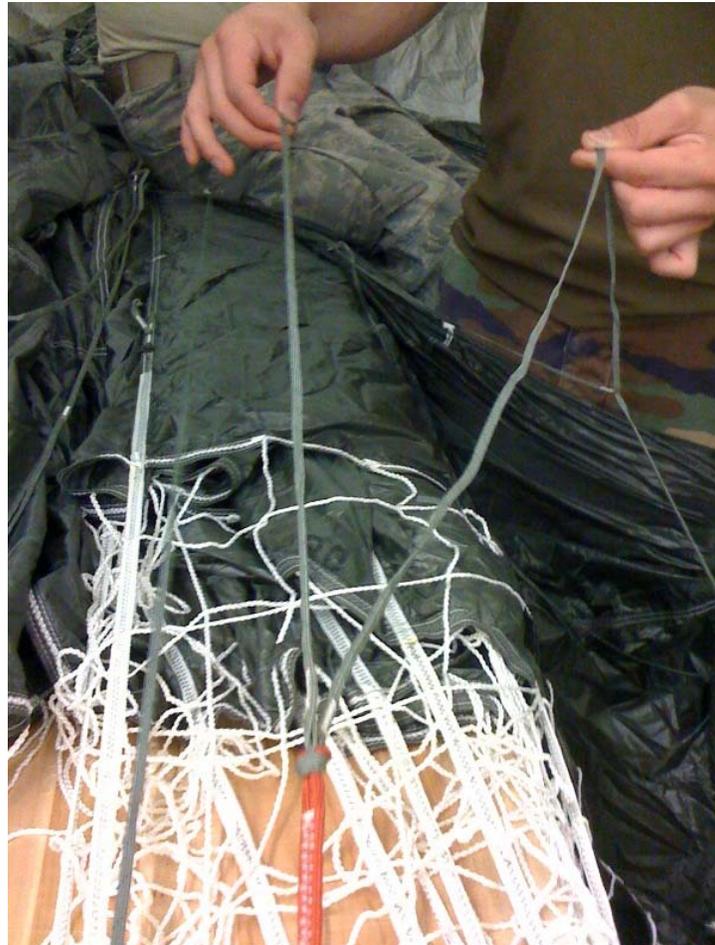
SL8_20100621_1/507PIR_T11R_Premature_Activation

Description of Suspected Malfunction or Incident & Damaged Incurred: It is suspected that the jumper exited the aircraft of his first jump in the Basic Airborne Course and prematurely activated his T-11R parachute.

Suspected Cause of Malfunction or Incident: On jump one, T-11; the jumper was third in the stick to exit. The aircraft was a C-130 flying at approximately 130 kts at 1250 ft AGL. The statements gathered state that nothing was observed to be wrong during "Actions in the Aircraft". When the jumper exited the aircraft it is proposed that he prematurely activated his T-11R parachute. The statement given by one of the coaches on Fryar DZ was the jumper was under canopy before the jumpers before and after him was fully under canopy of their main, T-11. The jumper stated that he got to a five thousand count and noticed that he was under his reserve parachute. After inspection of the both the main and reserve the results were as follows. The T-11 deployment sleeve was approximately 37 inches above the lower lateral band, rigger view. The majority of canopy remained in the deployment sleeve in a long fold configuration. All four of the T-11R load bearing (green) vent bridle loops were torn away from the apex. The apex tie was missing from the non load bearing (white) vent bridle loops. None of the white loops were damaged, and none of the skirt assist ties were broken. This suggests that the reserve was utilized during a high speed deployment. The extractor parachute was not recovered.

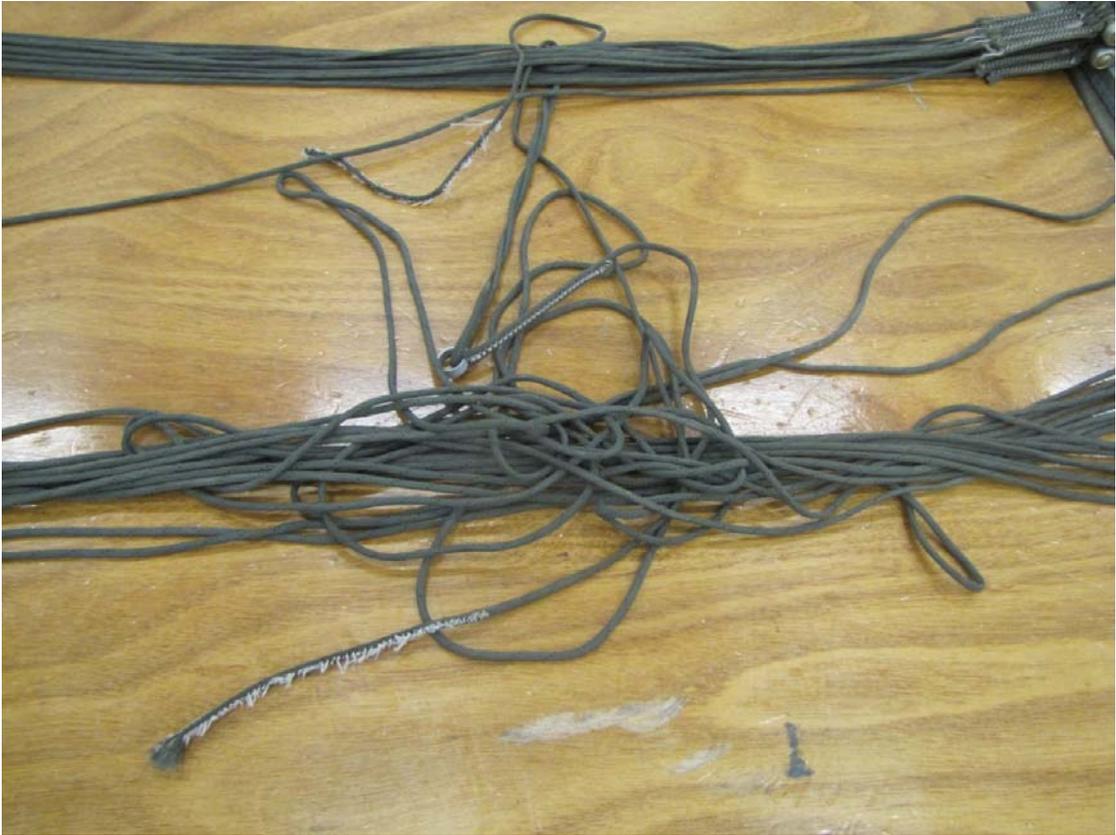
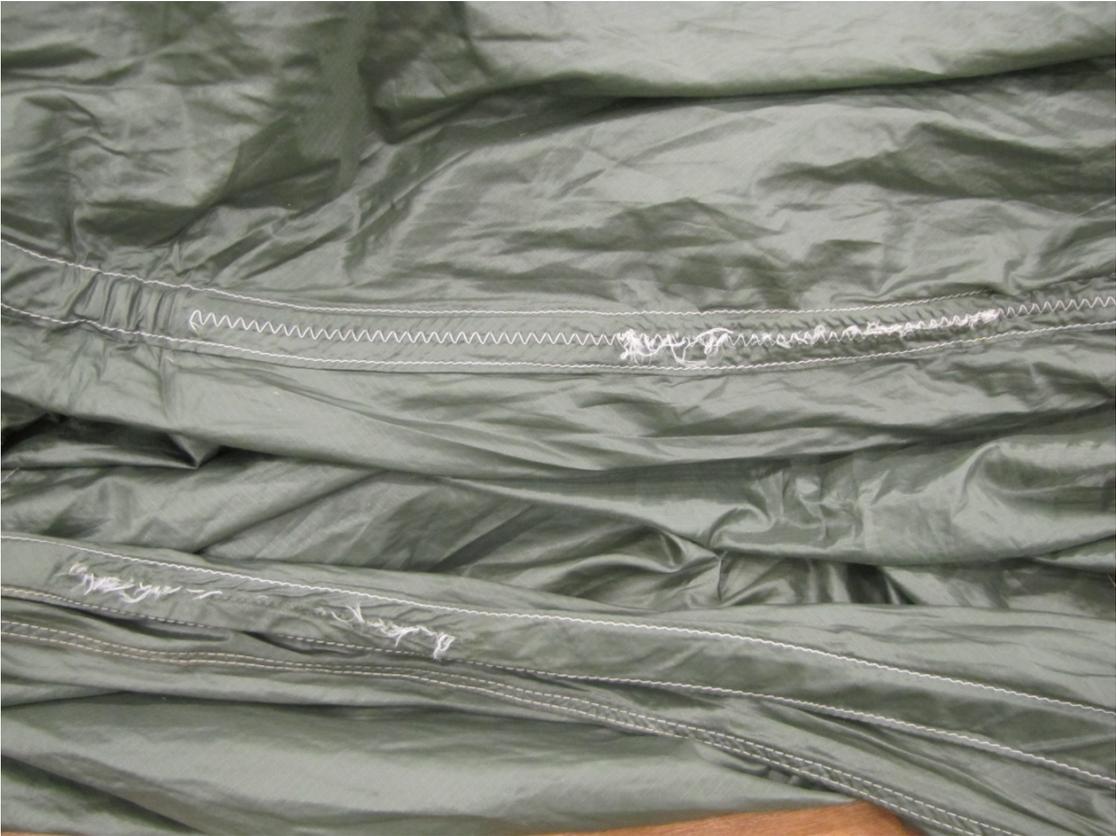
SL10_20100604_19SFA_MC6_Broke_Control_Line_C130

Description of Suspected Malfunction or Incident & Damaged Incurred: Broken Type IIA at the middle control line, approximately 23" up from the girth hitch of the lower control line left side of the canopy.

Suspected Cause of Malfunction or Incident: Aircraft speed in excess of 130 Knots

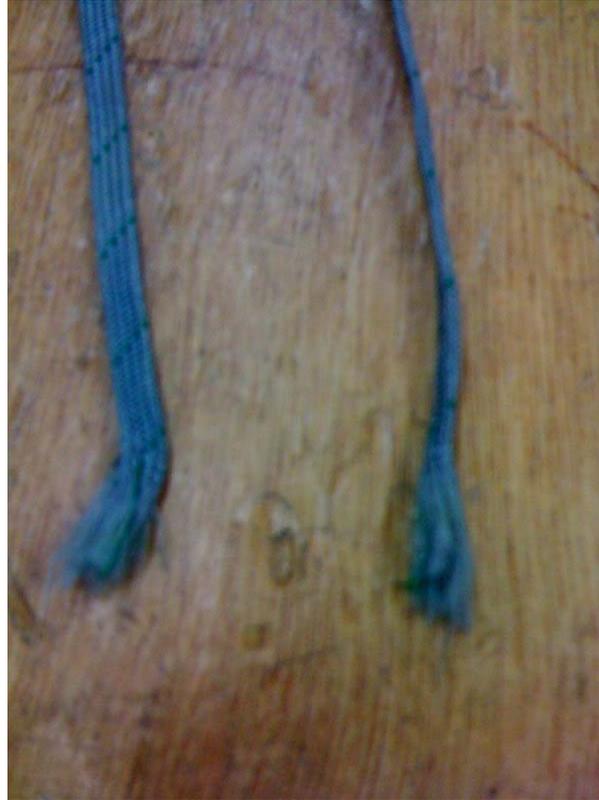
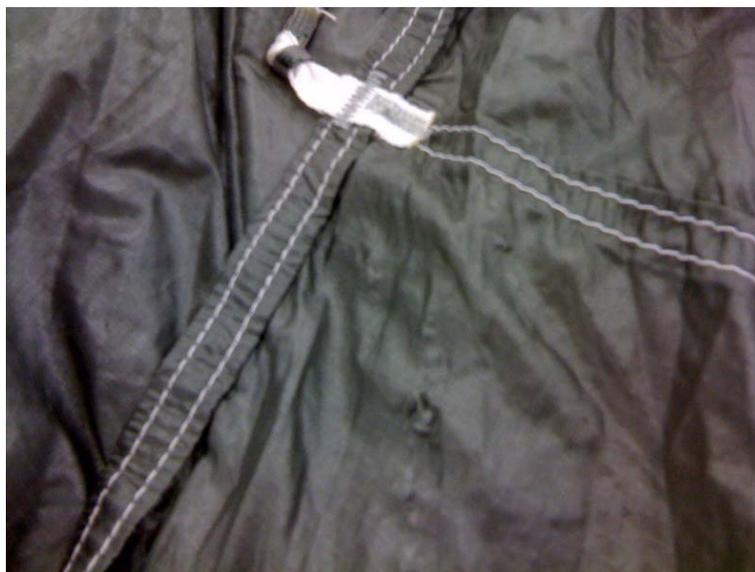
SL16_20100818_10SFG_Broken_Control_Line_C130

Description of Suspected Malfunction or Incident & Damaged Incurred: Left middle control line broke 28 inches from guide ring and the adjacent line broke 31 inches from the guide ring. Two burn holes located on gore 4 section 2.

Suspected Cause of Malfunction or Incident: Interviewing several jumpers on the DZ, it is suspected that the reported air speed of 130 knots was incorrect. The speed of the A/C and the possible material contact with the control line causing burns and weakening of the control line, is the suspected cause for this malfunction. The Soldier that packed this parachutes has since been retrained on the proper execution of rigger check number 2. The IP has also been retrained on the proper execution of properly inspecting rigger check number 2.

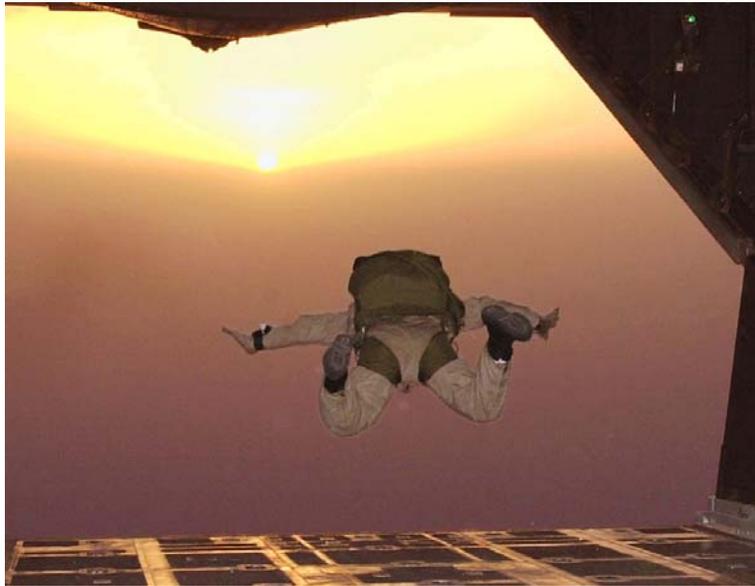
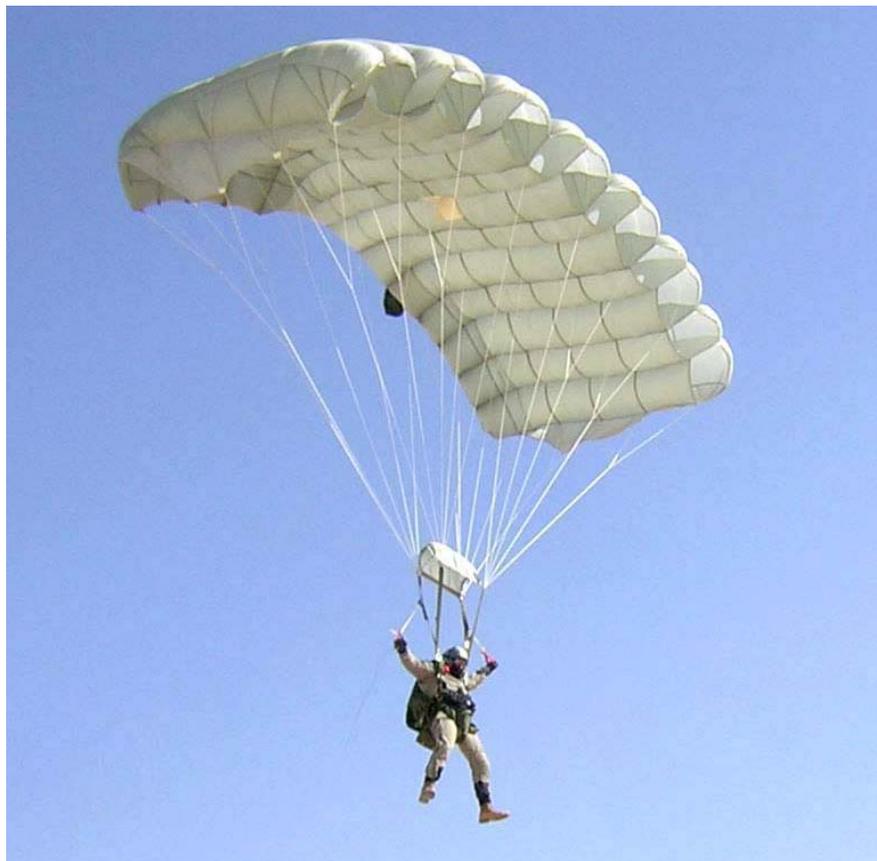
FF1_20100428_5SFG_MC-4_Twists_C7

Description of Suspected Malfunction or Incident & Damaged Incurred: Jumper had a normal dive exit and free fall. At 4000ft AGL jumper pulled his main ripcord and had a main canopy. Time was 0215. As he gained canopy control he had to bicycle to remove the twists. As it all untwisted out he noticed an uncontrollable right hand turn. Jumper claimed the canopy was uncontrollable and partially collapsed on the right side. He performed cut-away procedures and landed safely on the drop zone.

Suspected Cause of Malfunction or Incident: After the jumper landed on the ground we looked for several hours for the main canopy but could not find it. Two days later a civilian free faller found it and returned it to us. We performed a TRI on the canopy and found nothing wrong at all. The only thing that was noticed was the breaks were still stowed. After an extensive TRI and questioning of the jumper it is believed the jumper had a less than stable opening which caused his twists. Once the twists were removed the right side of the canopy had not fully developed and before the jumper performed proper emergencies procedures he then cut it away. Jumper did not do proper EP's by pulling or pumping the breaks to allow the canopy to fully inflate.

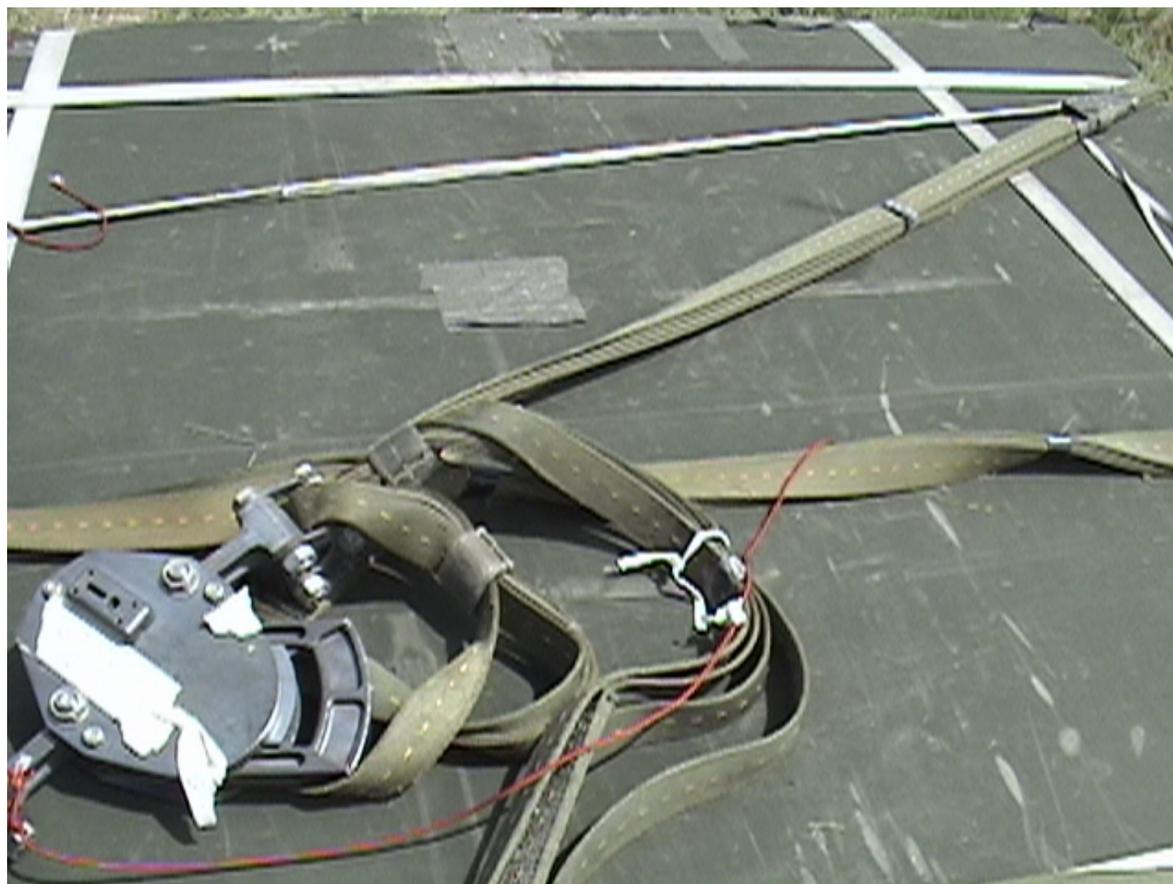
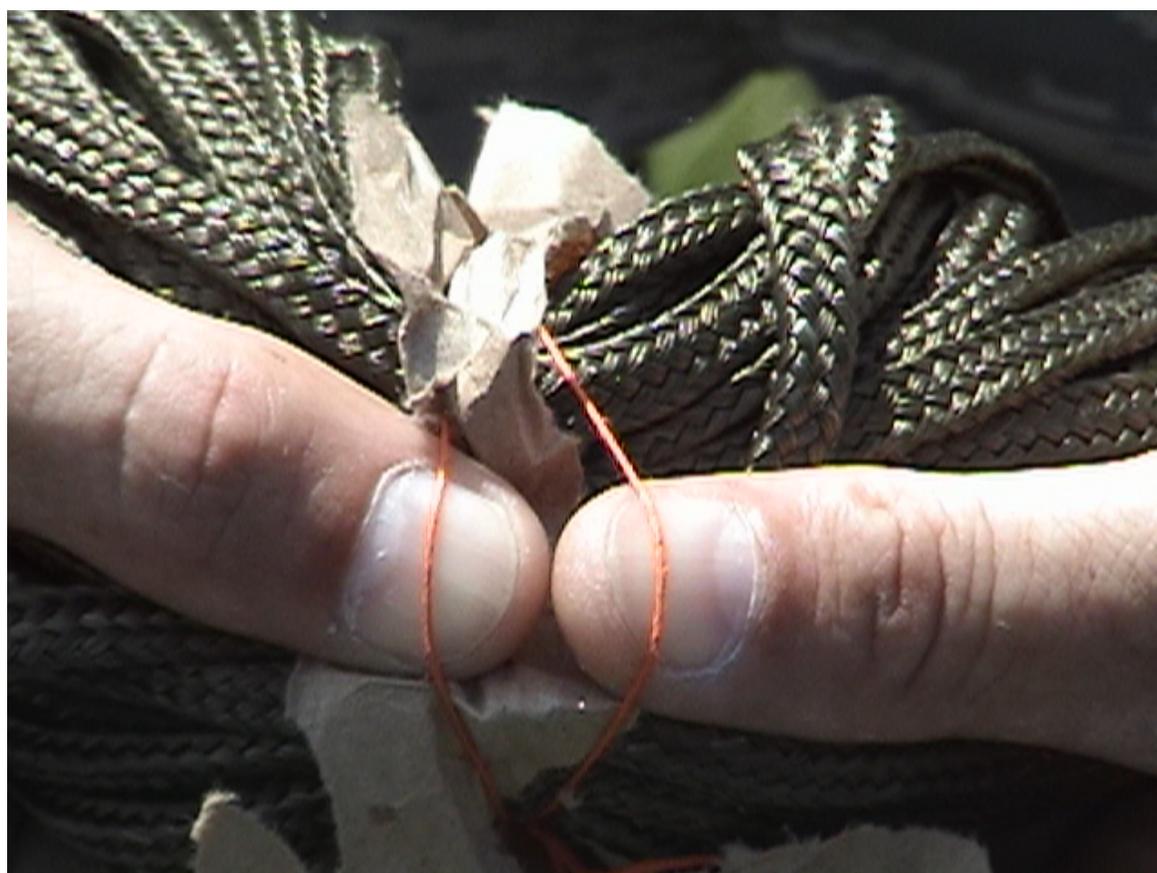
HE4_20100616_43AW_M1_Failure_C130

then removed from the parachute release connectors. At this time, the timer block fell allowing the upper suspension link to extend and release the parachute release connectors. Upon returning from Blackstone DZ, the M-1 release timer was inspected and conducted three delay release timer tests with an average time of 12.3 seconds

Suspected Cause of Malfunction or Incident: M-1 release did not properly release. Rigger inspected and timer had an average of 12.3 seconds. Suspected cause is fault on M-1 release. The M-1 release did not reach the critical angle.

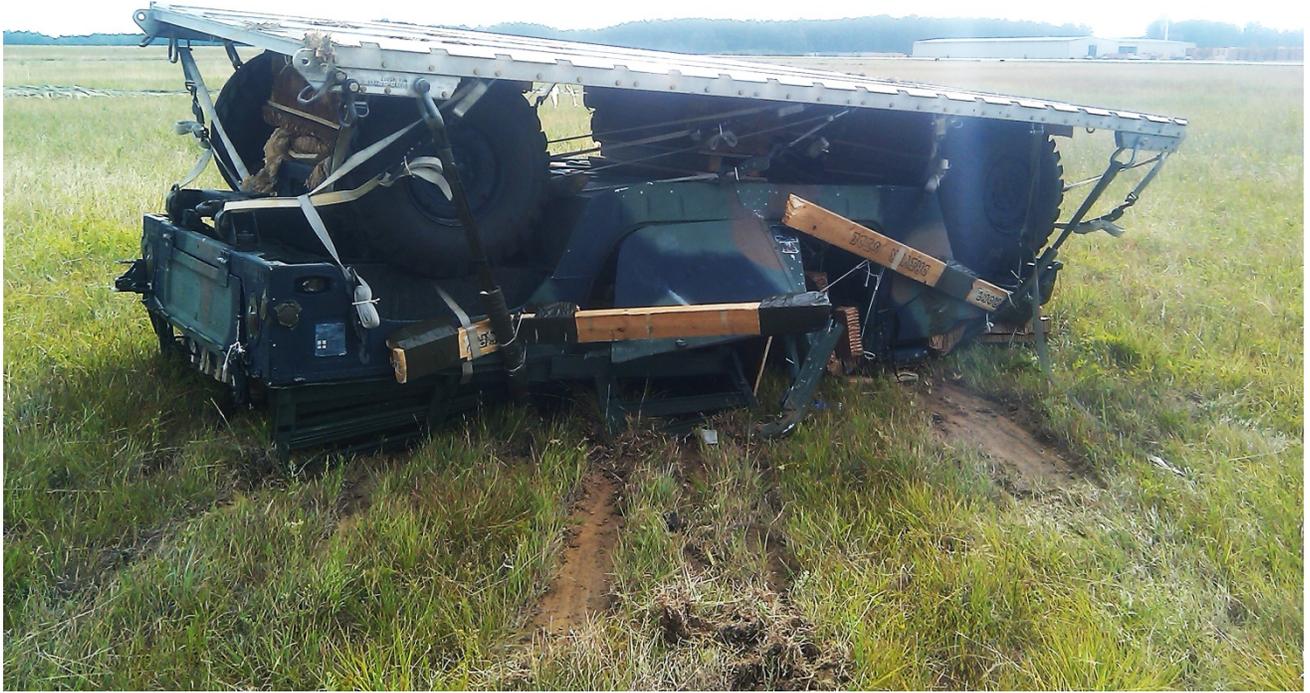
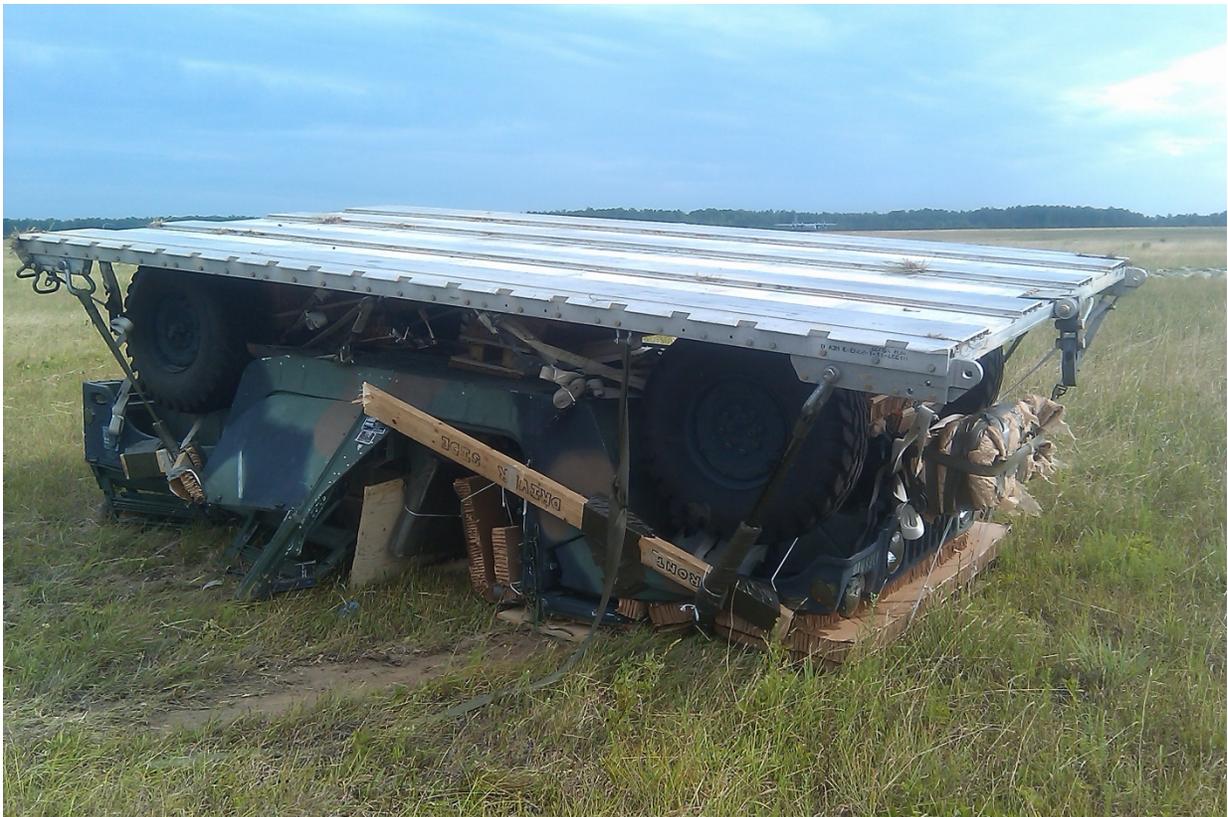
HE6_20100715_3170SS_15_Extract_Chute_Fail_C130

Description of Suspected Malfunction or Incident & Damaged Incurred: Upon green light, Loadmaster observed 15 foot extraction chute deploy and initially begin to open when it collapsed into itself and cigar rolled. This process took less than one second. Loadmasters initiated malfunction procedures and cut extraction chute away.

Suspected Cause of Malfunction or Incident: Panel 1 thru 4 blew out during initial employment causing the rest of the chute to deteriorate. Then lines 12 thru 16 snapped causing a cigar roll. This was due to deterioration of chute material around seams holding panels together. Other possible contributing factor was lock number 9 was set slightly past 2.5 and maintenance did a lock test and came up with 2870lbs pressure, which is greater than threshold of +/- 10 %. The type 5 platform was not found to be bound inside the aircraft most likely not the ultimate cause of chute failure.

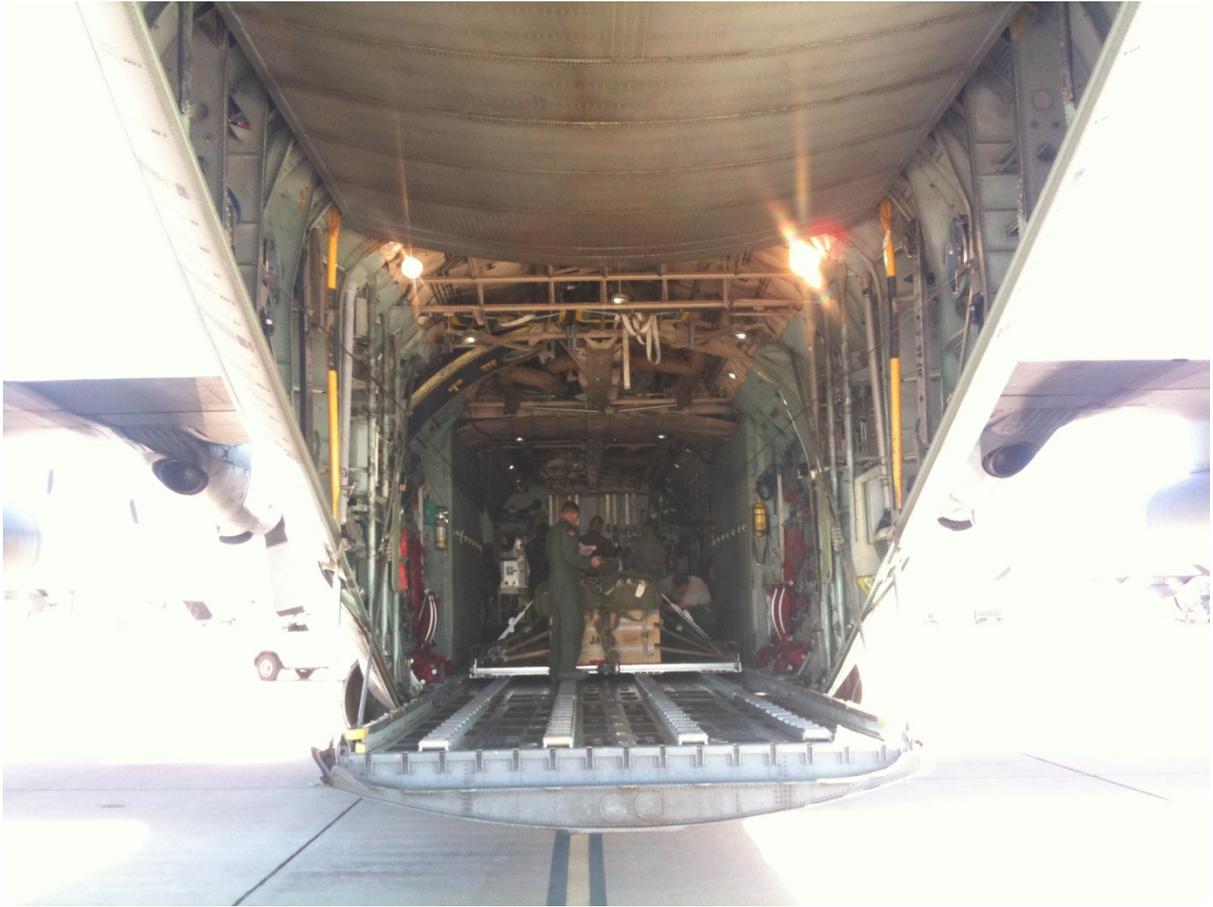
HE7_20100911_133LRS_G12_Extraction_By_Mains_C130

Description of Suspected Malfunction or Incident & Damaged Incurred: ., The Malfunction occurred during a heavy equipment airdrop, dropping a 3625lb 8ft platform utilizing one 15ft extraction parachute and two G 12E parachutes. After the extraction parachute released from the bomb rack, it opened and extracted the 60ft extraction line connected to the 3 point link assembly on the EFTC. At the time the extraction line became fully extended and the full extraction force was being applied to the latch and link assembly the latch and link assembly failed and the 3-point link released from the latch causing the extraction parachute to pull the two G12E cargo parachutes from the airdrop platform the two and both parachutes deployed/opened fully beyond the rear of the tail of the aircraft. Once both G12E cargo parachutes fully deployed, right hand lock (#10) was overcome and the airdrop platform extracted from the aircraft. Due to the majority of the extraction force pulling the FWD suspension slings during the extraction of the platform, the platform began to immediately rotate upward as it cleared the vertical restraint lip (ending at FS677) provided by the dual rail system, The platform rotated a full 90 degrees up by the time it cleared the ramp and door. The AFT edge of the platform struck (skipped) off the last 30 inches of ramp rollers causing damage to all 4 rows of ramp rollers as it exited the aircraft. The platform fell to the ground under both cargo parachutes and without incident. No major damage visible on the airdrop platform (to include the AFT edge of the platform which struck the ramp rollers). On the ground the actuator arm was found to be bent outward one inch from its normal position, and the cause of this is unknown but suspected to have happened as the airdrop platform landed on the ground. The 12ft release cable is still intact and connected to the actuator and latch assembly. At this time the link assembly and latch assembly work as advertised during initial rigging of connecting the link assembly to the latch assembly. At this time the platform and all items associated with the airdrop are secured awaiting further testing/direction from HHQ. NOTE: Airdrop Platform dimensions: HT: 44" W: 108" L 96" NOTE: The cargo parachute that was repacked on 24Aug09, was inspected on 25Feb10. Latch Markings: 11-1-1725 MRF 57282 87 Link Marking 1: 11-1-17154090 or 3434

Suspected Cause of Malfunction or Incident: Faulty Latch/Link Assembly on EFTC
