1748-2 Static-Line Report

ID: -175312218

FROM: 67 SOS Unit 8825 Box 260 APO AE 09459

TYPE OF REPORT: Incident

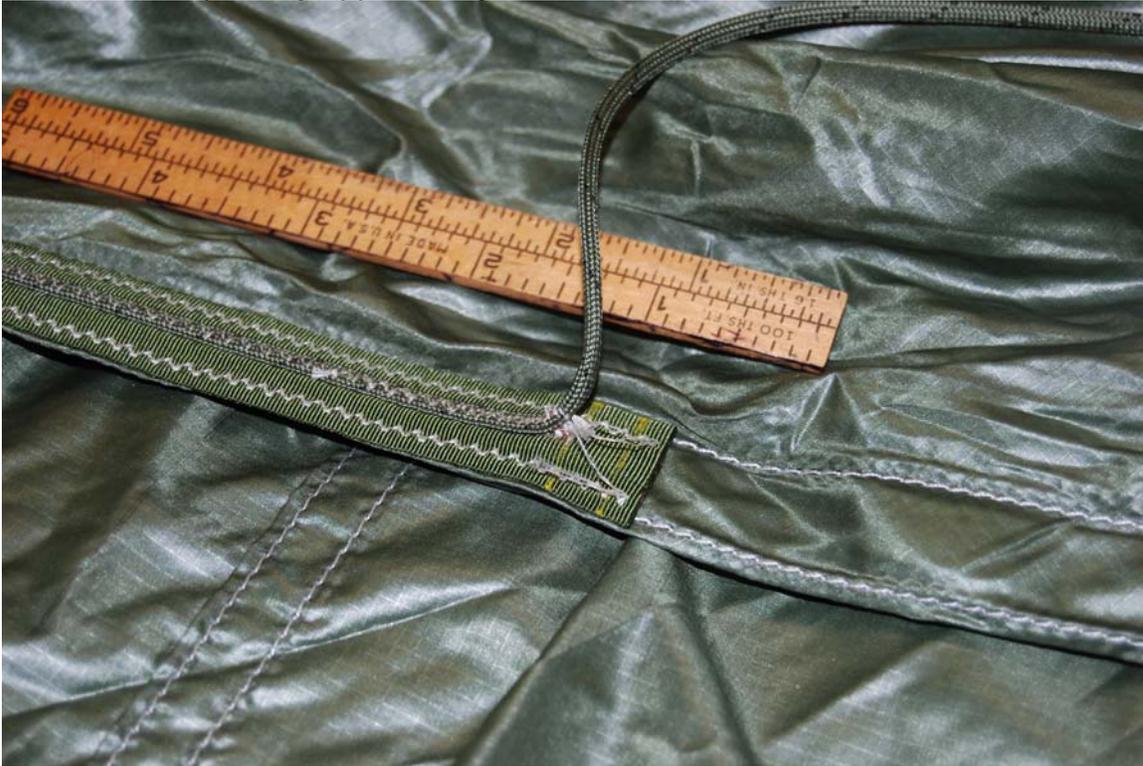
DESCRIPTION OF SUSPECTED MALFUNCTION OR INCIDENT: Jumper could not "find" toggle and although recognizing that his canopy was fully inflated noticed some "loose" suspension line "flying around" and decided to deploy SLCP MIRPS. Upon reporting to MFNCO of the incident the MFNCO found the Riser Assemblies and found a toggle on each riser and apparently thought no more of it. Main Canopy in question however was segregated along with deployed Reserve. Upon finding out about the Reserve deployment, the Loft NCOIC (different Rigger NCO) then initiated the incident report. Resultant damage was a near surgical separation of one end of the Left Steering Line Bridle from its attachment on Gore #06 and no damage noted on other end of Bridle, or Steering Line. Metal Guide Ring was intact on the end of the Left Steering Line. No other suspension lines, or Right Steering Line were damaged in this incident.

SUSPECTED CAUSE OF MALFUNCTION OR INCIDENT: Not positively known but based on newness of canopy the assessment is that perhaps the steering line was "set" too tight during Placed in Service procedures and/or the canopy hadn't developed a "set" from a multitude of jumps. The Right side Steering Line and Bridle exhibited no excessive wear or indication of damage.

1 of 3 – bridle partially ripped away from radial seam

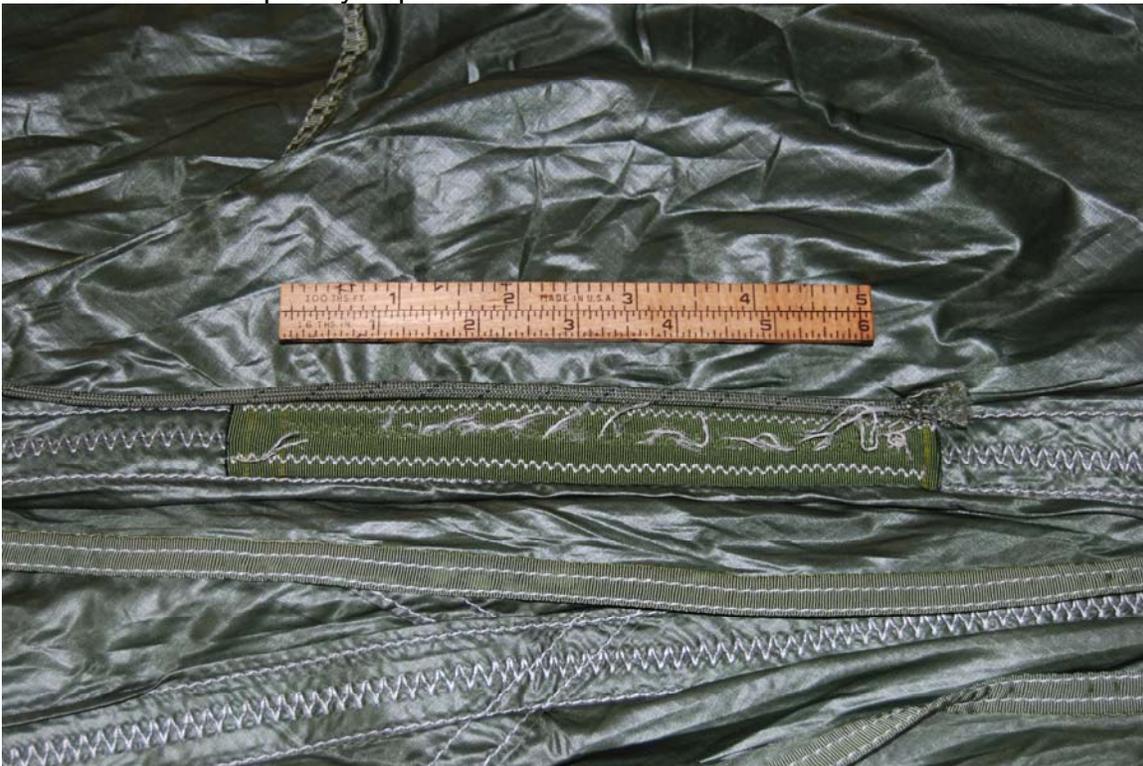
2 of 3 – bridle completely separated from radial seam

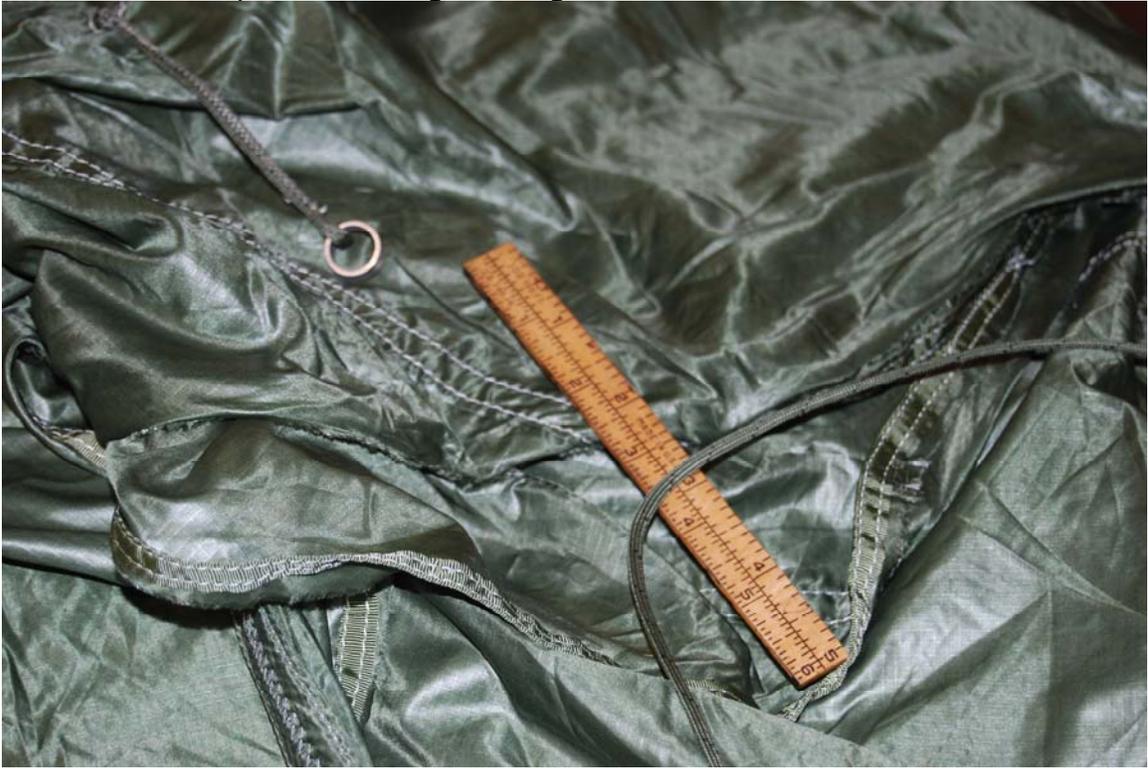
3 of 3 – bridle separated from guide ring

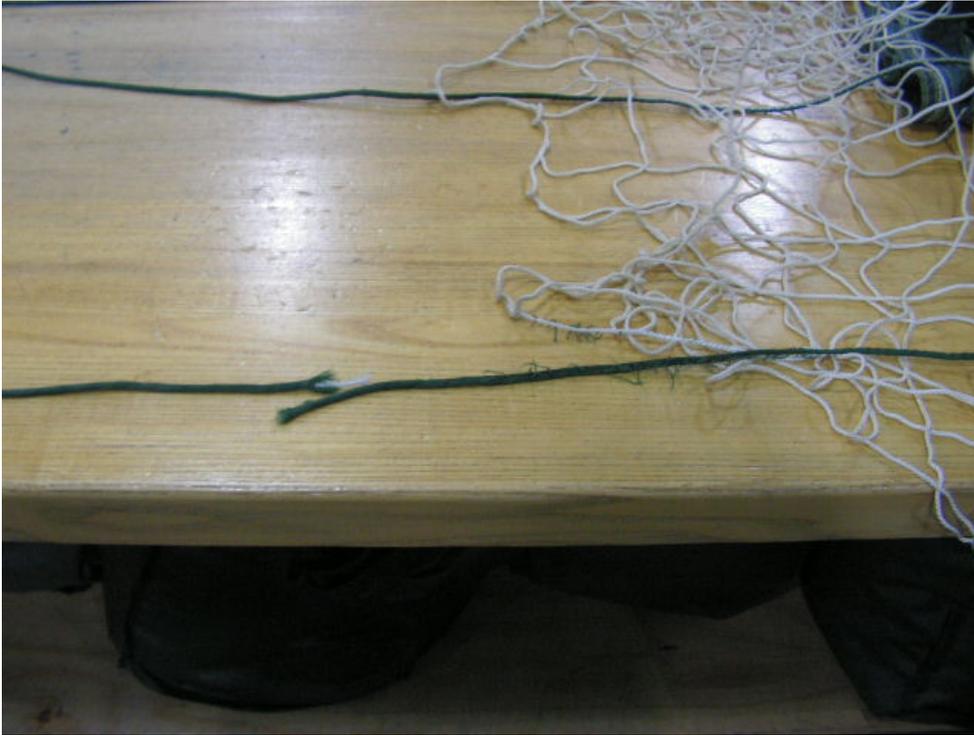
DESCRIPTION OF SUSPECTED MALFUNCTION OR INCIDENT: Suspension line broke during the deployment process. The damage incurred was on line 17 which broke approximately 6" from anti-inversion net and caused separation of the anti-inversion net from the suspension line. Jumper Landed safely on the DZ.

SUSPECTED CAUSE OF MALFUNCTION OR INCIDENT: The suspected cause of the malfunction is that suspension line # 17 caught the top connector link loop during the deployment process causing it to burn and pull until the suspension line broke. Reason for that conclusion is the evidence on both the deployment bag and the suspension line shows where the friction occurred.

1 of 3 - Suspension Line 17 broken 6" from anti-inversion net

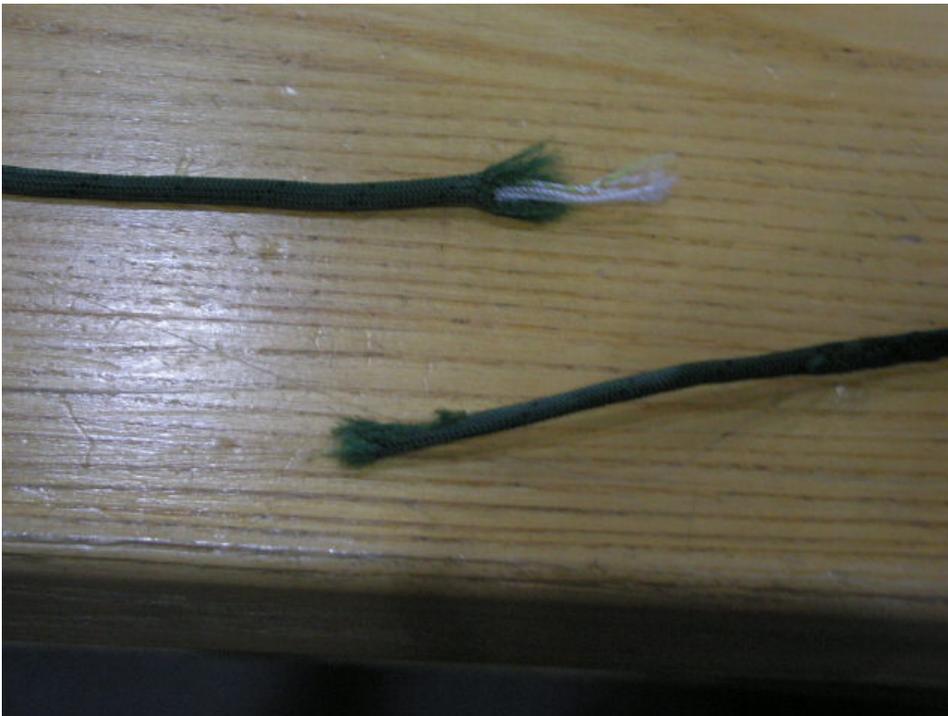
2 of 3 – close-up of suspension line 17

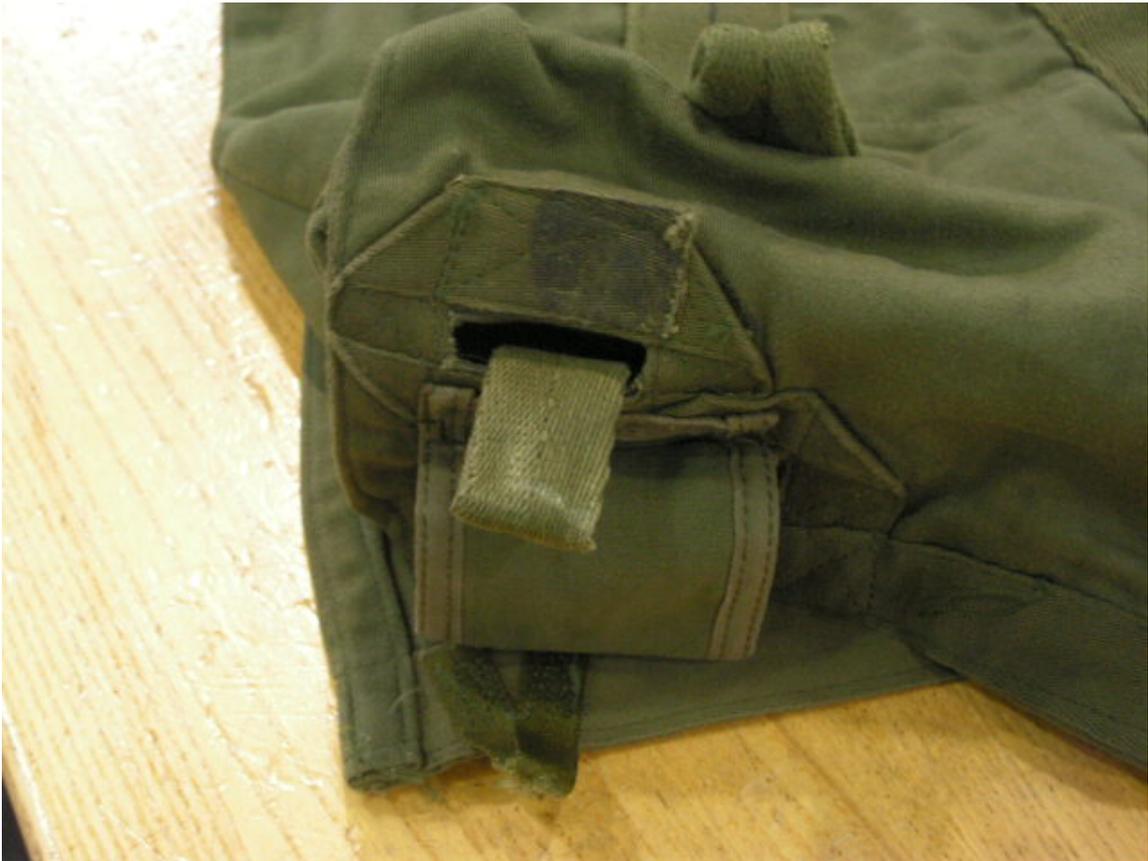
3 of 3 – top connector link loop

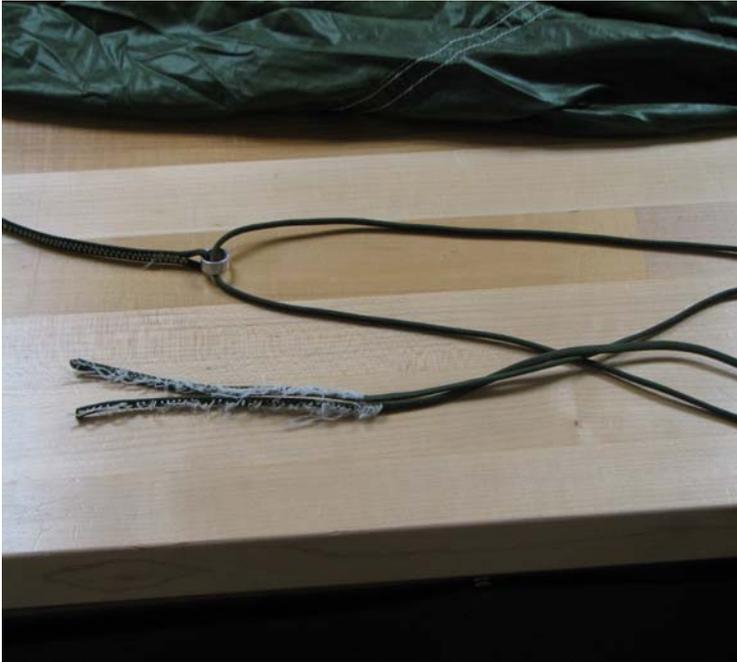
SUSPECTED CAUSE OF MALFUNCTION OR INCIDENT: After looking at the steering suspension line, it had ripped away from the main canopy. Compared the Delta to another Delta on the steering lines when attached by the manufacture only had one side of the line stitched with a backstitch. The lines were not properly attached to the canopy reinforcement area. Looked at the right steering line and also on that side only one side of the line was backstitched.

1 of 6 – control line bridle stitching ripped apart

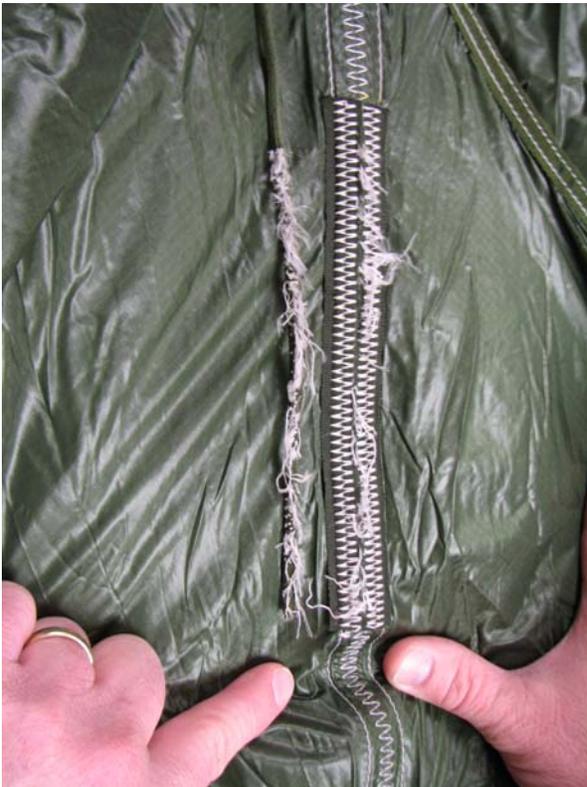
2 of 6 – control line bridle backside and where it was ripped away from

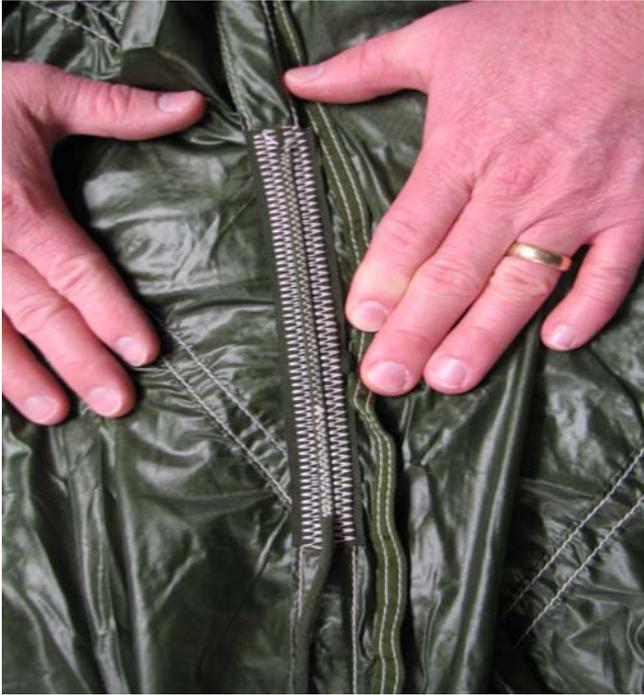
3 of 6 – one example of a manufacturers control line bridle stitching with backstitching

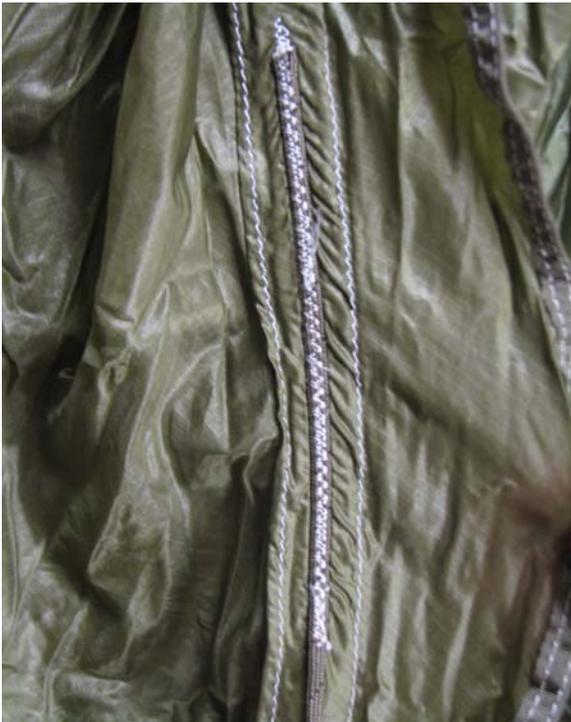
4 of 6 – another example of a manufacturers control line bridle stitching with backstitching

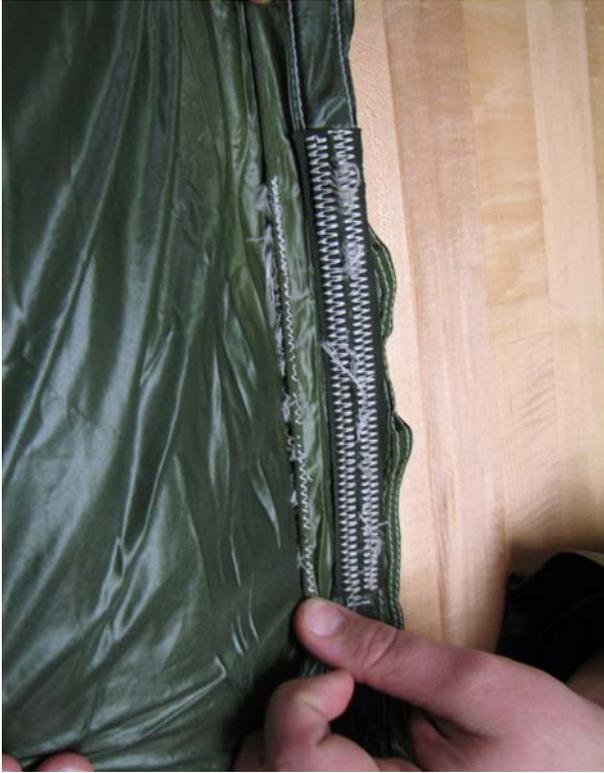
5 of 6 – the other end of the control line bridle top view and placed next to where it ripped away from

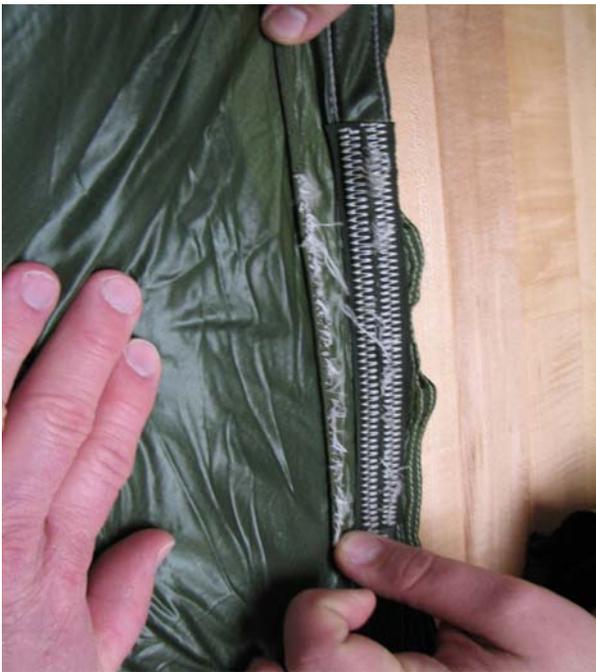
6 of 6 – control line bridle backside and placed next to where it ripped away from

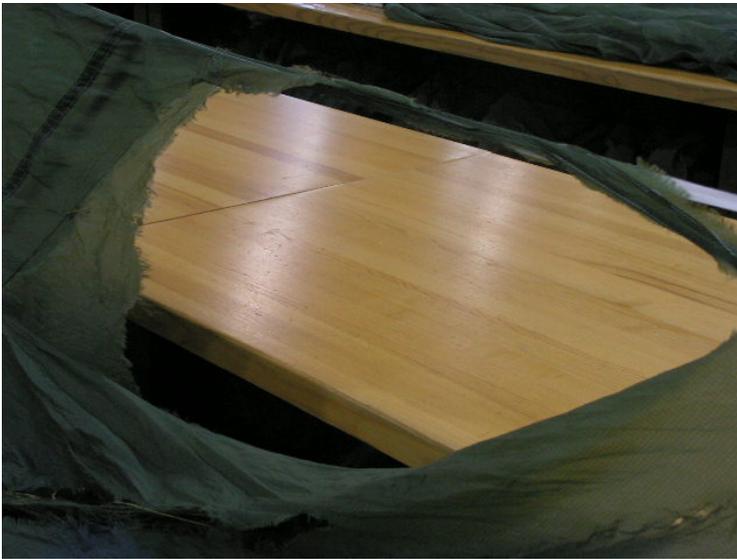
DESCRIPTION OF SUSPECTED MALFUNCTION OR INCIDENT: SM stated he exited the A/C and felt an immediate shock as if he collided into something. SM also stated that his parachute did not open immediately and it felt like he was being dragged. SM parachute eventually opened but had damage to the canopy as well as the suspension lines. SM compared his rate of decent and felt he wasn't falling faster than his fellow jumpers so he didn't activate his reserve. During the same pass Jumper 8 had broken suspension lines and pulled his reserve when he noticed he was falling faster than his fellow jumpers (see malfunction report ID# -174127410). Jumper 8 stated he did not feel anything other than an opening shock. The Malfunction NCO stated that the unit only exited the left door on that pass and he didn't see any towed jumpers, however, they were close when exiting. The damage incurred was all gores except gores 5-9 were burned. Gores 25 and 26 were completely blown. The suspension lines had burns and one suspension line separated at the connector link. The deployment bag was torn partially in half. Pack tray had burns on the top closing flap and inside where the deployment bag is placed with the risers. Two burned suspension lines about 3" in length were seared above and below the left canopy release assembly. SM top pocket of uniform on left side was torn. SM left hand, bicep, and neck had abrasions and bruising.

SUSPECTED CAUSE OF MALFUNCTION OR INCIDENT: After inspecting the equipment the incident occurred during the deployment process. The SM had a poor exit resulting in him being a towed jumper. With the static line wrapped around him it caused stress to the static line which cause stress to the deployment bag upon opening. With the deployment bag being torn partially in half it exposed the canopy while the suspension lines were deploying causing the canopy to be damaged upon opening. The suspension lines above and below the left canopy release assembly were Jumper # 8's because he had five broken and burned suspension lines upon deployment.

1 of 14 – blown gores

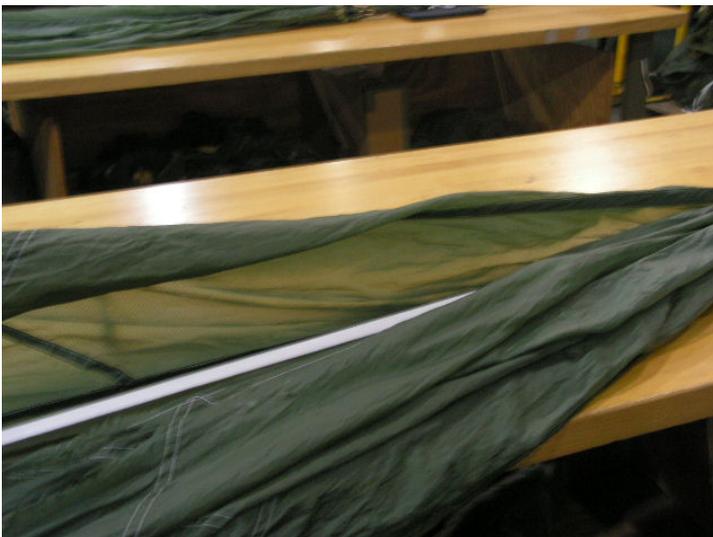
2 of 14 – exposed tape in radial seam

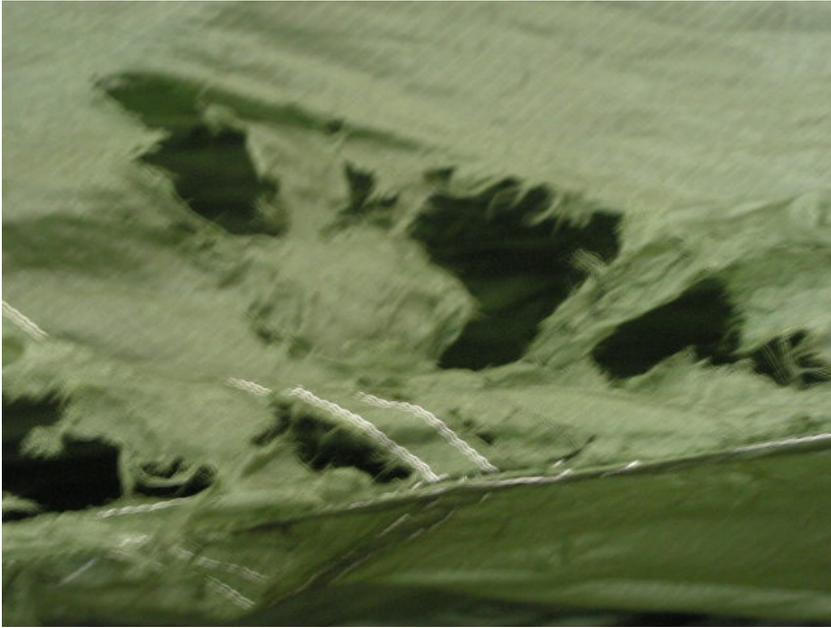
3 of 14 – burns on canopy

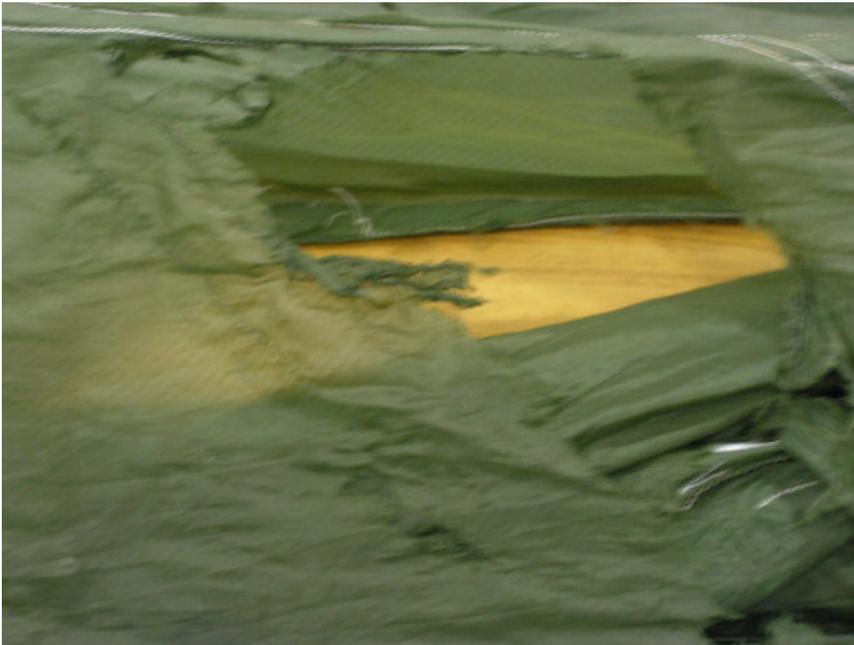
4 of 14 – burns on canopy

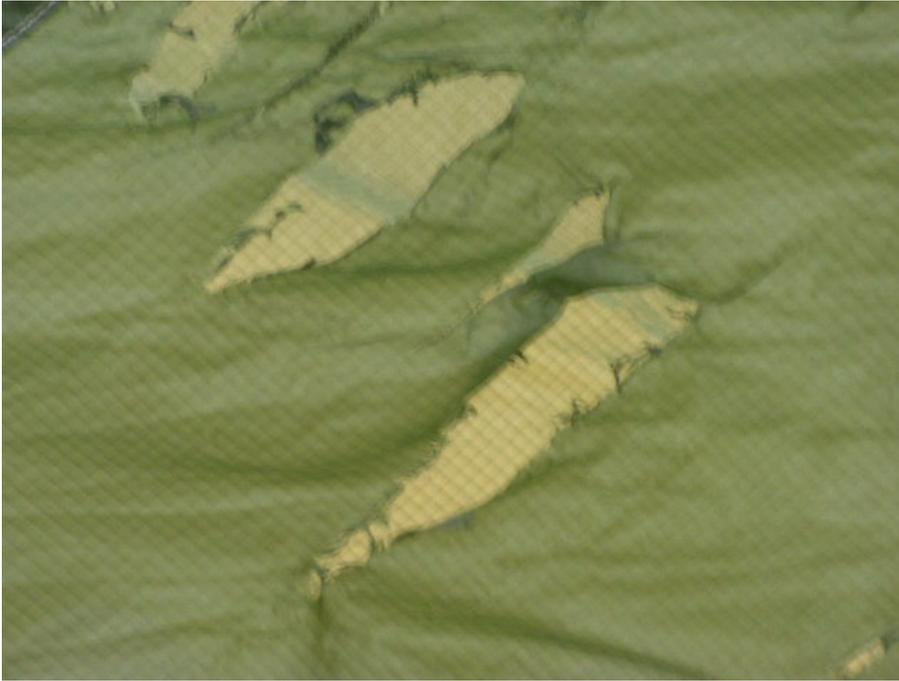
5 of 14 – burns on canopy

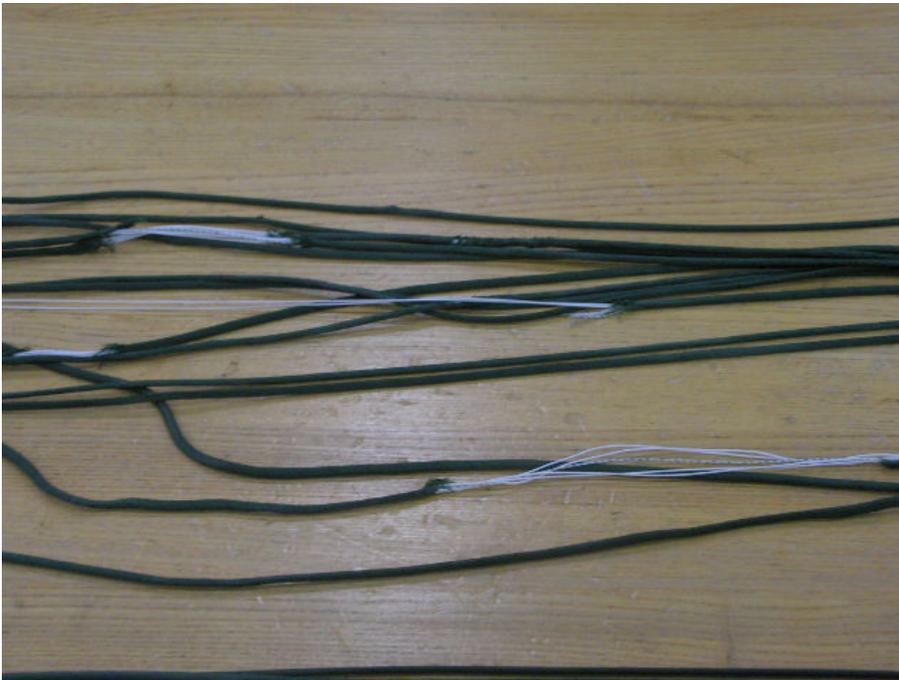
6 of 14 – broken casing of suspension lines with some filler cords intact

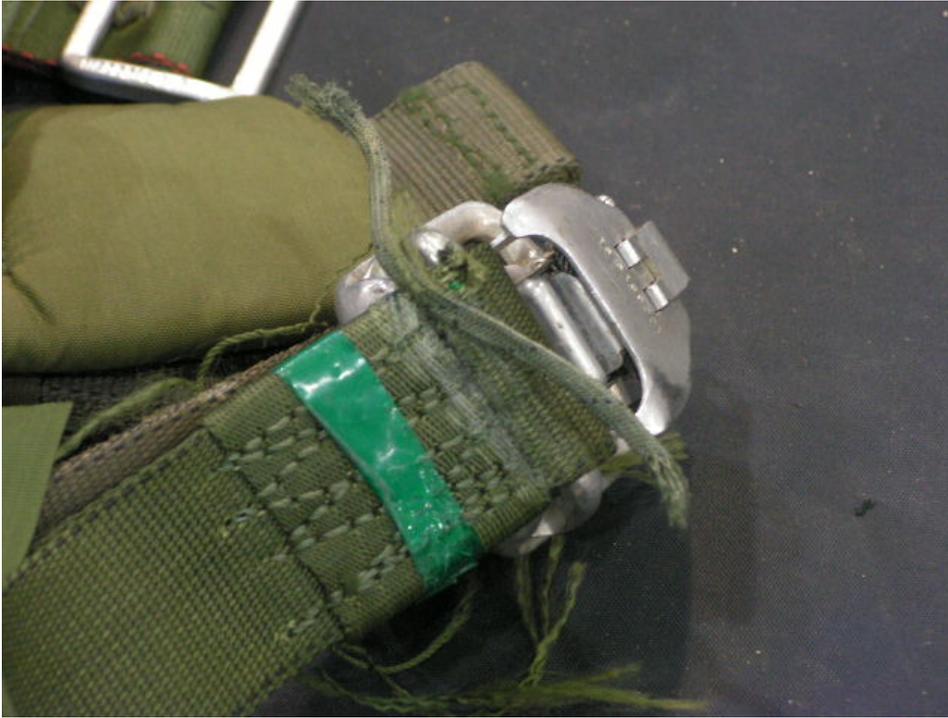
7 of 14 – another jumper's suspension line melted to this SM riser

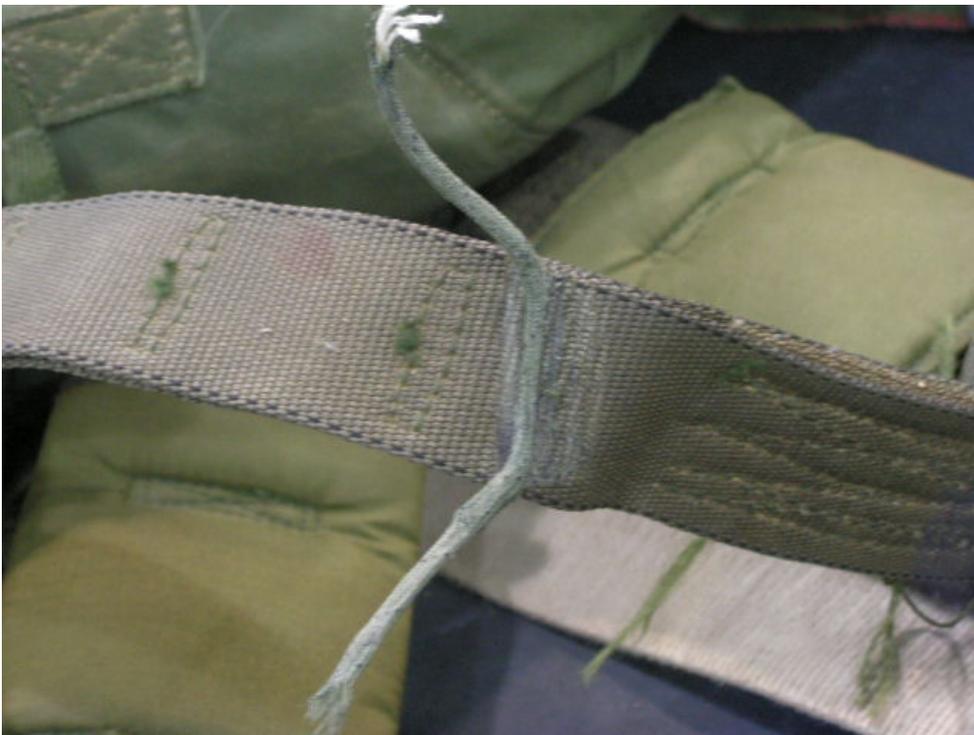
8 of 14 – another of the other jumper's suspension line melted to this SM riser

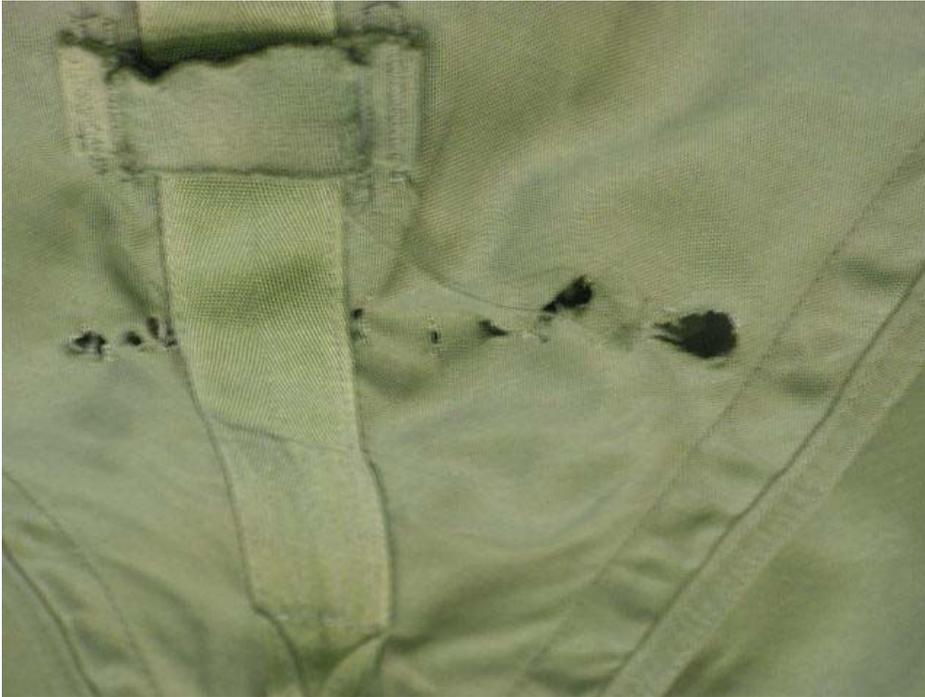
9 of 14 – burns on deployment bag top flap

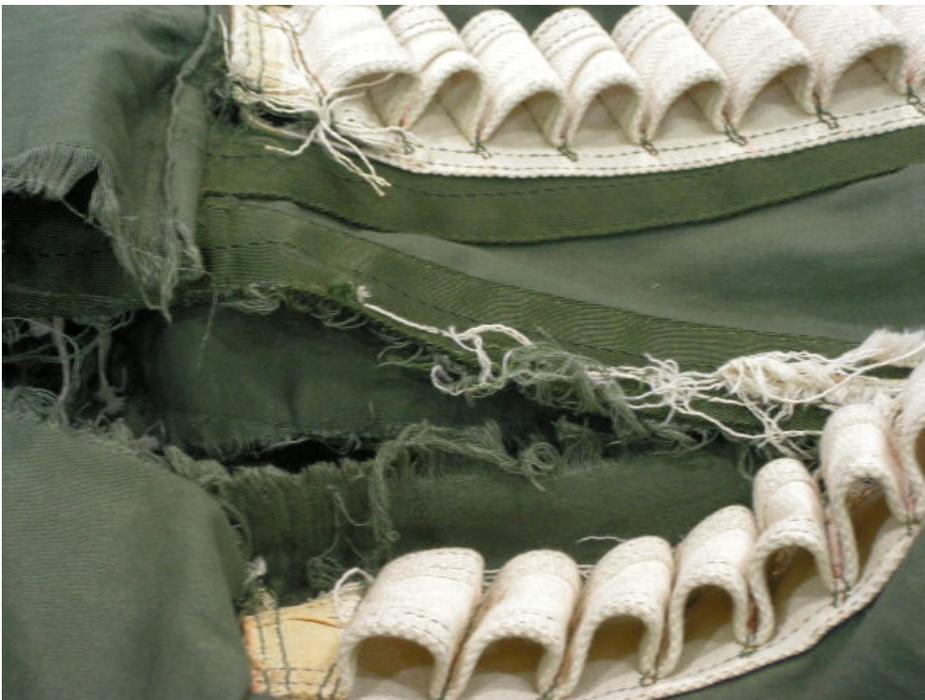
10 of 14 – ripped deployment bag

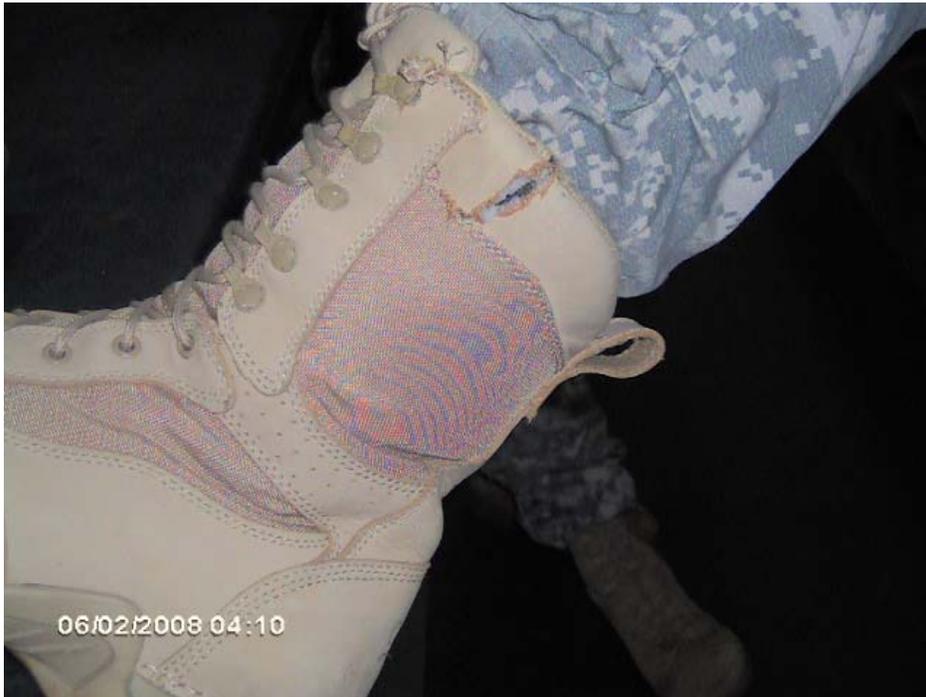
11 of 14 – burn/cut on SM right boot

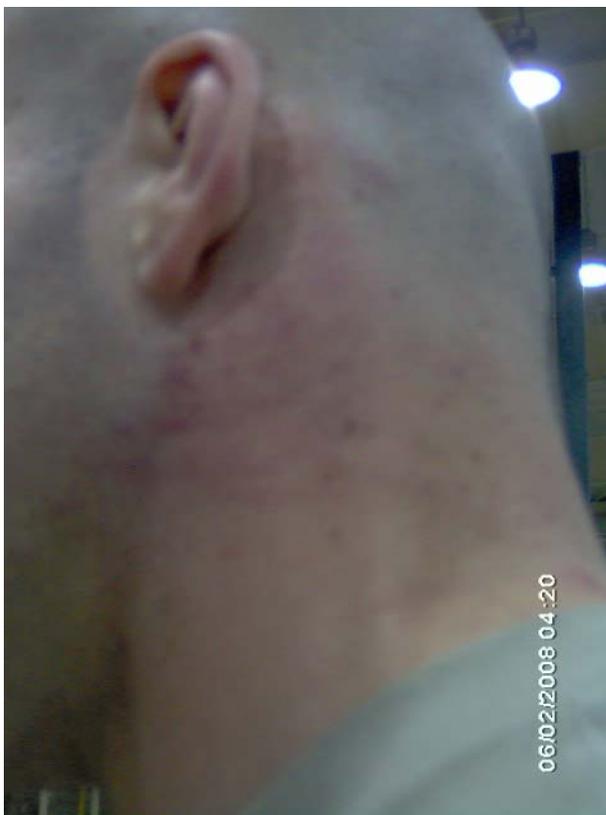
12 of 14 – SM bruising to head/neck

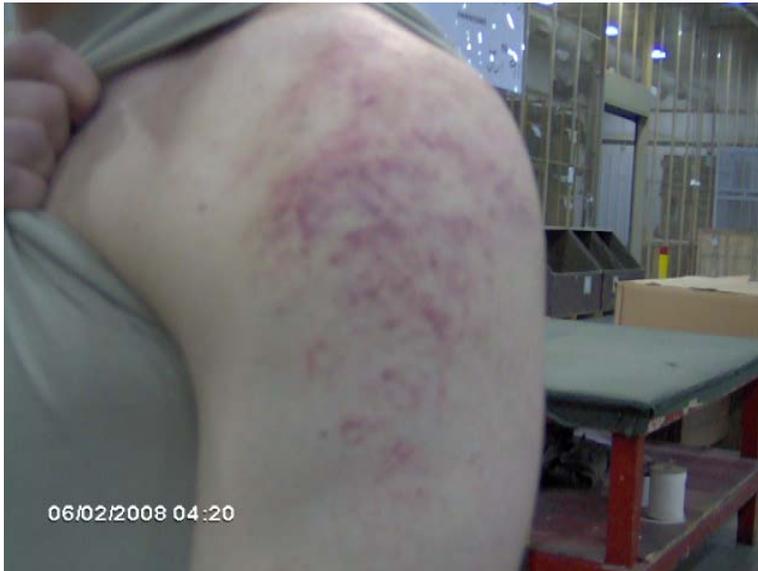
13 of 14 – SM bruising on left arm/shoulder

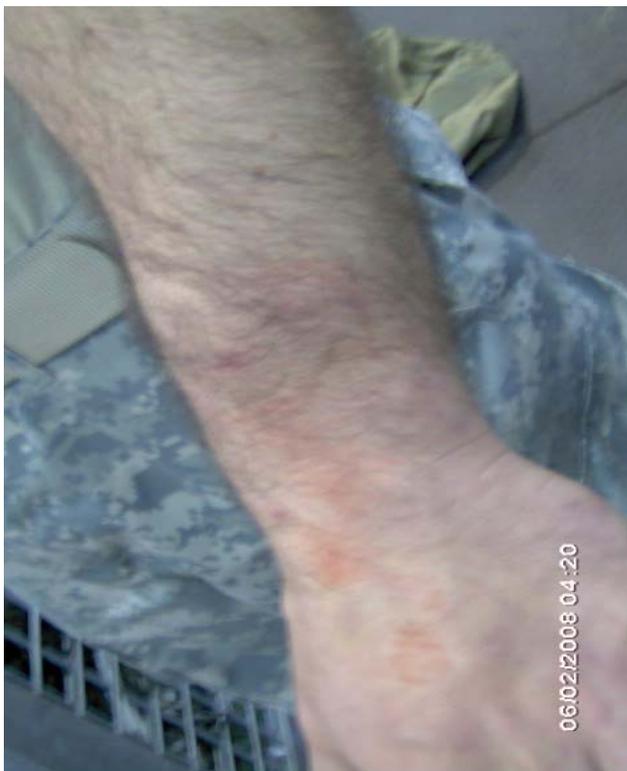
14 of 14 – SM bruising on left hand/arm

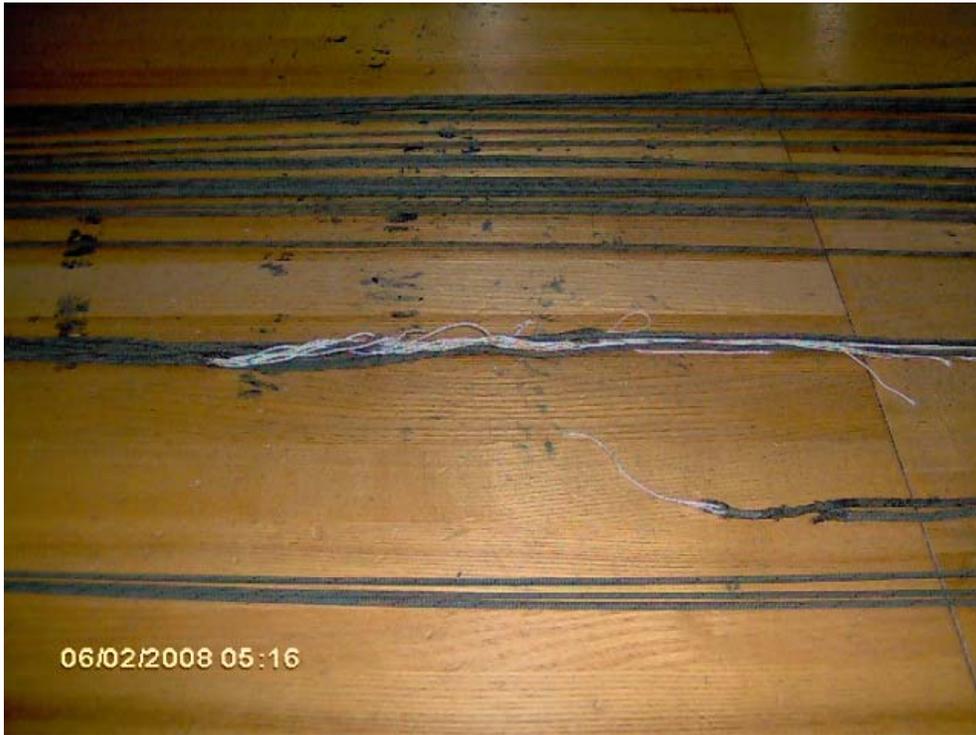
DESCRIPTION OF SUSPECTED MALFUNCTION OR INCIDENT: SM stated he had a perfect exit but when he checked canopy and gained canopy control suspension lines fell in his face. So he compared his rate of decent with his fellow jumpers and felt he was falling faster than them and he pulled his reserve. Damaged incurred was five broken and burn suspension lines. SM had no injuries.

SUSPECTED CAUSE OF MALFUNCTION OR INCIDENT: After inspecting the equipment the incident occurred during the deployment process. As the SM exited the A/C his suspension lines collided with Jumper #3 harness and canopy release assembly causing the suspension lines to burn and break. Reason for Jumper #3 still being under the aircraft was that he was a towed jumper for about 4-5 seconds (see malfunction report ID# 113420065). Only one door was exiting at a time.

1 of 2 – broken/ burned suspension lines from collision with another jumper

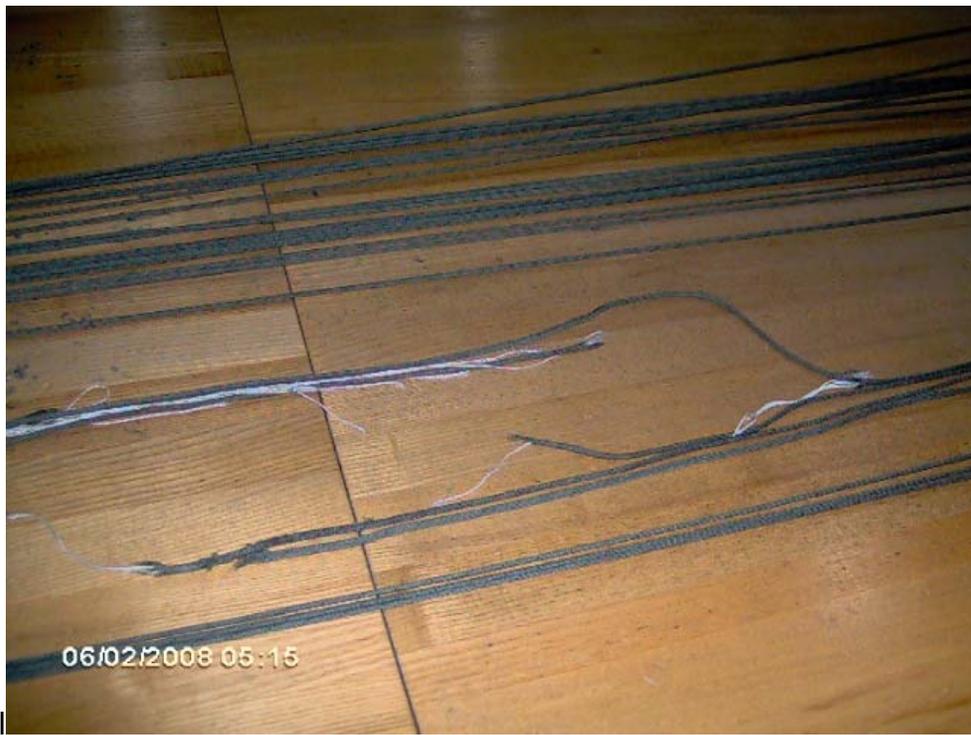
2 of 2 – longer shot of broken/ burned suspension lines

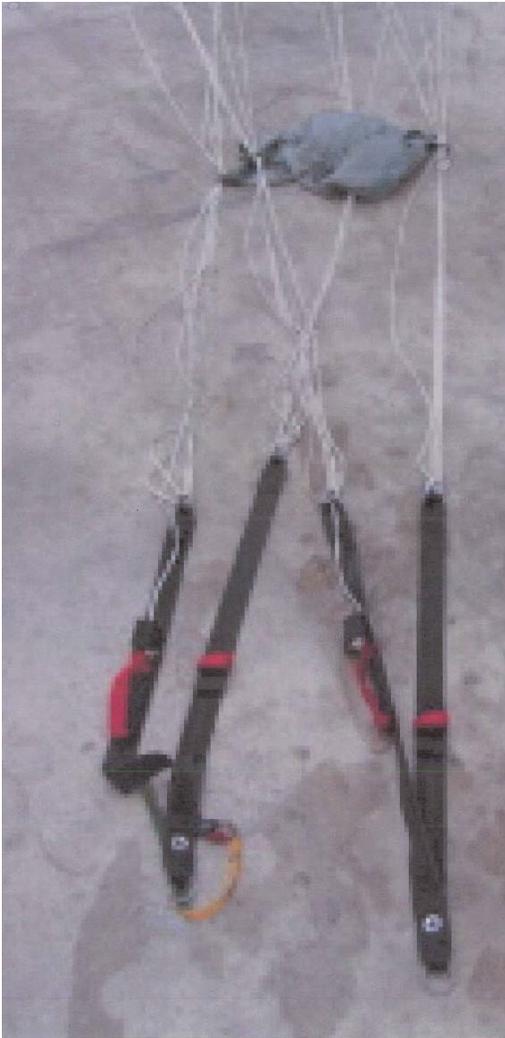
SUSPECTED CAUSE OF MALFUNCTION OR INCIDENT: Tangled suspension lines beneath slider may have prevented slider from fully deploying. Images are available by contacting 320th STS parachute shop via DSN number below in contact info.

Malfunction Investigator - After I submitted the malfunction report, I sat down with our commander and DO, to further discuss the malfunction. We came to the conclusion that the entanglement was caused when the canopy was released, relieving the tension in the lines, causing the lines to snap back into its self. We believe the jumper experienced a slow opening, not a entanglement in the lines.

1 of 2 – view from slider down to risers

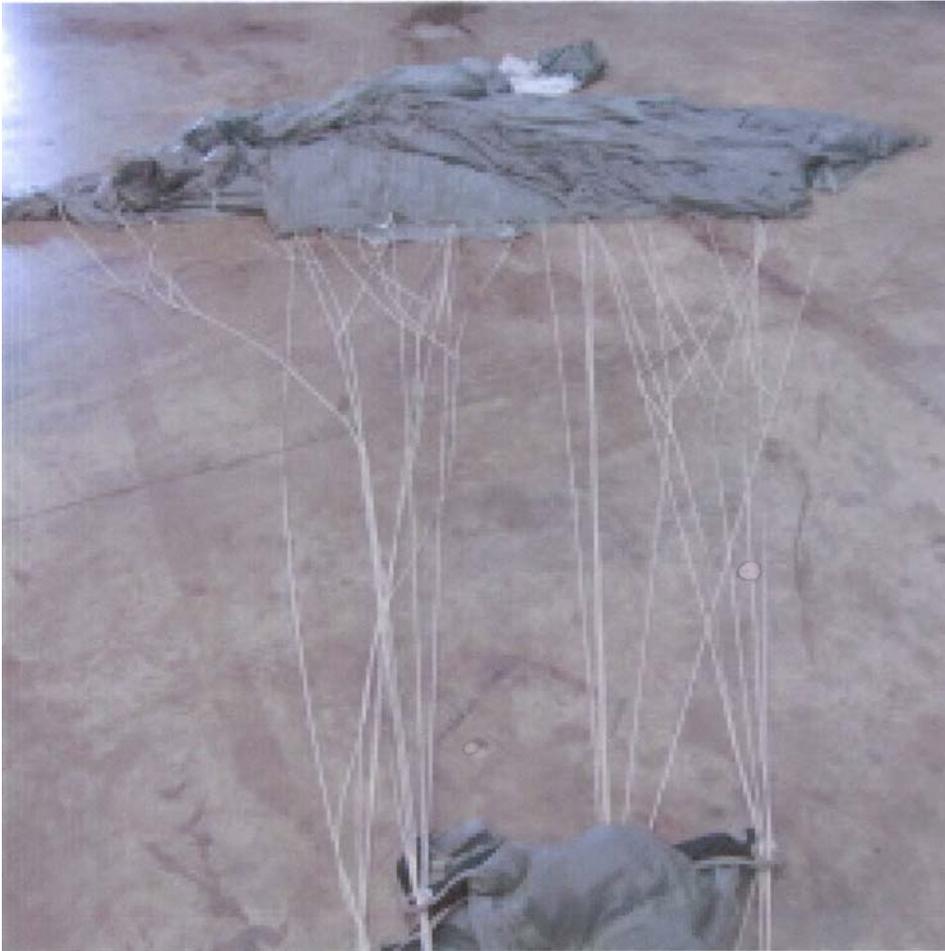
2 of 2 – view from slider on up to canopy

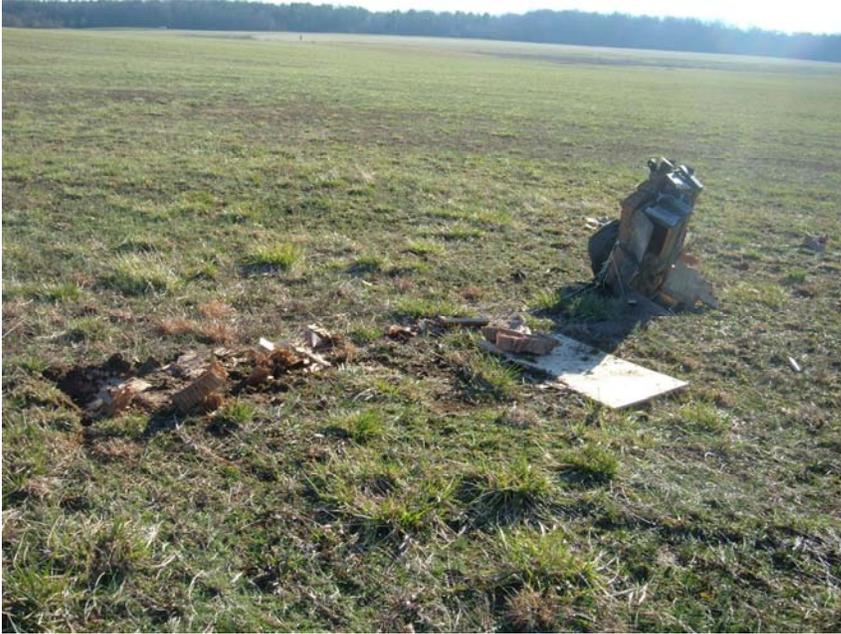
SUSPECTED CAUSE OF MALFUNCTION OR INCIDENT: DURING THE DEPLOYMENT AND EXTRACTION PHASE, THE GUTTED 550 ALLOWED FOR THE STATIC LINE TO ELONGATE AS WELL AS HAVE A NORMAL TIP OFF FROM THE RAMP, THIS OCCURED AFTER THE GRAVITY DEPLOYMENT WAS EN-PLACED. THE LOAD WAS RIGGED FOR A BREAKAWAY AND THE GUTTED 550 BROKE AWAY BEFORE THE 1/4 IN COTTON WEBBING. SUSPECTED CAUSE OF MALFUNCTION COULD BE THAT THE STATIC LINE CAUGHT OR WRAPPED ON THE LOAD CAUSING THE GUTTED (550) TYPE III NYLON TO BREAK BEFORE THE (QUARTER INCH COTTON WEBBING) PACK CLOSING TIE BROKE. THE G-14 WAS PACKED IAW TM 10-1670-282-23&P AND THE A-7A (3 STRAP LOAD) WAS RIGGED IAW FM 4.20-103.

1 of 4 – the door bundle bounce\

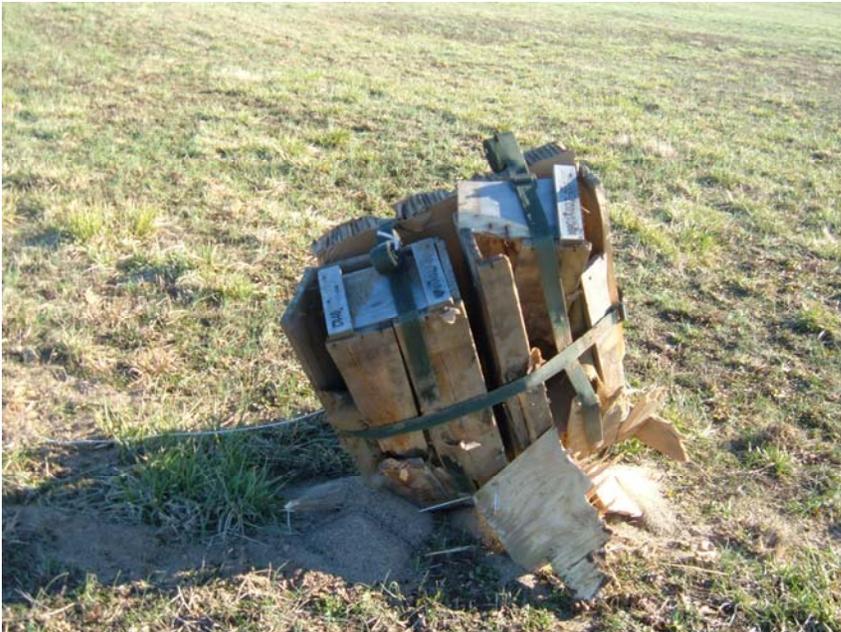
2 of 4 – bottom of door bundle

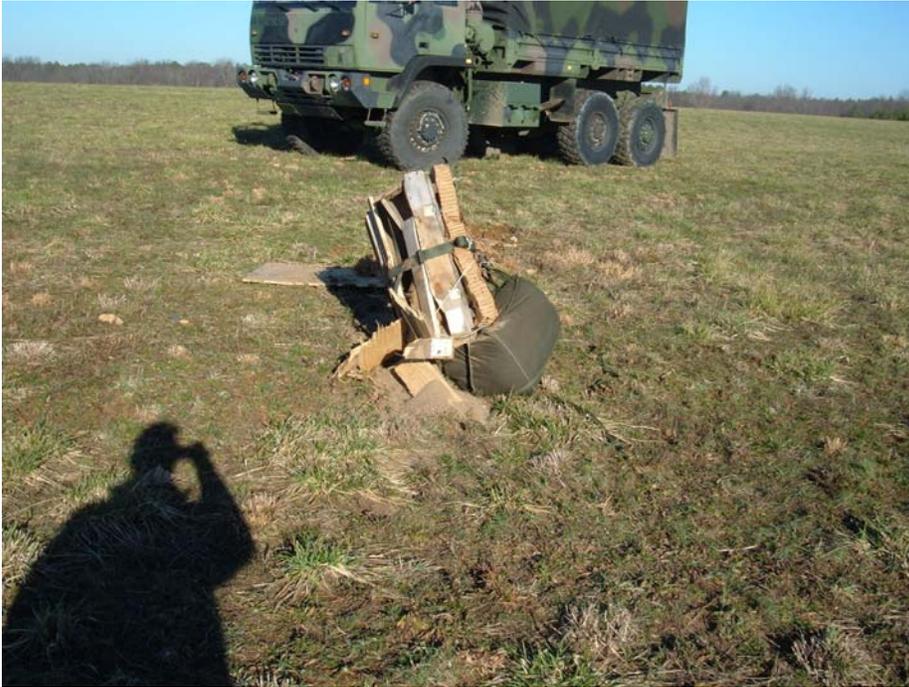
3 of 4 – side of door bundle

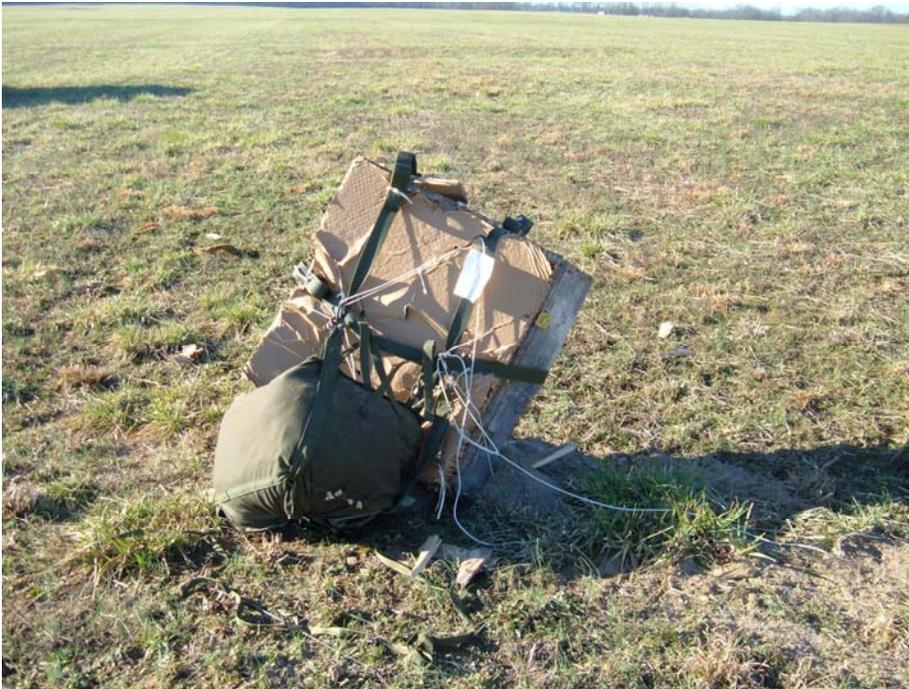
4 of 4 – top of door bundle
