1748-2 Static-Line Report

ID: -175312218

FROM: 67 SOS Unit 8825 Box 260 APO AE 09459

TYPE OF REPORT: Incident

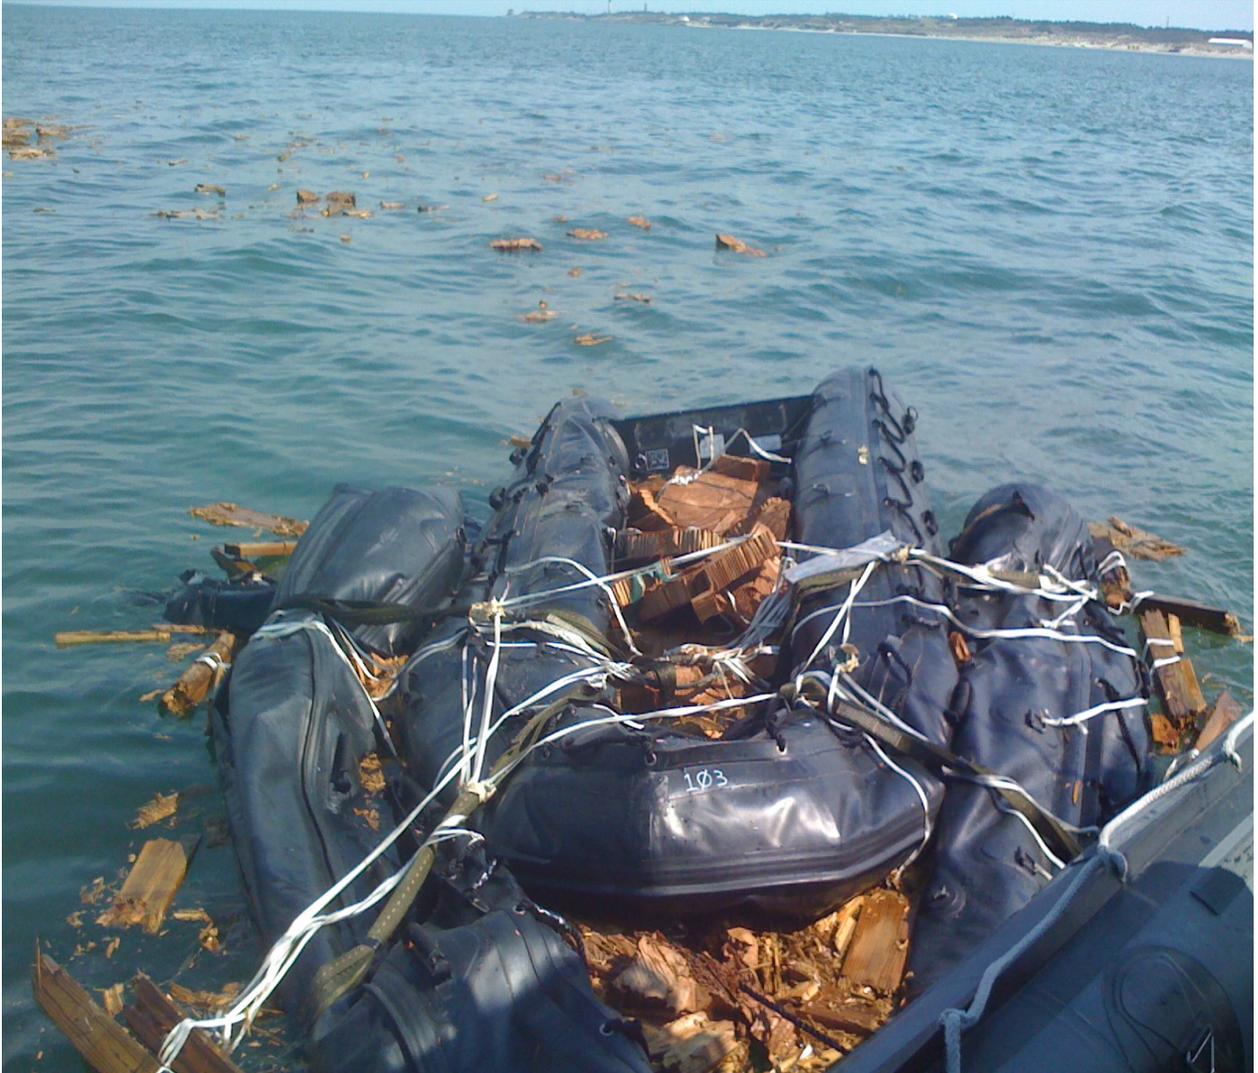
1 of 8 – CRRC after drop

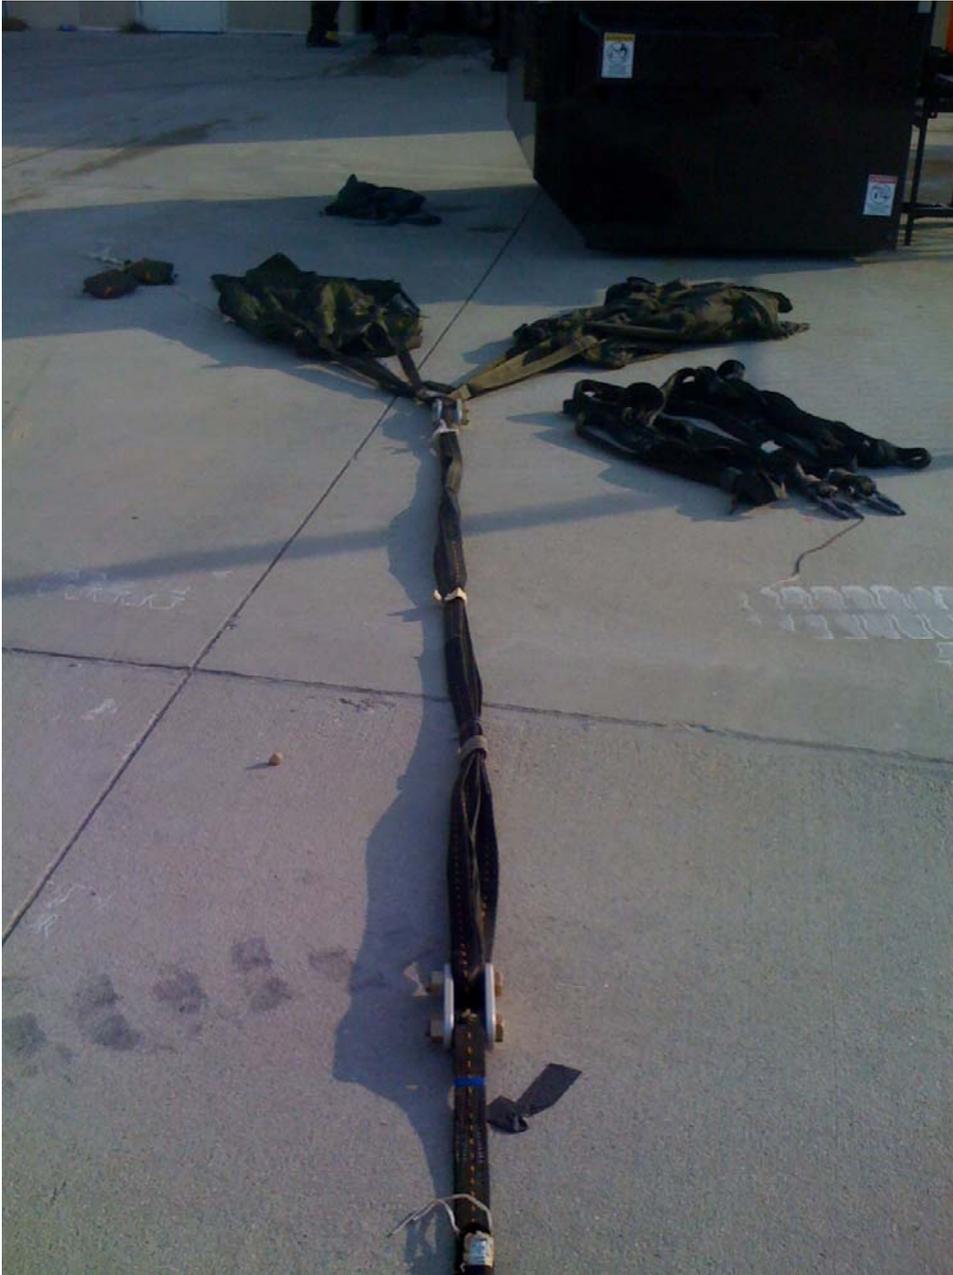
2 of 8 – G-12 d-bags connected to 2 point link then to extraction line

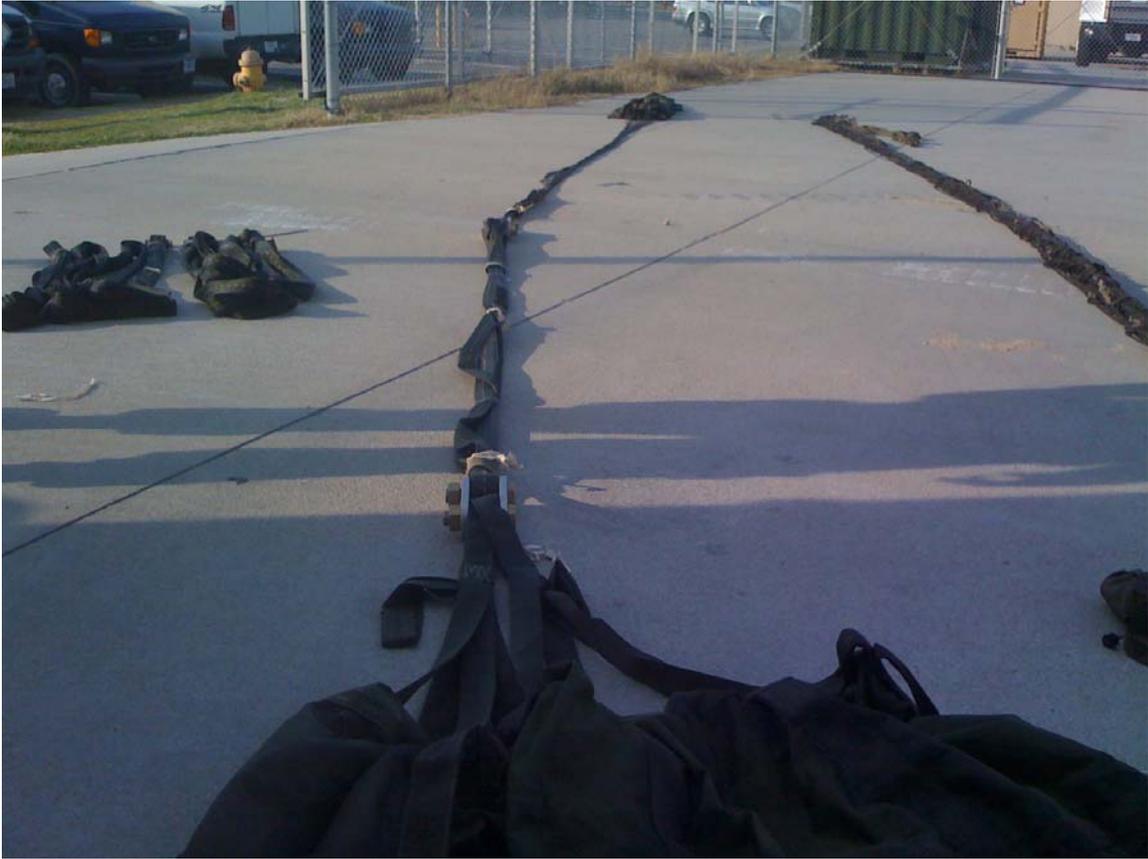
3 of 8 – 15' extraction parachute viewed at top back down to G-12 d-bags

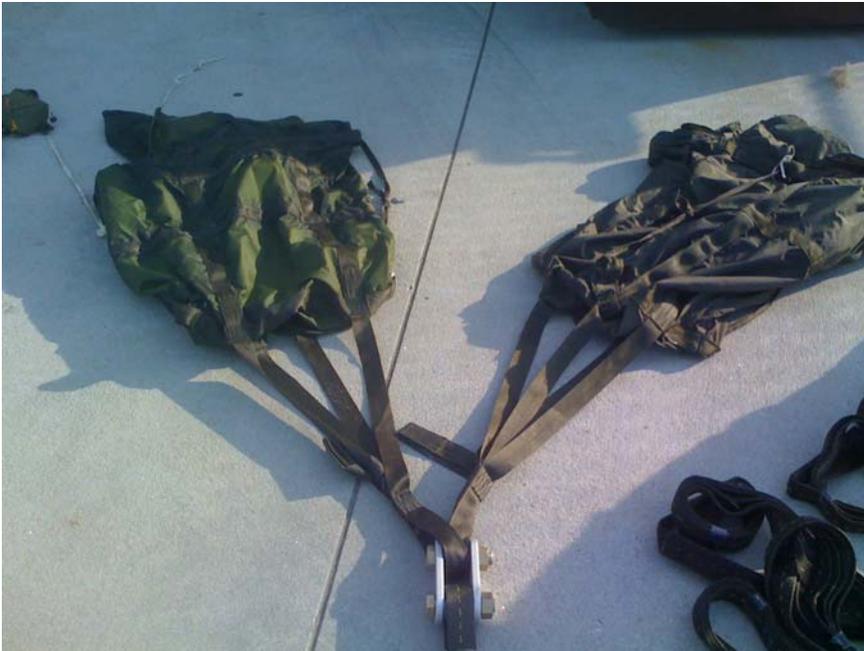
4 of 8 – G-12 d-bags connected to 2 point link

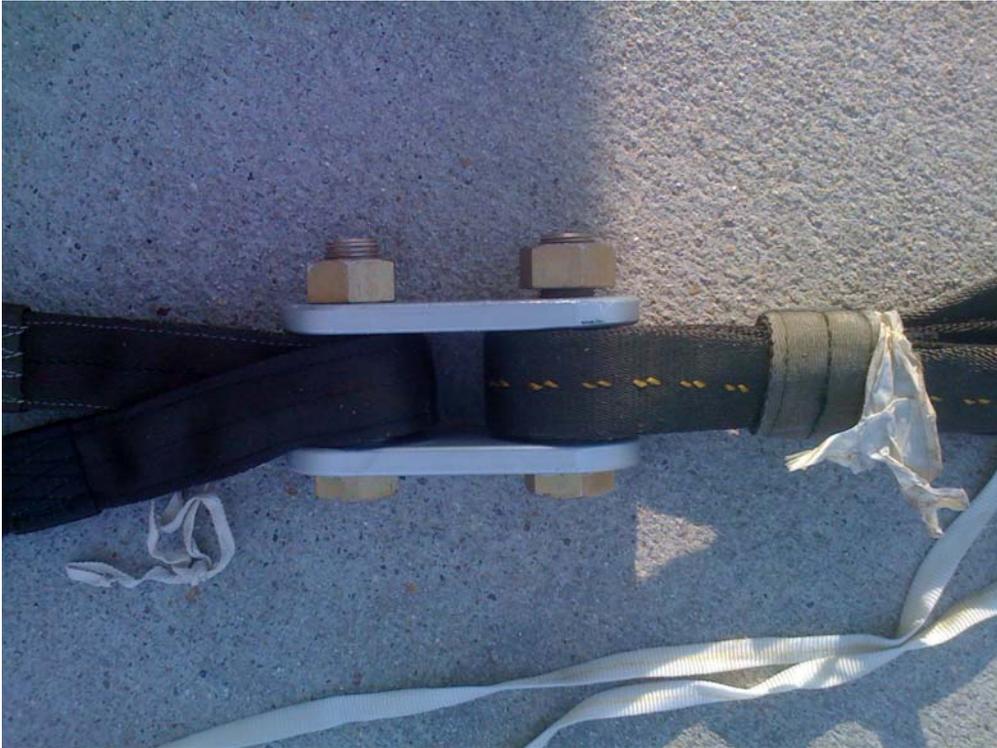
5 of 8 – 2 point link connecting G-12 d-bags to extraction line

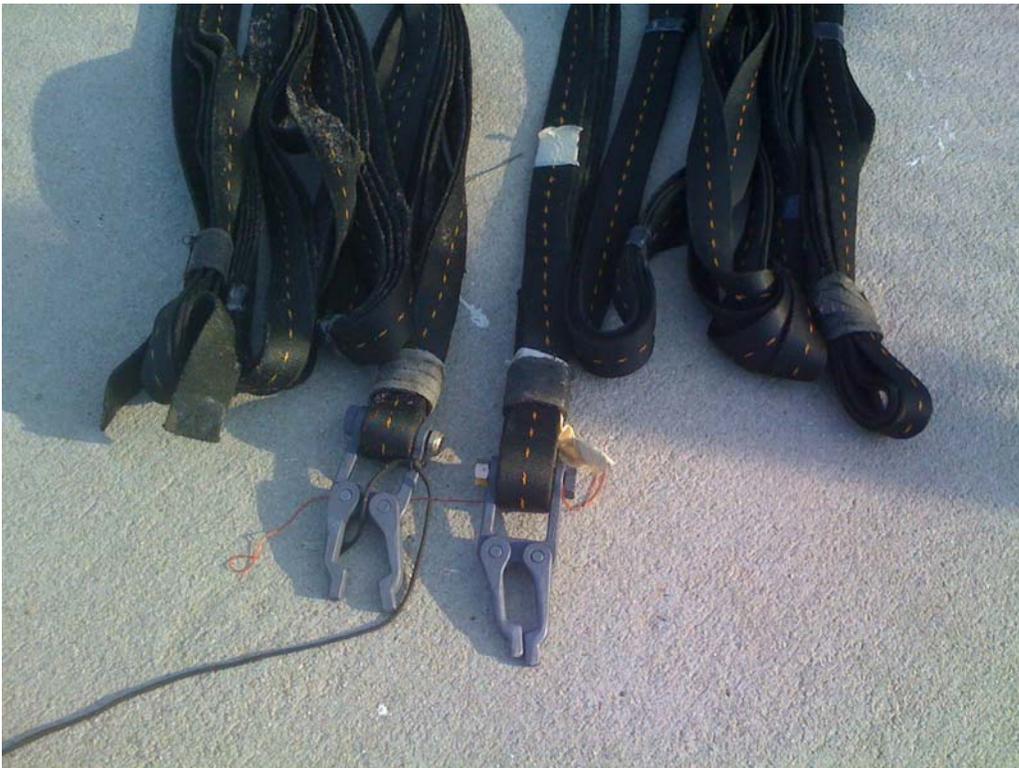
6 of 8 – G-12 riser extensions and parachute connectors from M-1

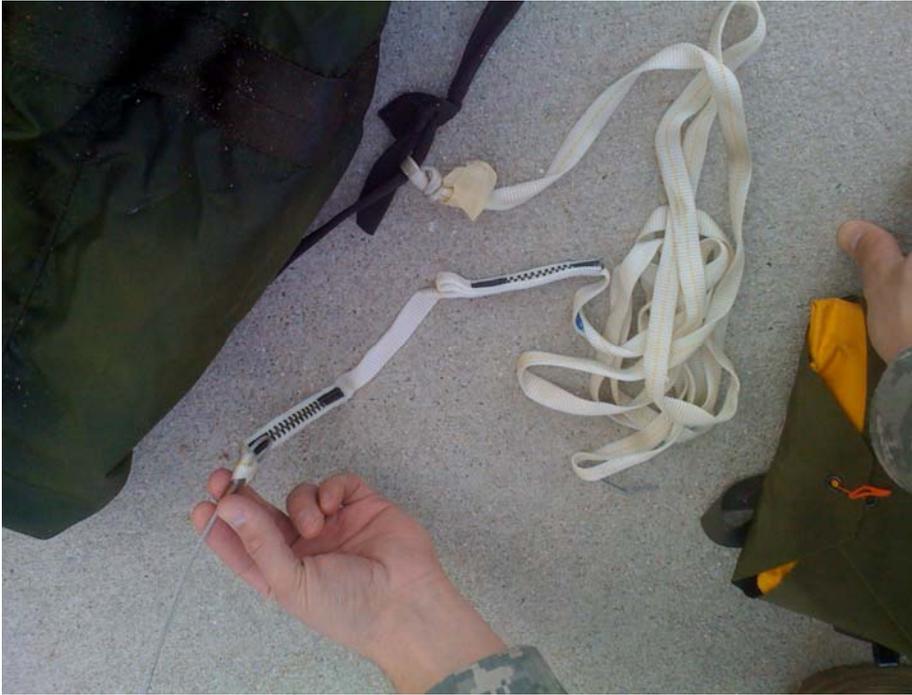
7 of 8 – M-1 arming wire and lanyard

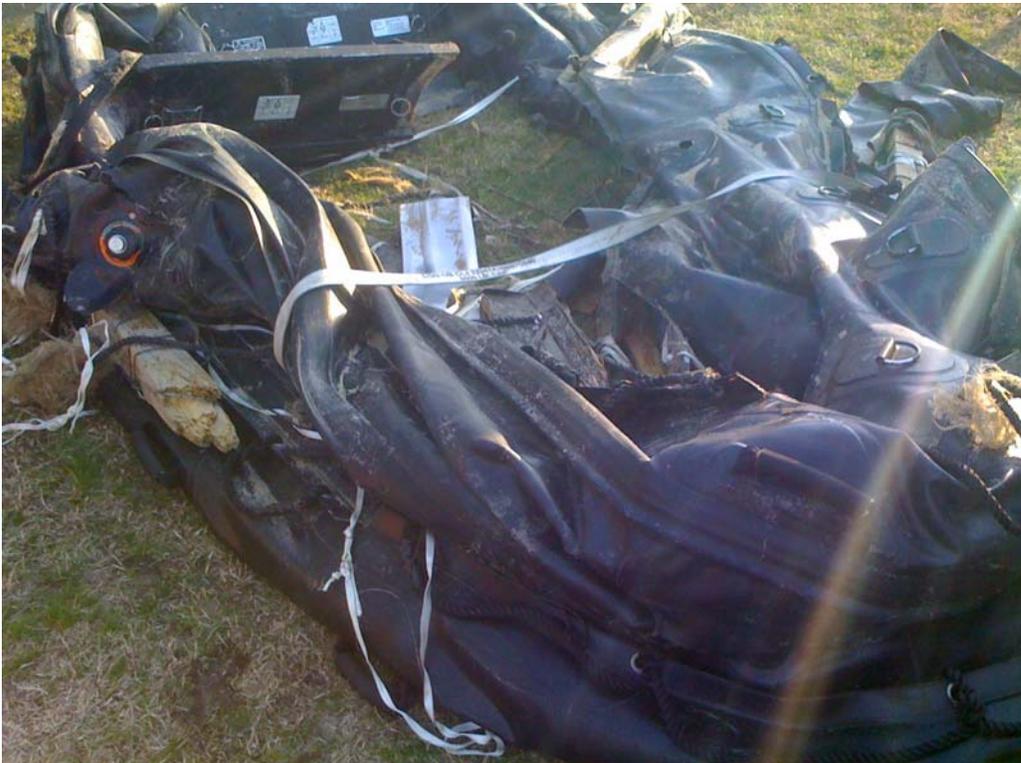
8 of 8 – CRRC after recovery from DZ (total annihilation)
