137th TRIANNUAL AIRDROP REVIEW and MALFUNCTION SAFETY ANALYSIS BOARD

Oct 25 - 27, 2011

MALFUNCTIONS / INCIDENTS REPORTED

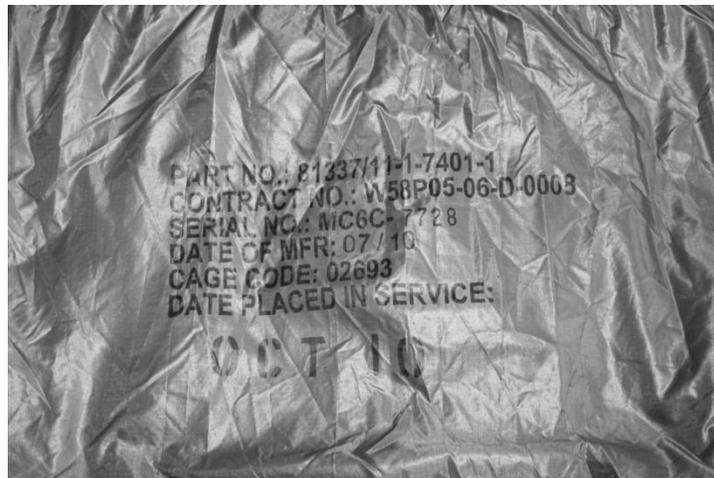
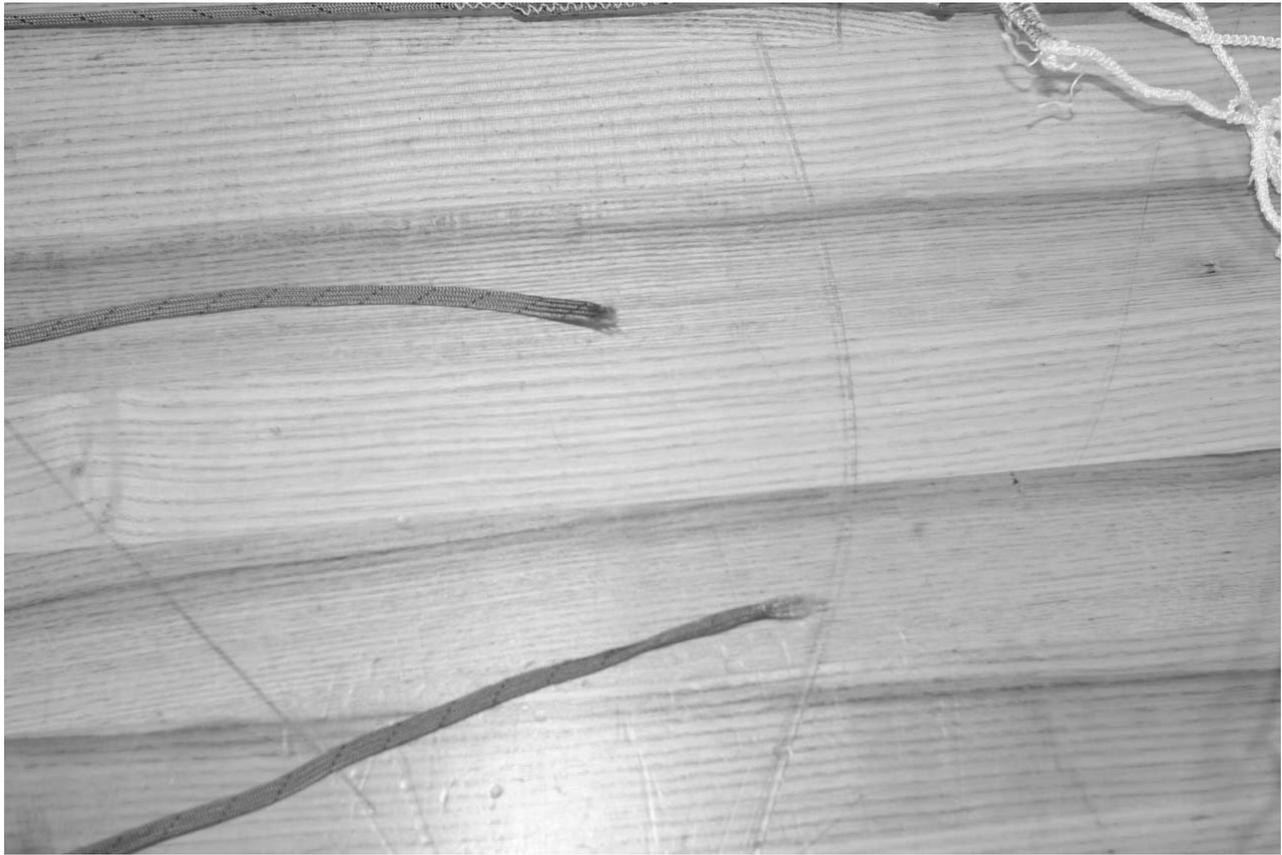
SL8_20110621_EODTEU_MC6_BrokenControlLine_C212

Type of Malfunction - Incident - Specify: broken left control line & holes in canopy found post jump.

Description of Suspected - Malfunction - Incident - Damaged Incurred: Jumper executed a normal ramp exit from a Casa-212 aircraft traveling at 120 KIAS. Assumed normal airborne body position and counted to 4, checked his canopy and gained canopy control. While checking his canopy he noticed that there were holes in various sections of his canopy and a broken left control line. He checked his rate of descent with other jumper, which appeared to be normal. Continued to monitor his rate of descent and landed parachute with a proper PLF without incident.

Suspected Cause of Malfunction - Incident: undetermined due to insufficient facts

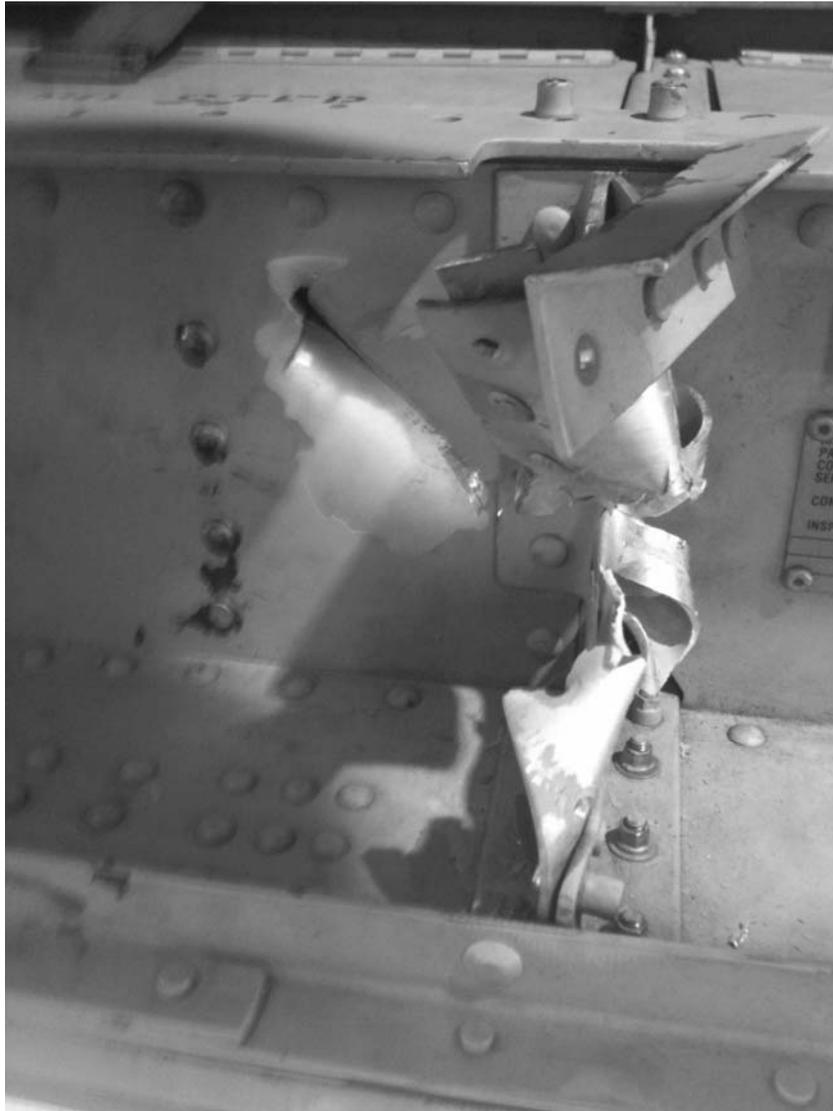
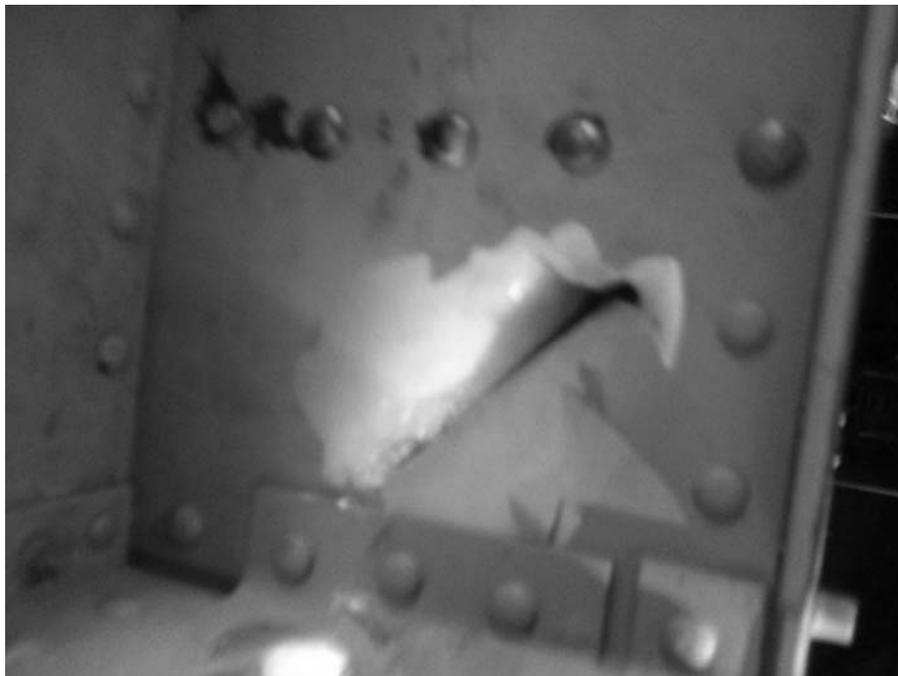
Suspected Cause of Malfunction - Incident: Drogue jettison strike pin.

Recommendations: replace enhanced tow plate
