135th TRIANNUAL AIRDROP REVIEW and MALFUNCTION SAFETY ANALYSIS BOARD

Feb 8-10, 2011

MALFUNCTIONS / INCIDENTS REPORTED

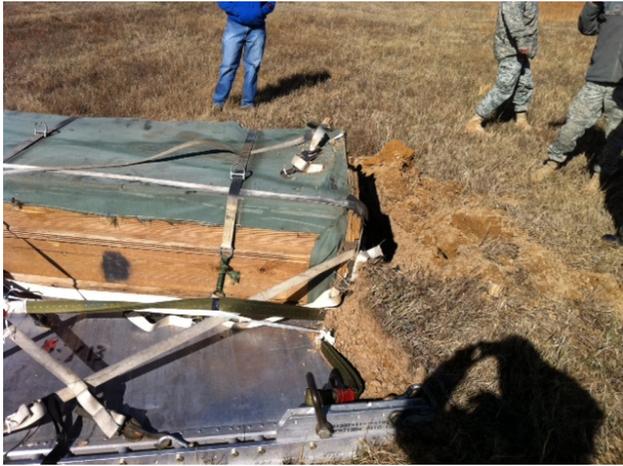
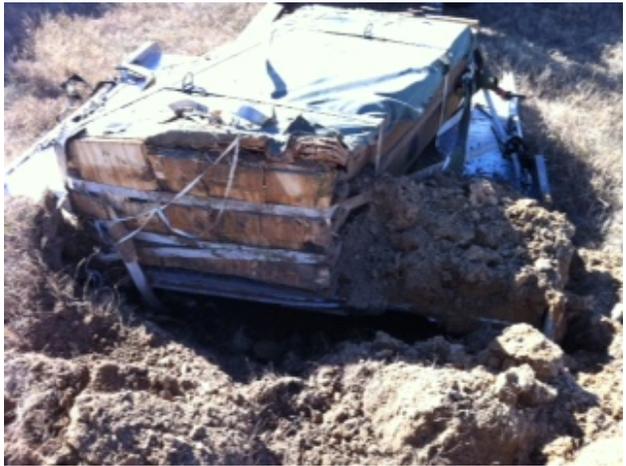
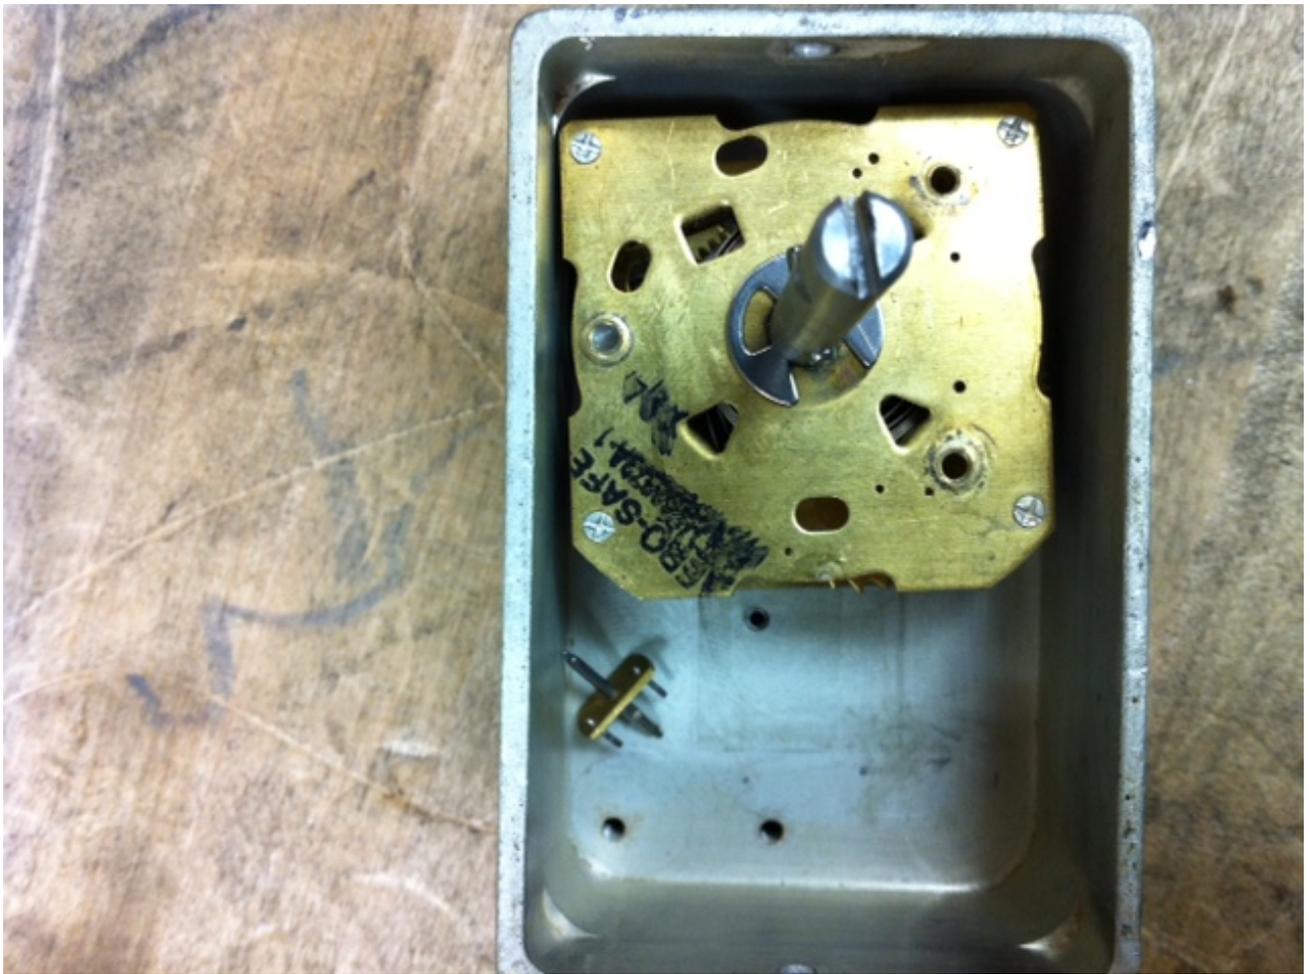
Description of Suspected - Malfunction - Incident - Damaged Incurred: Acft was dropping a 8ft HE wt 2588lbs, HE left acft without incident. During main chute deployment both the LM and DZ crew saw the chutes only inflate approx 75% then release from the load. The HE free fell and impacted the DZ. HE looks to be a complete loss, chutes are ok.

Suspected Cause of Malfunction - Incident: After inspection, Tactics LMs and AD took apart suspect M-1 and timer block. M-1 looked good but when opening timer block there was a noticeable rattle within the block itself. Upon opening the timer block assembly there was a cog loose, and it appears that it was the one that controls how fast the tension is released. This timer block was initially timed at 16 sec by AD, but the loss of this part caused the early release of the mains.
