136th TRIANNUAL AIRDROP REVIEW and MALFUNCTION SAFETY ANALYSIS BOARD

June 21-23, 2011

MALFUNCTIONS / INCIDENTS REPORTED

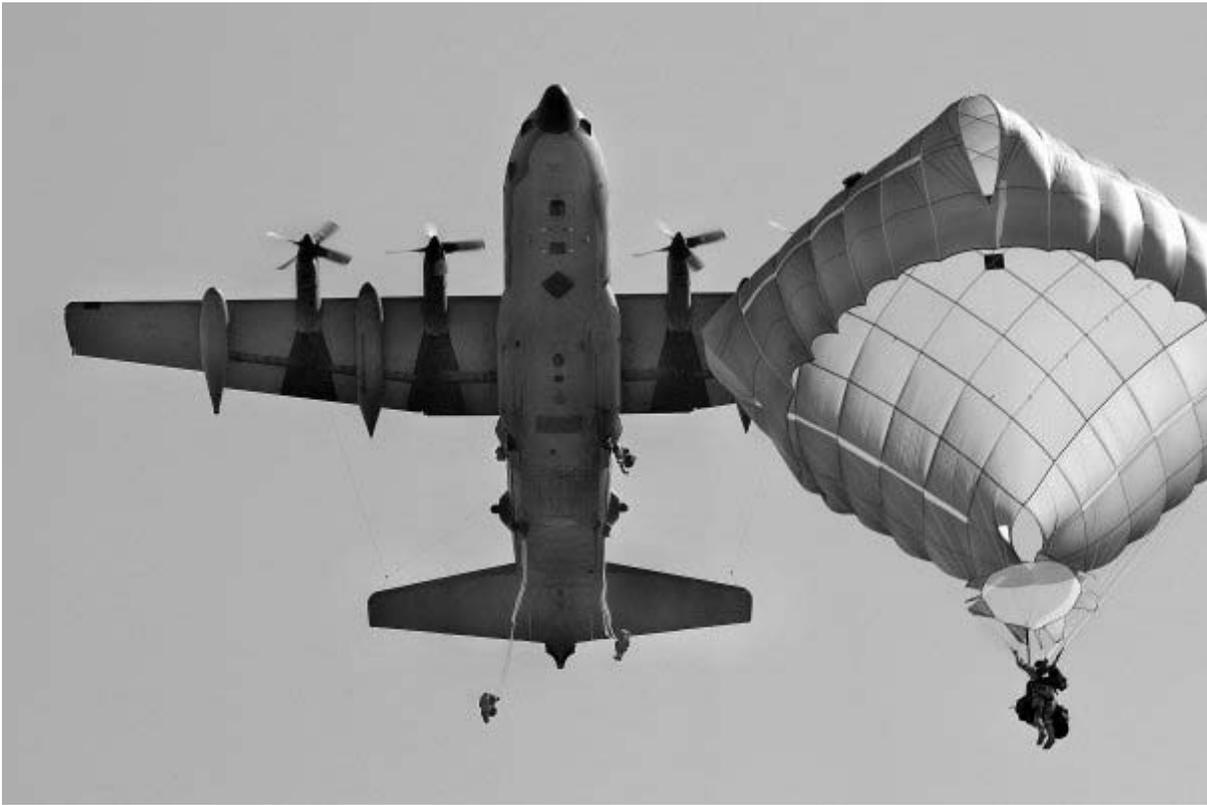
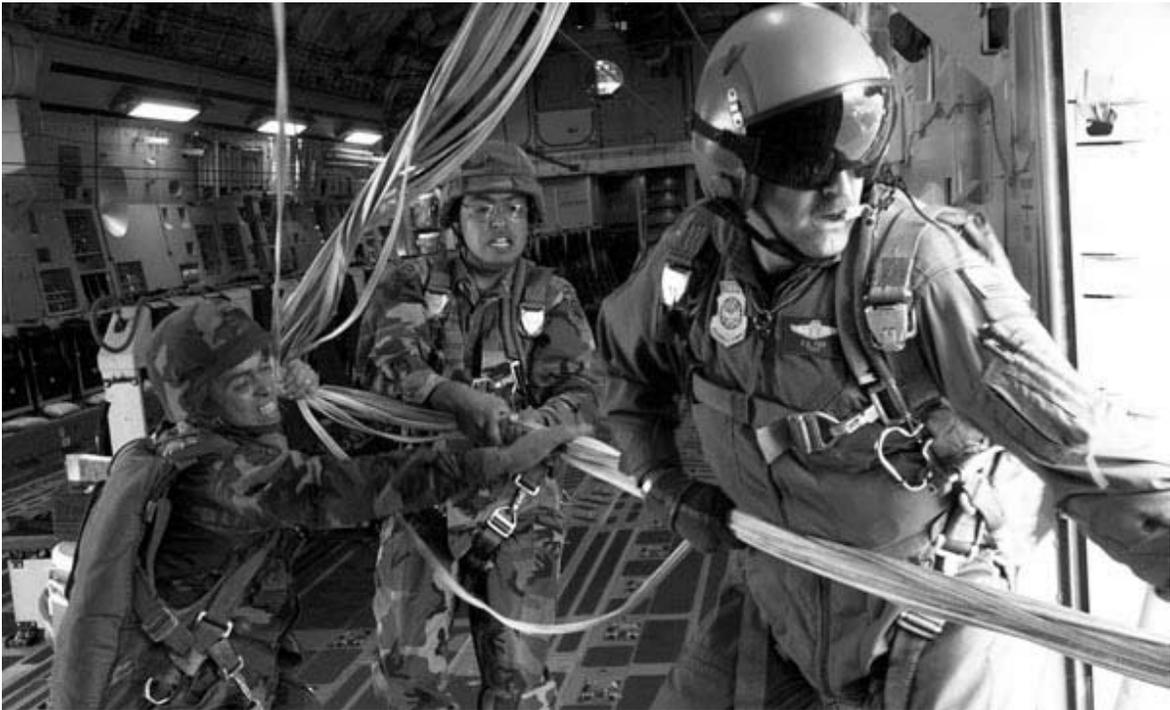
SL1_20110202_507PIR_Broken_USL_C130

Description of Suspected - Malfunction - Incident - Damaged Incurred: He is the #1 jumper on Chalk eight of 13 jumpers. The jumper leaves the jump platform leading off with his left foot just as his right foot clears the platform he experiences a violent jerking, pulling and turning him back towards his right side now facing the aircraft. The deployment process of his T-10D main never gets past the 13th and 14th stows (seven and seven). The pack closing and connector link ties were broken. His body is being thrown both vertically and horizontally and he is rotating counter clock wise around the point of attachment which is the universal static line snap hook at its point of attachment inside the A/C. Approximately 16 seconds after he exits he pulls his reserve parachute. As the A/C begins its left hand pattern turn, the pilot accelerates, the right door safety begins to retrieve the D-bags and the jumper's static line breaks. He does land on the surveyed Drop Zone.

Extensive burns on the right set of risers (rear outside) width of USL from the Male Fitting Canopy release extending to 9 1/2 inches down the risers

Burns on the right rear outside & right front inside

SLCP left connector snap tie is broken, the retaining strap is not assembled and the slot has extensive damage, Static line sleeve is shredded; Cotton buffer is also extensively damaged

Right Main lift web has burns and searing between the CRA and equipment D-ring

Waist band has burns approx 5 inches from the pack tray behind the SLCP Left waistband retainer

Suspected Cause of Malfunction - Incident: The Universal Static Line was misrouted under the right set of risers. As the jumper exits, this is what causes the initial violent jerk to the jumpers right as the jumper begins to be towed by his USL which is misrouted under/behind his right set of risers, he is being thrown vertical and horizontal which causes his USL to become routed through his left connector snap.

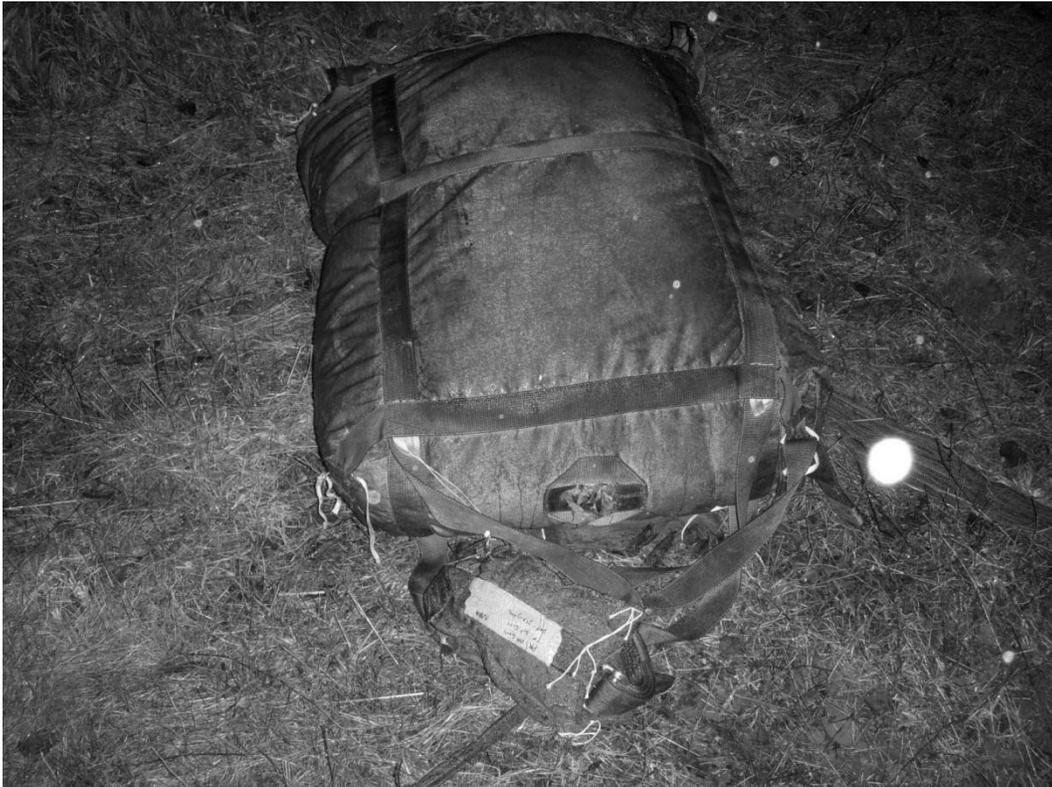
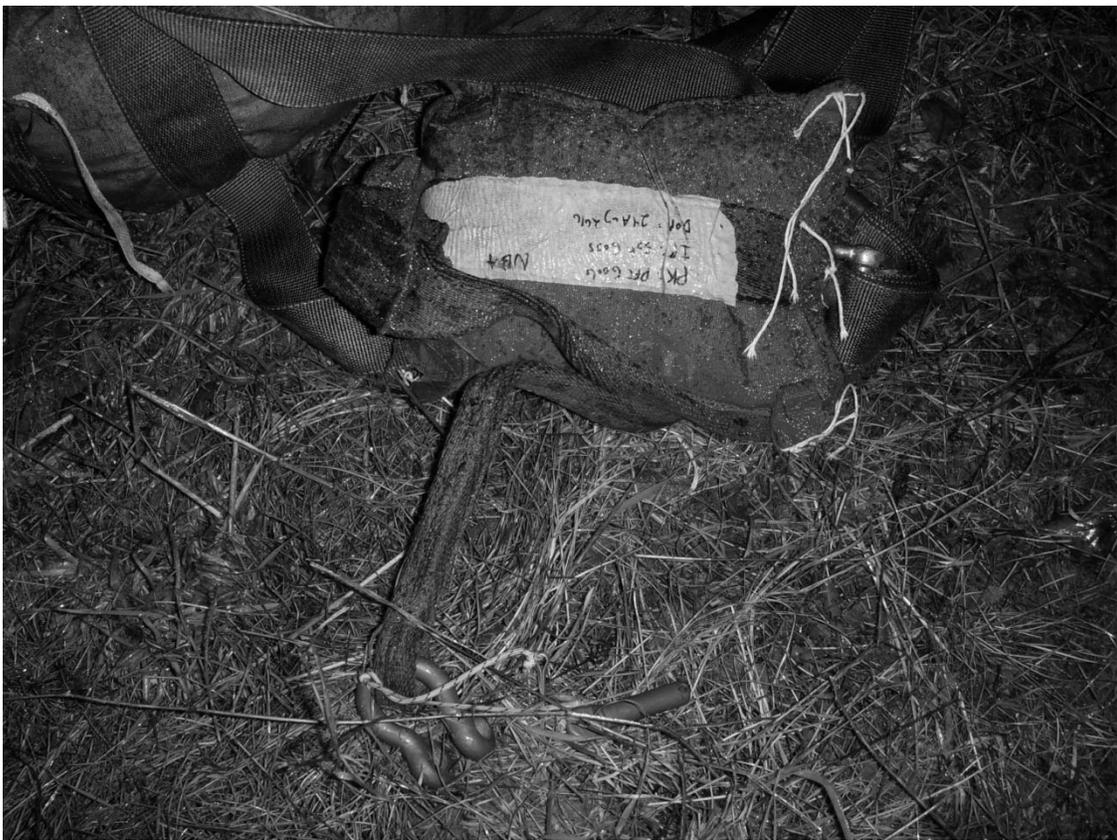
CDS6_20110231_5QM_Static_Line_C130

There was minor damage to the G-12 deployment bag, no damage to the G-12 parachute and 68” pilot parachute. The A-22 container is BER.
