140th TRIANNUAL AIRDROP REVIEW and MALFUNCTION SAFETY ANALYSIS BOARD

Feb 26- 27, 2013

MALFUNCTIONS / INCIDENTS REPORTED

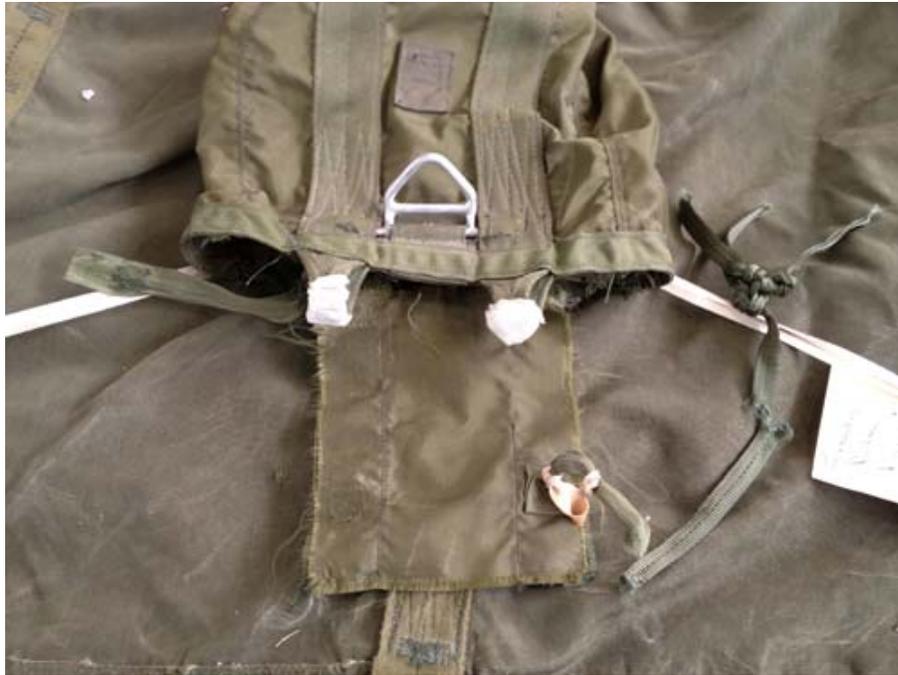
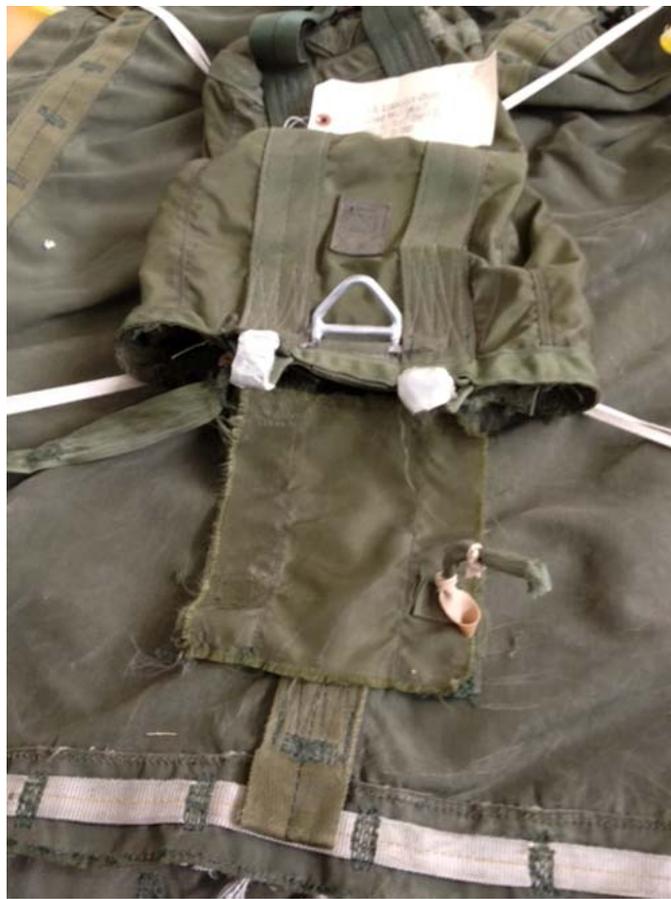
HE3_20120627_62AW_15'Extraction_Bag_Damage-C17

Additionally the figure eight tie was cut on one side. The other side was partially cut.

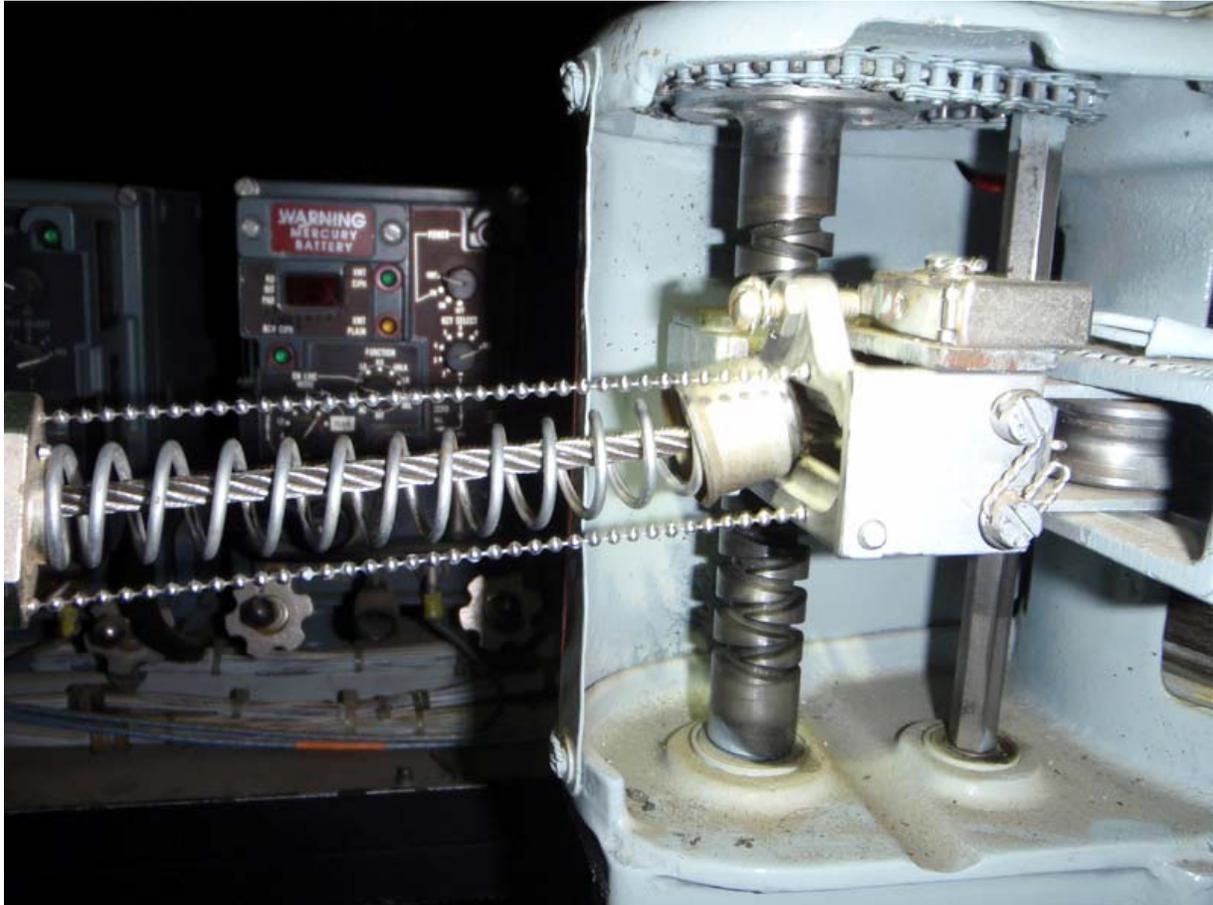
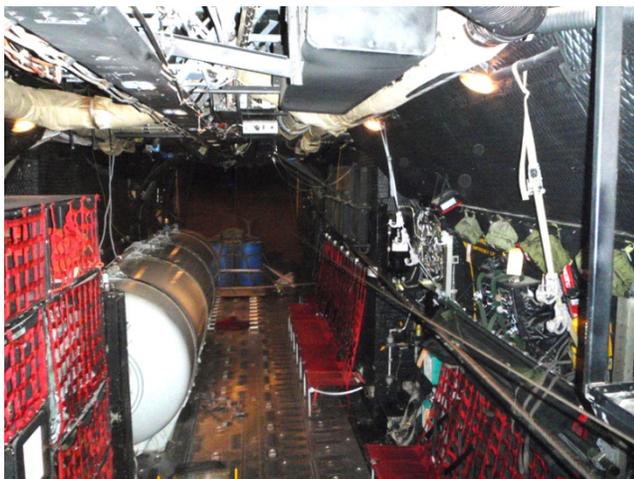
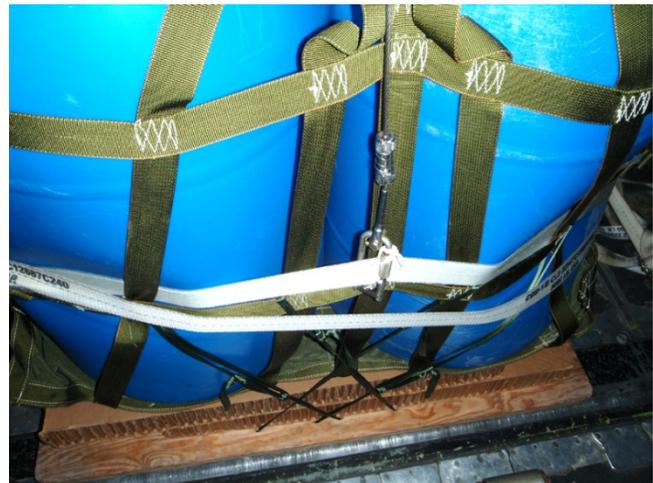
Suspected Cause of Malfunction - Incident: After going to the aircraft we noticed that that spring was not fully seated. We measured the beaded chains and found that one was 3/16 inch longer than the other and determined that the beaded chains being different lengths caused the spring to come out when the slack was taken up and pressure was applied to the static line retriever cable.
