134nd TRIANNUAL AIRDROP REVIEW and MALFUNCTION SAFETY ANALYSIS

Oct 19-21, 2010

MALFUNCTIONS / INCIDENTS REPORTED

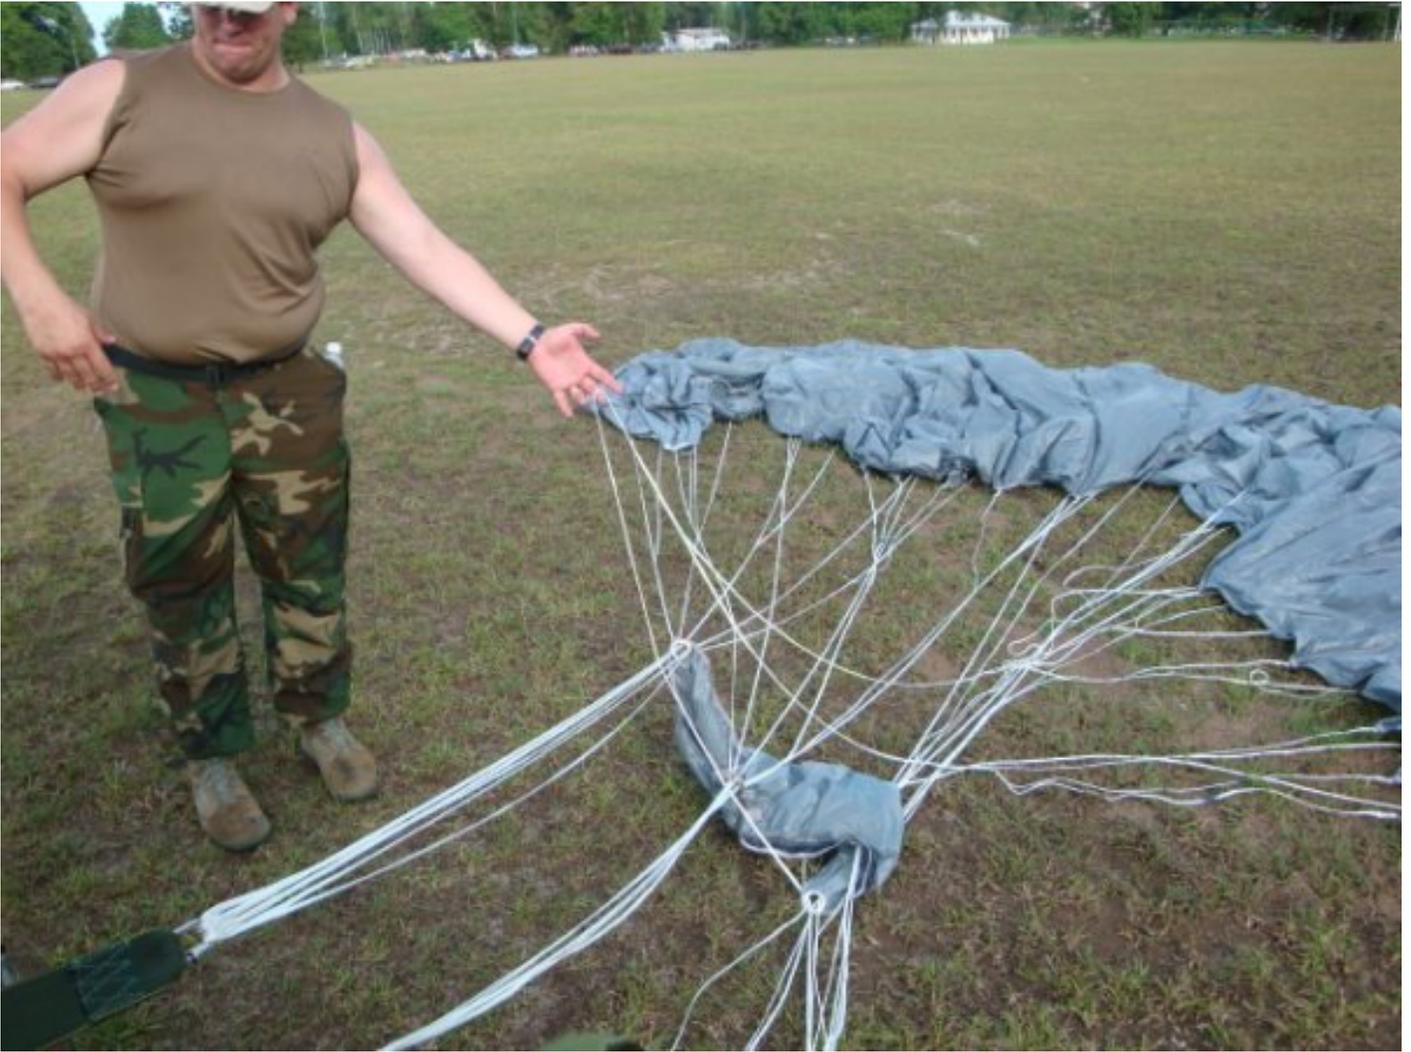
Description of Suspected Malfunction or Incident & Damaged Incurred: Upon diving out of the ramp jumper went into a tumble followed by a slow right spin, then two more tumbles until regaining control. Control was achieved at 7,000', Jumper realizing that he had lost track of the remaining jumpers and picked a clear lane and tracked stable for approx. 5 sec. Upon terminating the track, Jumper was between 4,500' and 5,000', he waived off and pulled the main ripcord. Jumper experienced normal opening and deployment of parachute getting out of the bag and deploying normally, Jumper saw a green strap fly in front of his face and immediately it started to cinch around his neck, instinctively, he pulled it over his helmet. Thinking that it was just a strap coming loose, maybe from the rucksack, he continued to monitor the main canopy which at that time was fully inflated. Then he started to be pulled to his left and upon checking, realized that the reserve was also fully inflated and at 90 degrees from his left. The two canopies looked fully inflated but jerking him left and right uncontrollably, he checked the altimeter and was at 3,000', he then cut away the main. Immediately upon cutting away he saw the main canopy flying away and began a fast spinning motion to the right. Jumper realized that the right steering line was wrapped around the left side suspension lines and it was choking all the suspension lines along with the slider. One attempt was made to trace the line and untangle it, to no avail. In order to stop the spinning, jumper had to pull hard on the left toggle until it was down to his feet. The reserve canopy stopped spinning but it was very uncontrollable but managed to steer it toward the east side of the DZ. Just before crossing the east edge of the DZ on final, jumper managed to lower his rucksack to his feet and hold it with his foot, Approx. at 30'-40' he lowered the rucksack and gently start to pull the steering lines without completely collapsing the parachute. The canopy went into an almost vertical descent so he did a quick PLF after reaching the DZ.

Suspected Cause of Malfunction or Incident: The three STS jumpmasters and the two riggers conducted a board and concluded that the probable cause of the dual main and reserve deployment may have been a combination of over stretched Cypress closing loops and the excessive G forces on the jumper and parachute from the instability just prior to canopy deployment. The likely cause of the line over partial malfunction may have been the low speed deployment of the reserve parachute, and that may have resulted in the reserve free bag going through a line on opening.

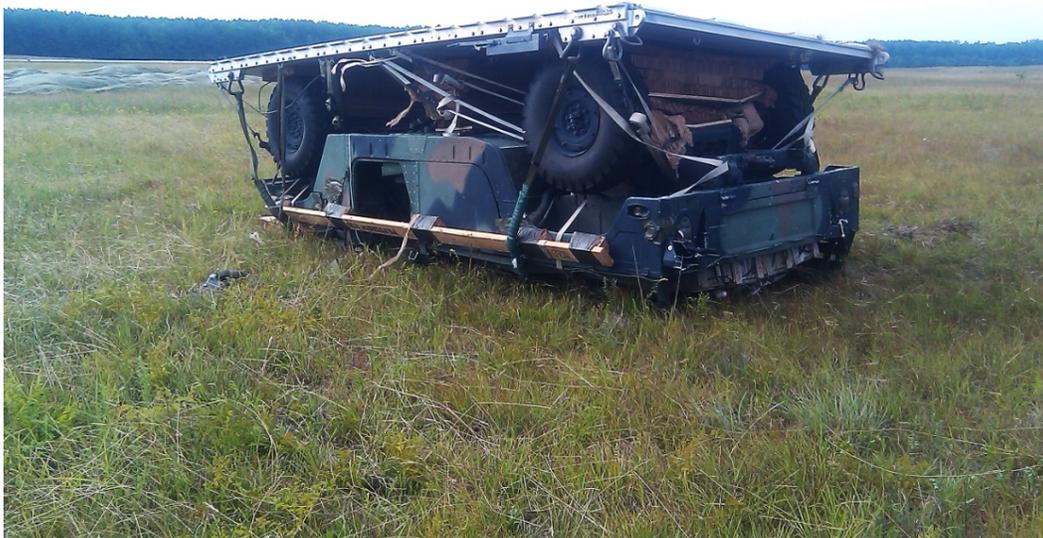
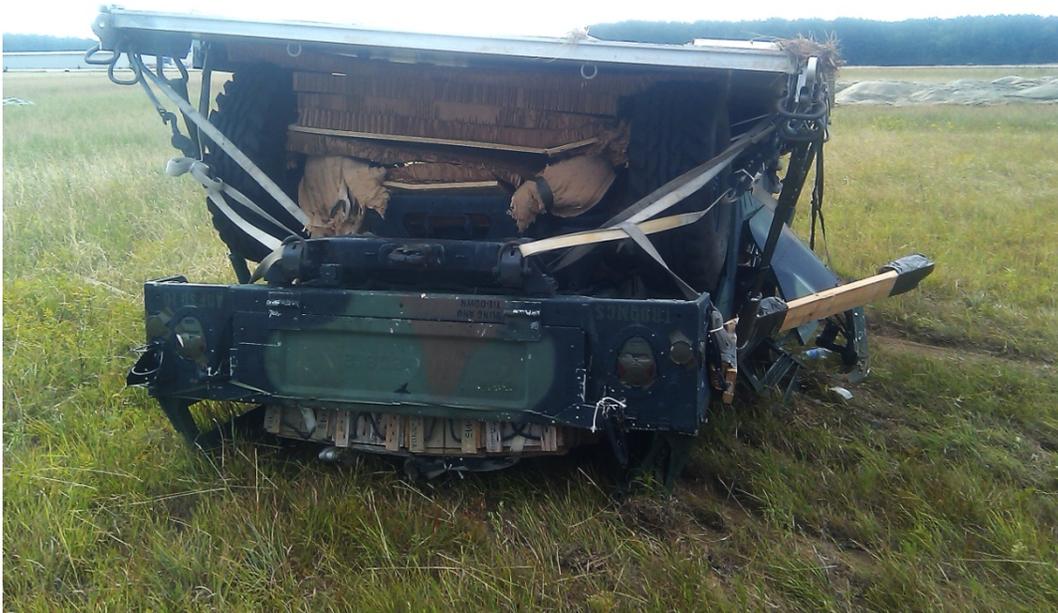
then removed from the parachute release connectors. At this time, the timer block fell allowing the upper suspension link to extend and release the parachute release connectors. Upon returning from Blackstone DZ, the M-1 release timer was inspected and conducted three delay release timer tests with an average time of 12.3 seconds

Suspected Cause of Malfunction or Incident: M-1 release did not properly release. Rigger inspected and timer had an average of 12.3 seconds. Suspected cause is fault on M-1 release. The M-1 release did not reach the critical angle.

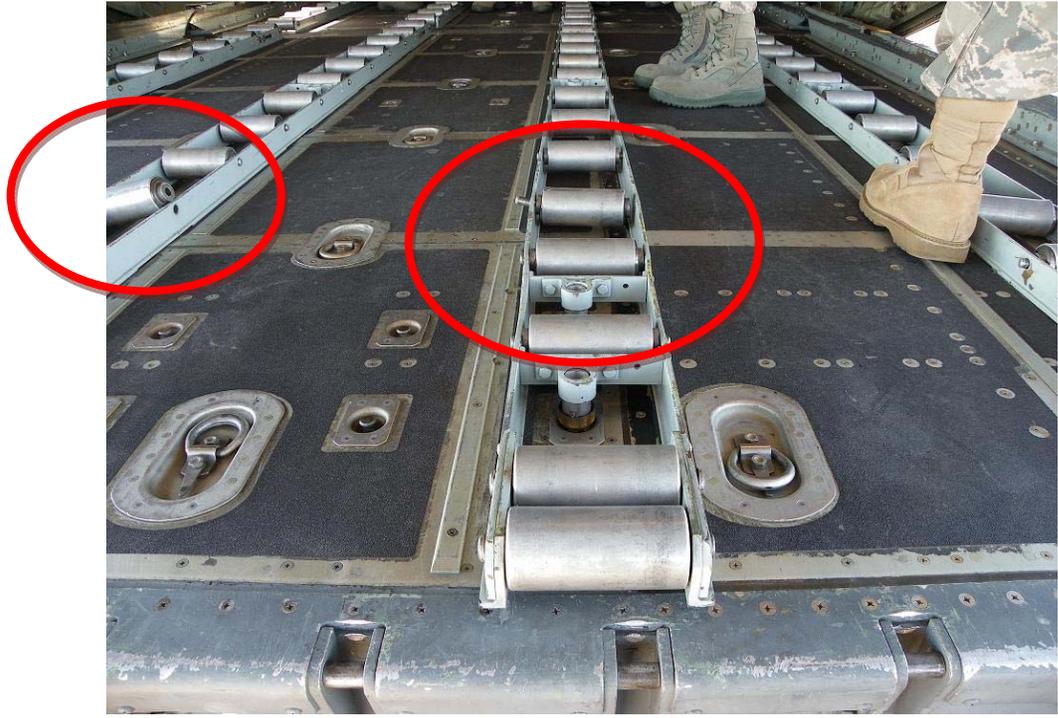
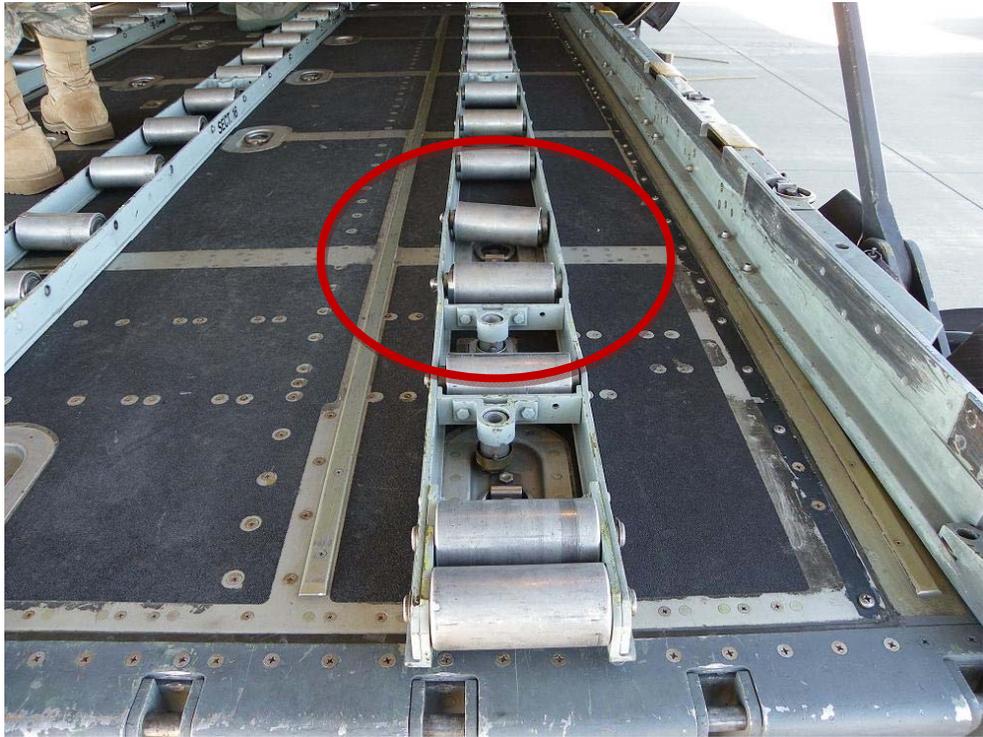
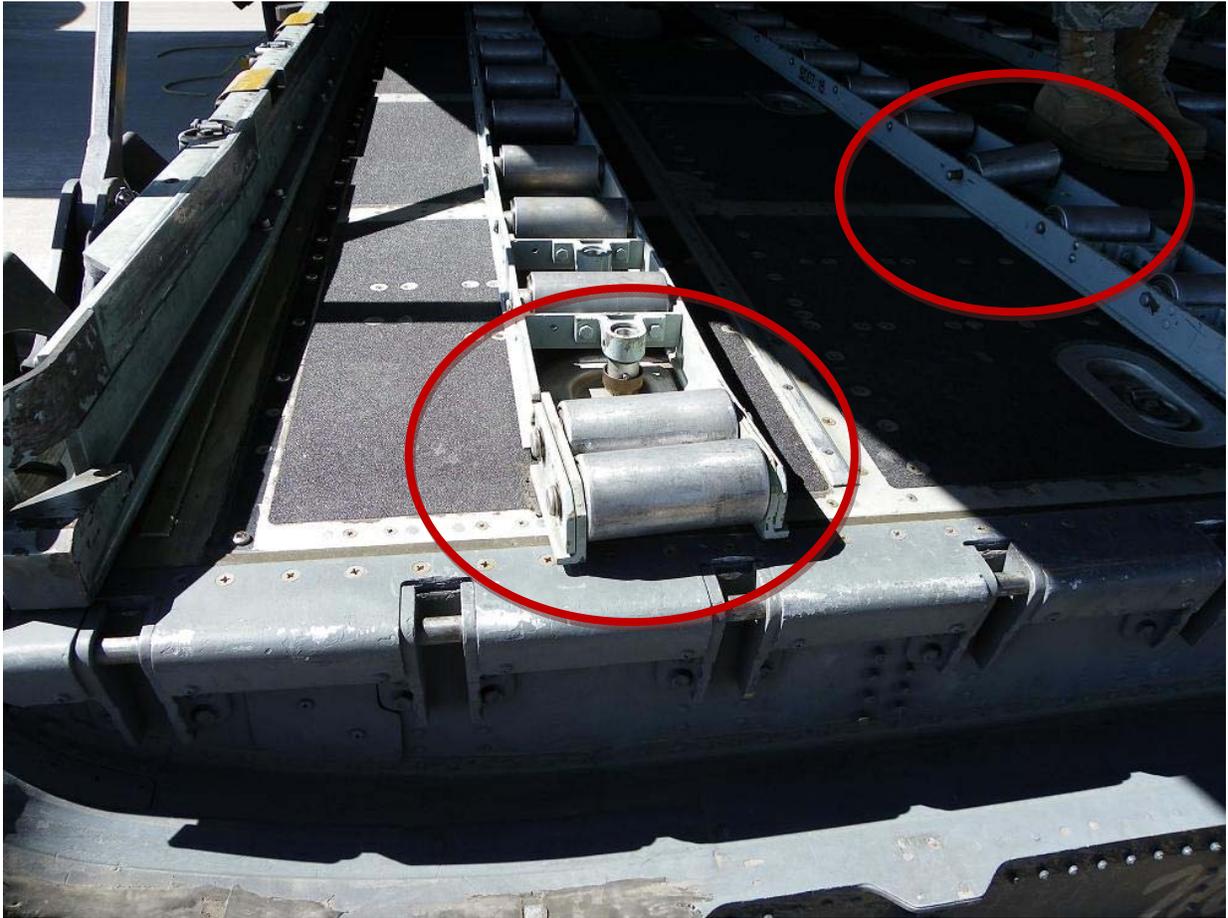
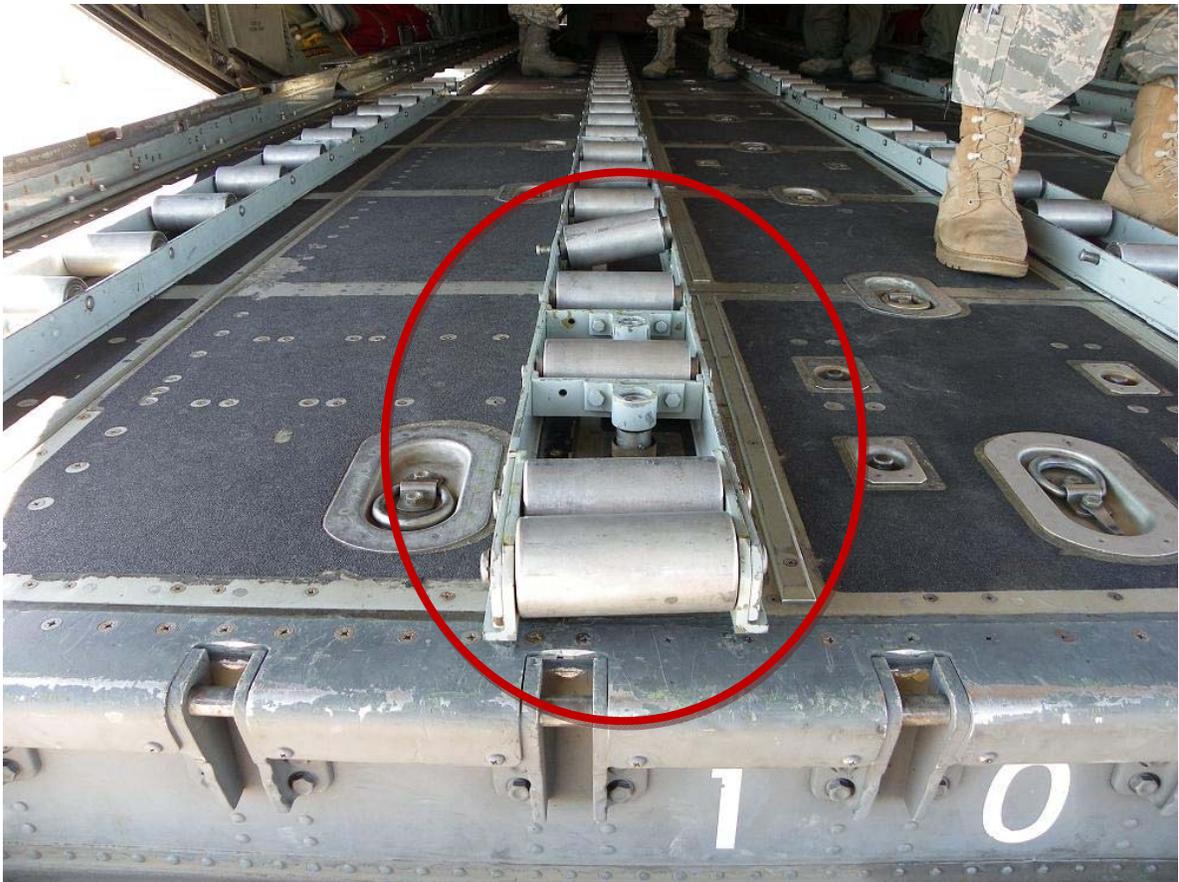
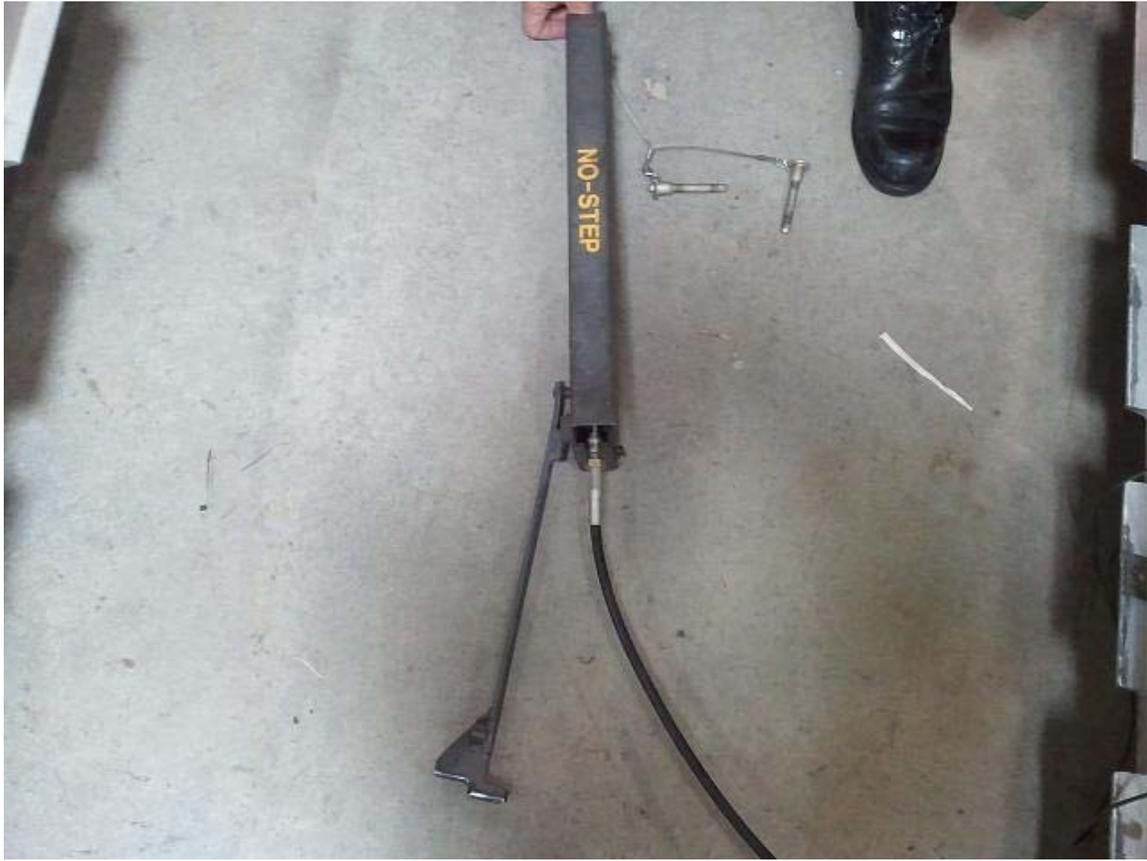
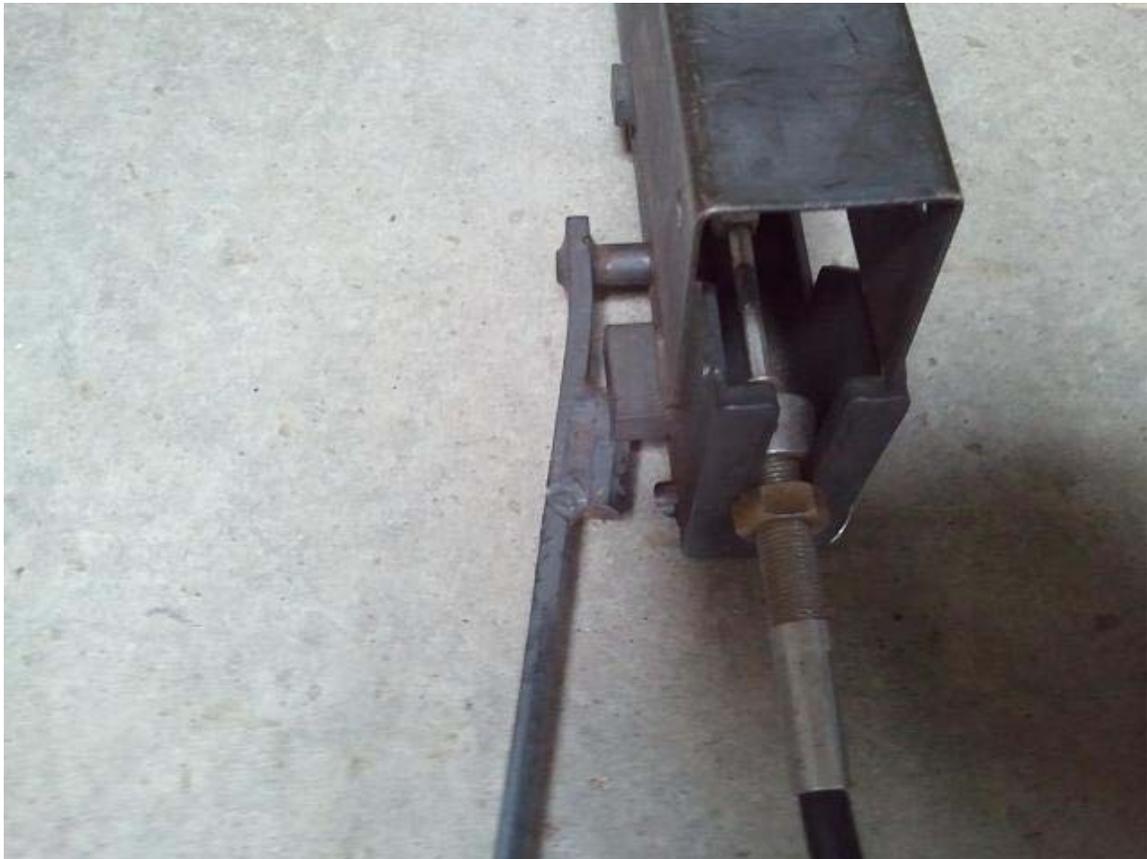
Description of Suspected Malfunction or Incident & Damaged Incurred: ., The Malfunction occurred during a heavy equipment airdrop, dropping a 3625lb 8ft platform utilizing one 15ft extraction parachute and two G 12E parachutes. After the extraction parachute released from the bomb rack, it opened and extracted the 60ft extraction line connected to the 3 point link assembly on the EFTC. At the time the extraction line became fully extended and the full extraction force was being applied to the latch and link assembly the latch and link assembly failed and the 3-point link released from the latch causing the extraction parachute to pull the two G12E cargo parachutes from the airdrop platform the two and both parachutes deployed/opened fully beyond the rear of the tail of the aircraft. Once both G12E cargo parachutes fully deployed, right hand lock (#10) was overcome and the airdrop platform extracted from the aircraft. Due to the majority of the extraction force pulling the FWD suspension slings during the extraction of the platform, the platform began to immediately rotate upward as it cleared the vertical restraint lip (ending at FS677) provided by the dual rail system, The platform rotated a full 90 degrees up by the time it cleared the ramp and door. The AFT edge of the platform struck (skipped) off the last 30 inches of ramp rollers causing damage to all 4 rows of ramp rollers as it exited the aircraft. The platform fell to the ground under both cargo parachutes and without incident. No major damage visible on the airdrop platform (to include the AFT edge of the platform which struck the ramp rollers). On the ground the actuator arm was found to be bent outward one inch from its normal position, and the cause of this is unknown but suspected to have happened as the airdrop platform landed on the ground. The 12ft release cable is still intact and connected to the actuator and latch assembly. At this time the link assembly and latch assembly work as advertised during initial rigging of connecting the link assembly to the latch assembly. At this time the platform and all items associated with the airdrop are secured awaiting further testing/direction from HHQ. NOTE: Airdrop Platform dimensions: HT: 44" W: 108" L 96" NOTE: The cargo parachute that was repacked on 24Aug09, was inspected on 25Feb10. Latch Markings: 11-1-1725 MRF 57282 87 Link Marking 1: 11-1-17154090 or 3434

Suspected Cause of Malfunction or Incident: Faulty Latch/Link Assembly on EFTC

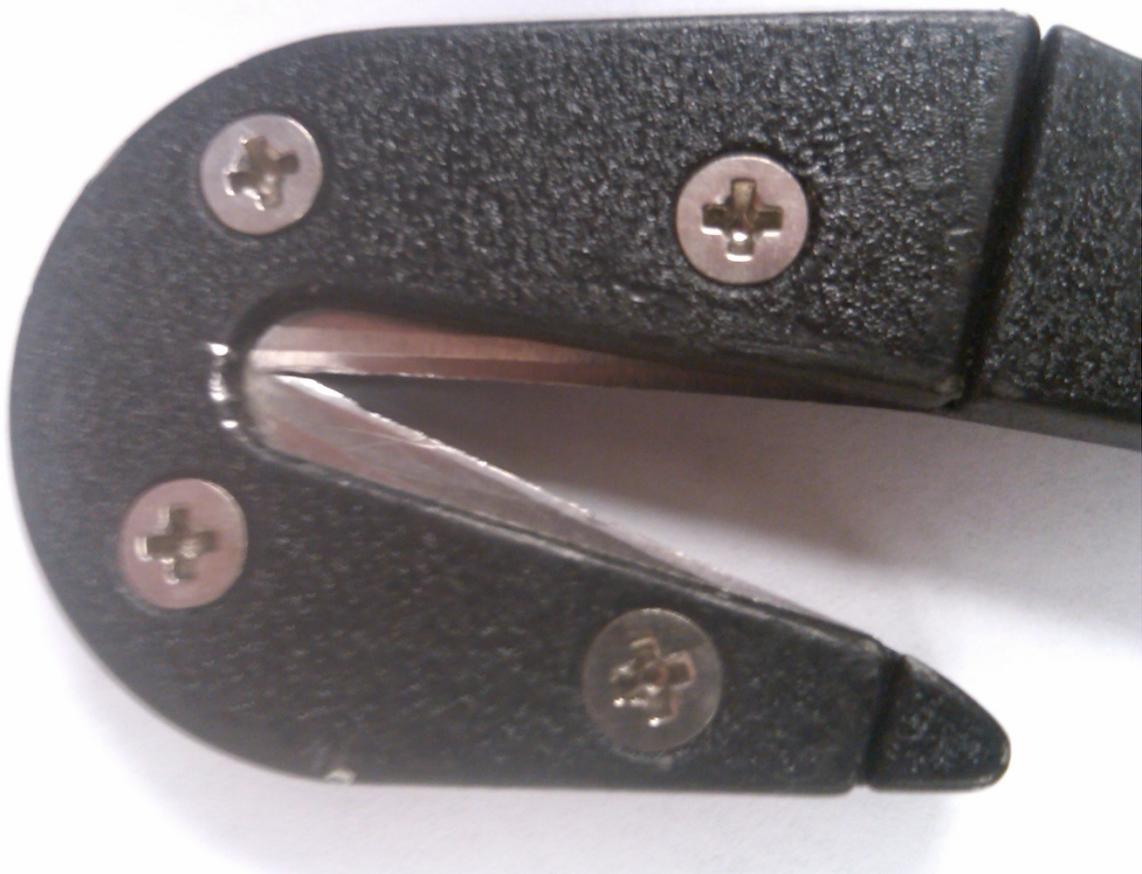
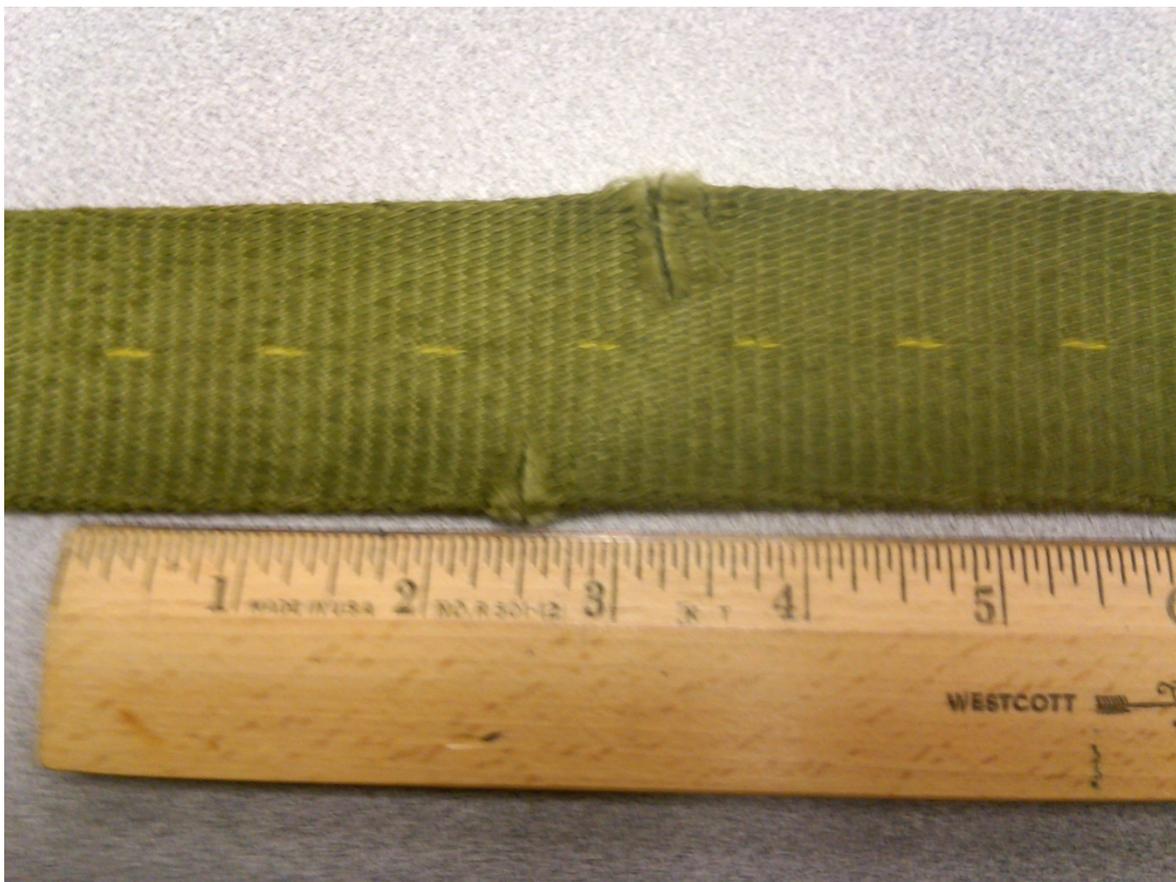
Description of Suspected Malfunction or Incident & Damaged Incurred: Incident. Planned mission was a local tactical airdrop, dropping a single 700 lb CDS load using manual gate cut procedures utilizing the miniature J-knife. At green light, the Loadmaster attempted to cut the Type XXVI nylon release gate. The knife stopped cutting after making an approximate 9/16 inch cut into the nylon. The Loadmaster attempted to cut the release gate a second time (making a 1/2 in. cut), and a third time (making a 7/16 in. cut) to the bottom side of the release gate. The gate failed to cut and malfunction procedures were initiated.

Suspected Cause of Malfunction or Incident: The miniature J-knife blades were worn down to the point that the cutting edges were curled over or flatten, not allowing the knife to cut through the release gate material. Recommend that the airdrop Loadmaster(s) inspect their personal airdrop equipment for serviceability.
